2.0 ROYAL STANDARD: The property comprises a conversion of what was originally nurses accommodation for the local hospital.

2.1 EXTERNAL

Front Elevation

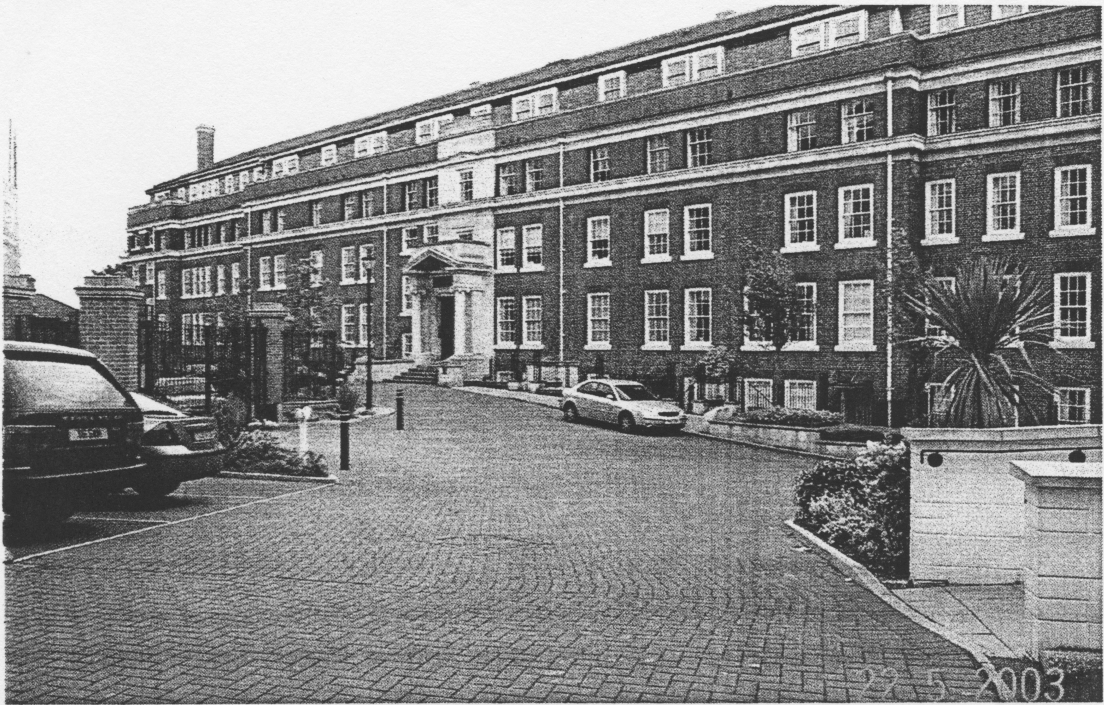
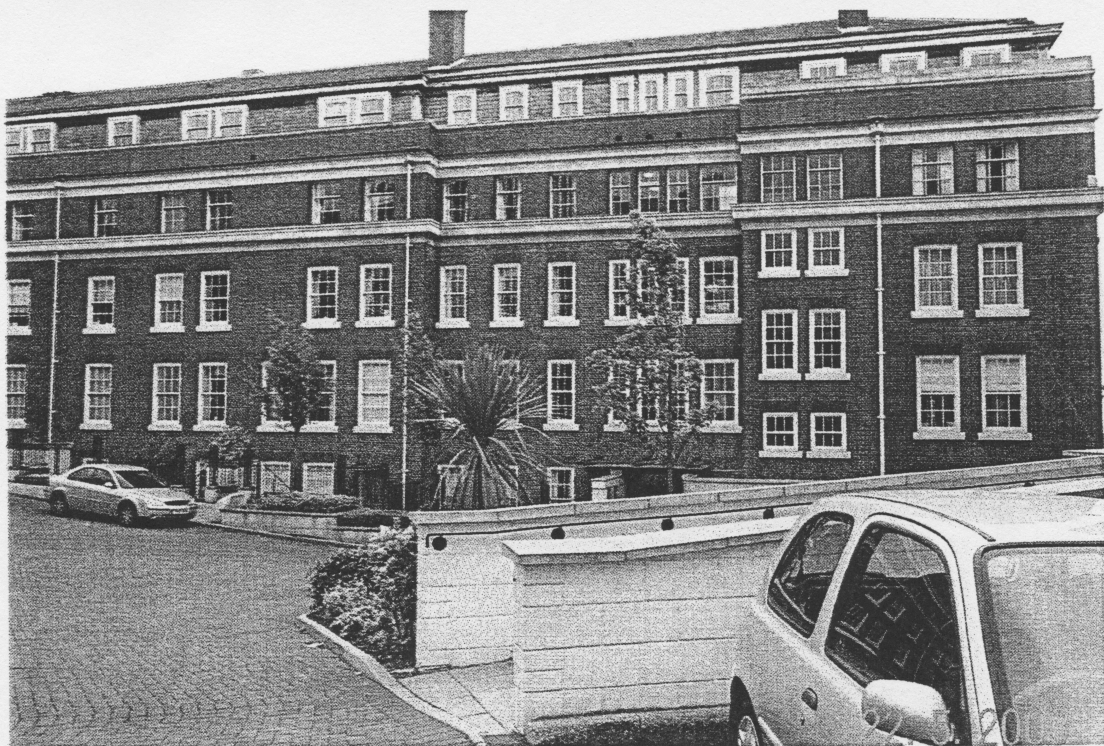
Roof Coverings: The roof is covered with slates having a copper ridge and what I believe replacement copper hips.

Along the pitch there are a number of replacement slates, possible ventilating slates and several roof lights.

To the right hand ridge there is one patch repaired section and a further more substantial length at the abutment to the hip. The roof slope is generally covered with algae and staining, particularly to the main areas and the left hand side.

The roof steps forward to the central section and there are a number of displaced slates at eaves level in this location.

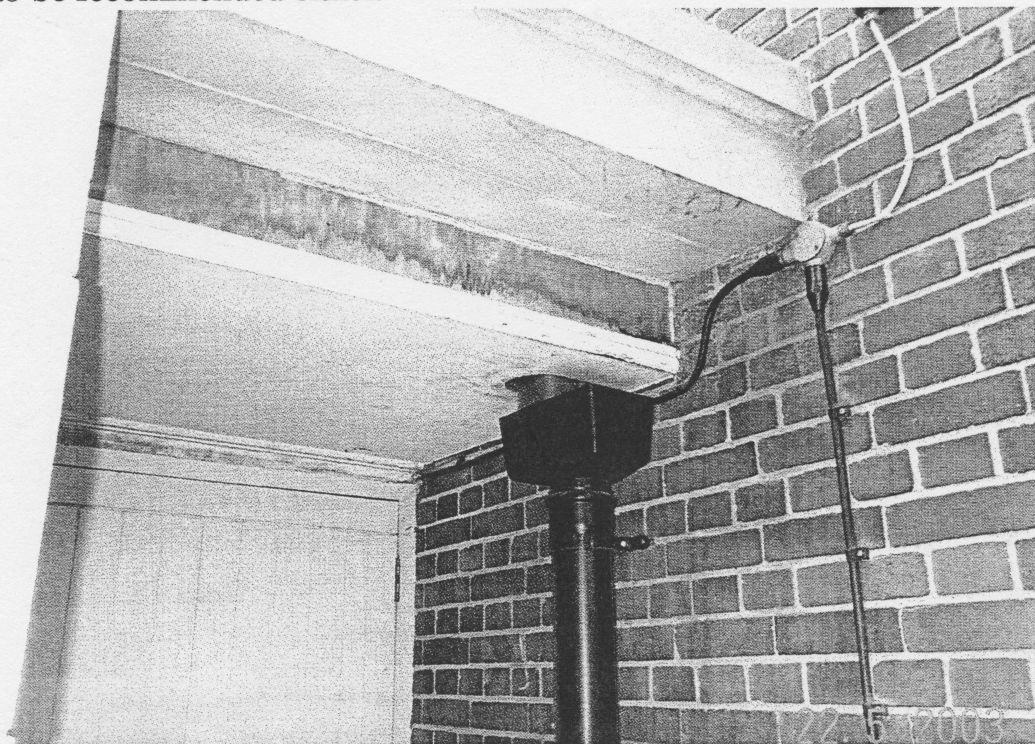
Most rainwater pipes (but in particular the left hand one) show signs of corrosion grinning through and the bottom pipe is displaced out of vertical alignment. This routes through and within the left hand bottom stone enclosure.

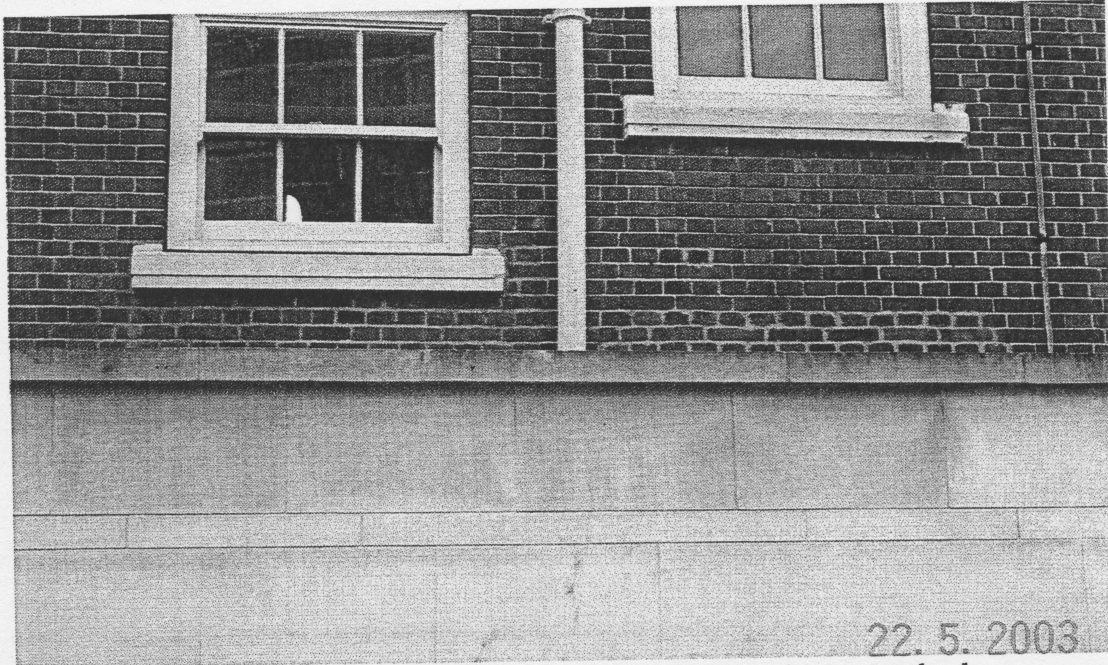
Within the brickwork, particularly to the right hand side, there are sections of isolated bricks which have been replaced above both the first and second floor window head areas.

Brickwork is laid to an English Bond with tight mortar joints which have not been matched when repointing has been undertaken and there are stone cills beneath the various windows.

In various areas these have cracked and have been patch repaired and repointed.

The above photograph is an illustration of none matching patched brickwork.

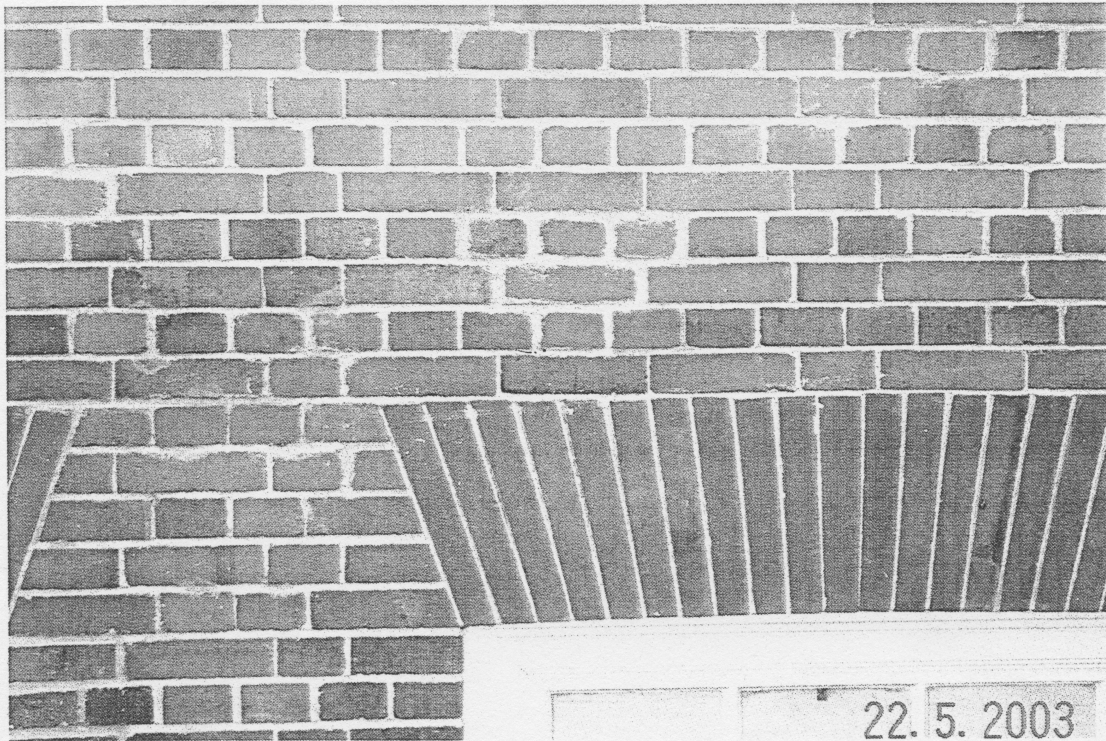
A closer examination of the brickwork revealed various areas where bricks have been replaced in the past, again in a none matching mortar and undersized bricks.

The above photograph illustrates none matching brickwork where isolated patch repairs undertaken.

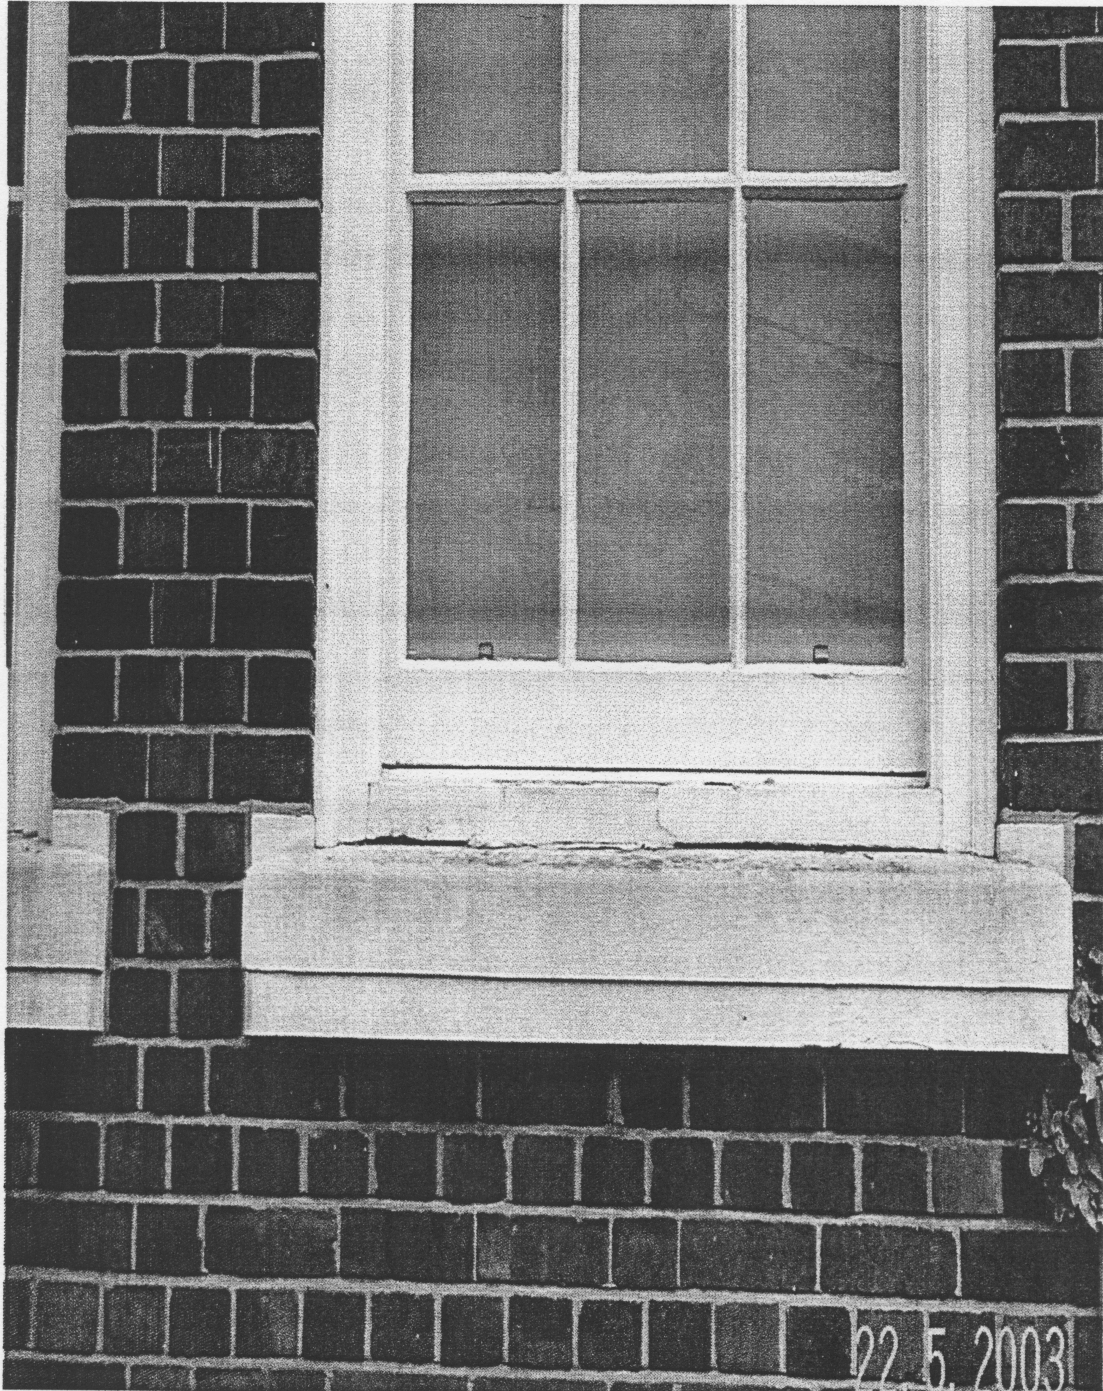
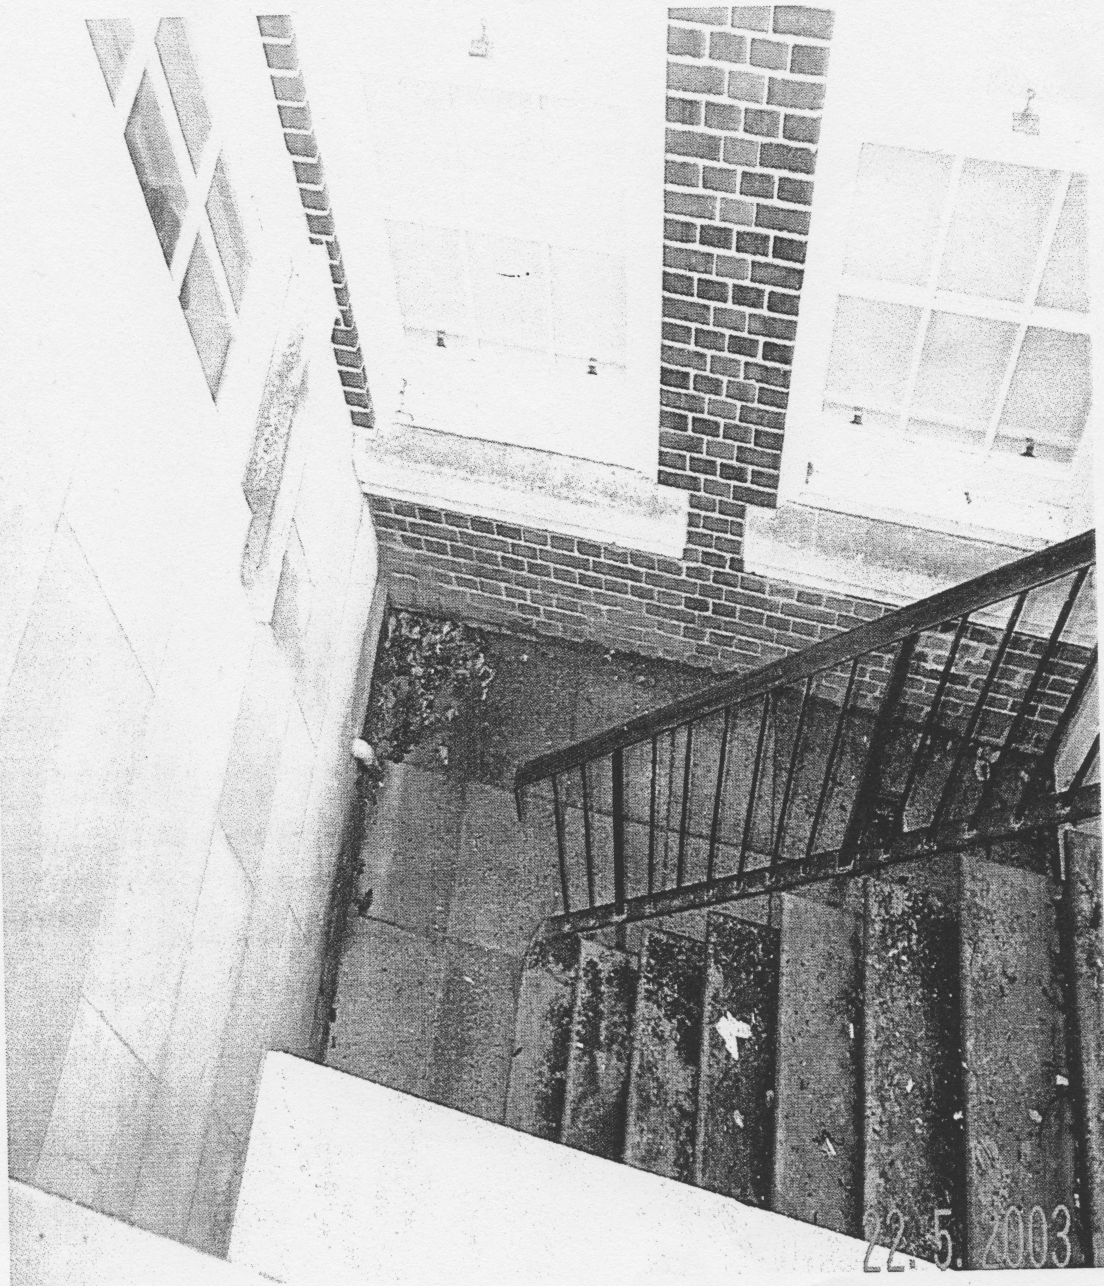
The various basements although having gullies to collect surface water, all appeared quite wet following recent rainfall and this had manifested itself in green mould growth traversing up the bottom courses of brickwork and also the stone work in the vicinity of the central entrance.

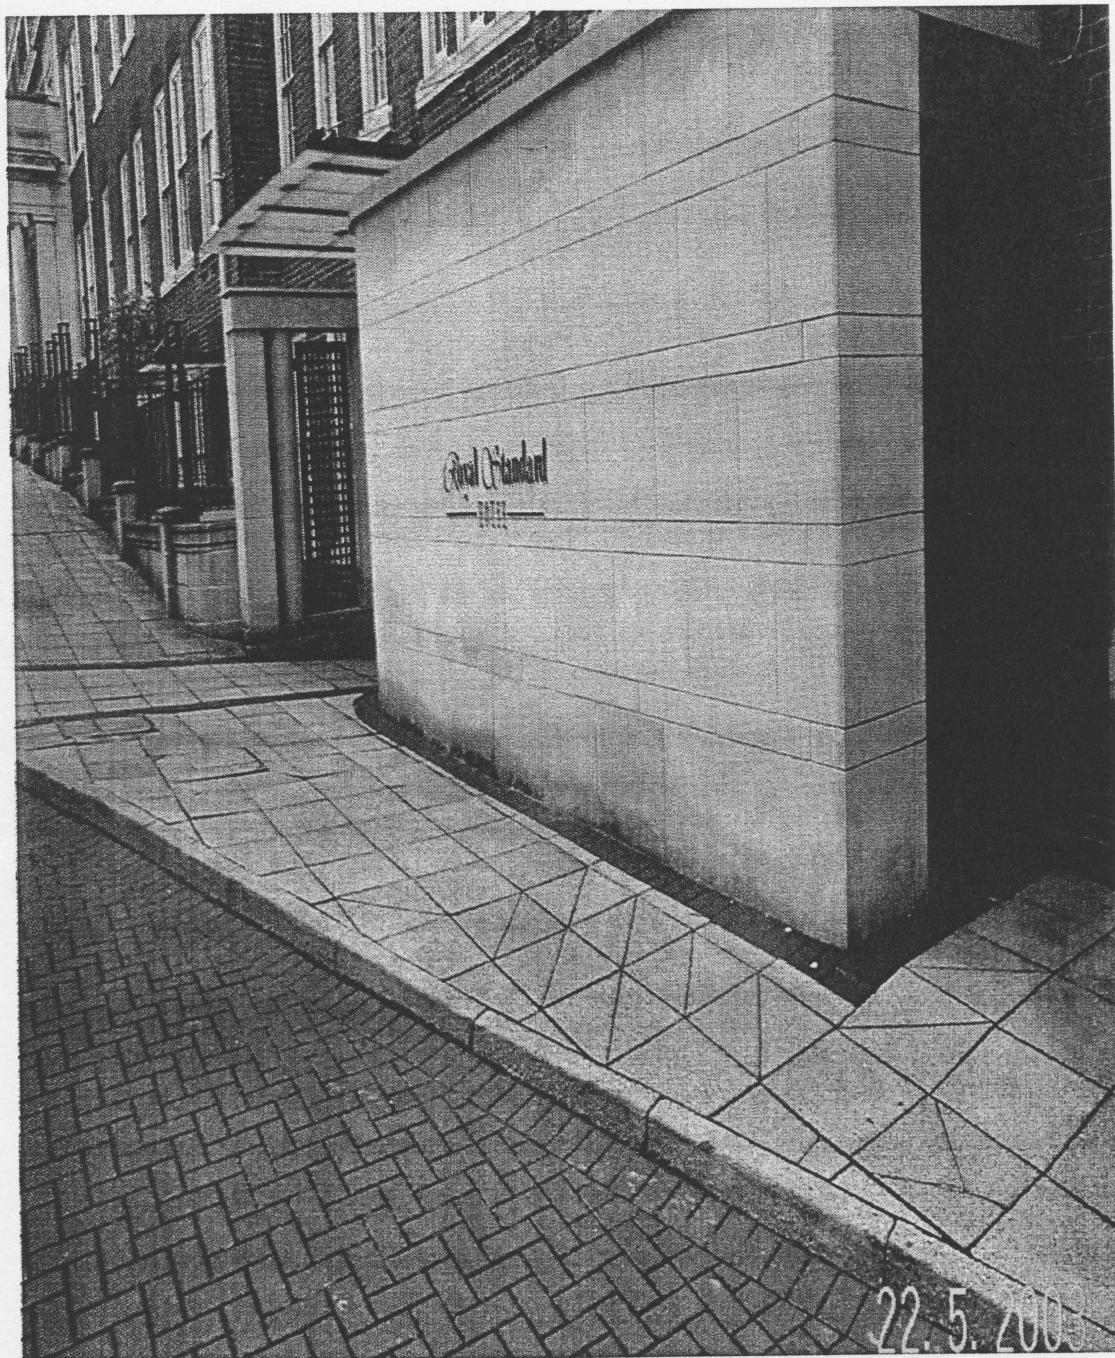
There is evidence throughout of mould and algae staining to the stonework, particularly where abutting the front footpath and isolated previous repairs to the stone blocks themselves.

Each extremity of stone surround to stores either end again has rising damp staining to the bottom courses of stonework.

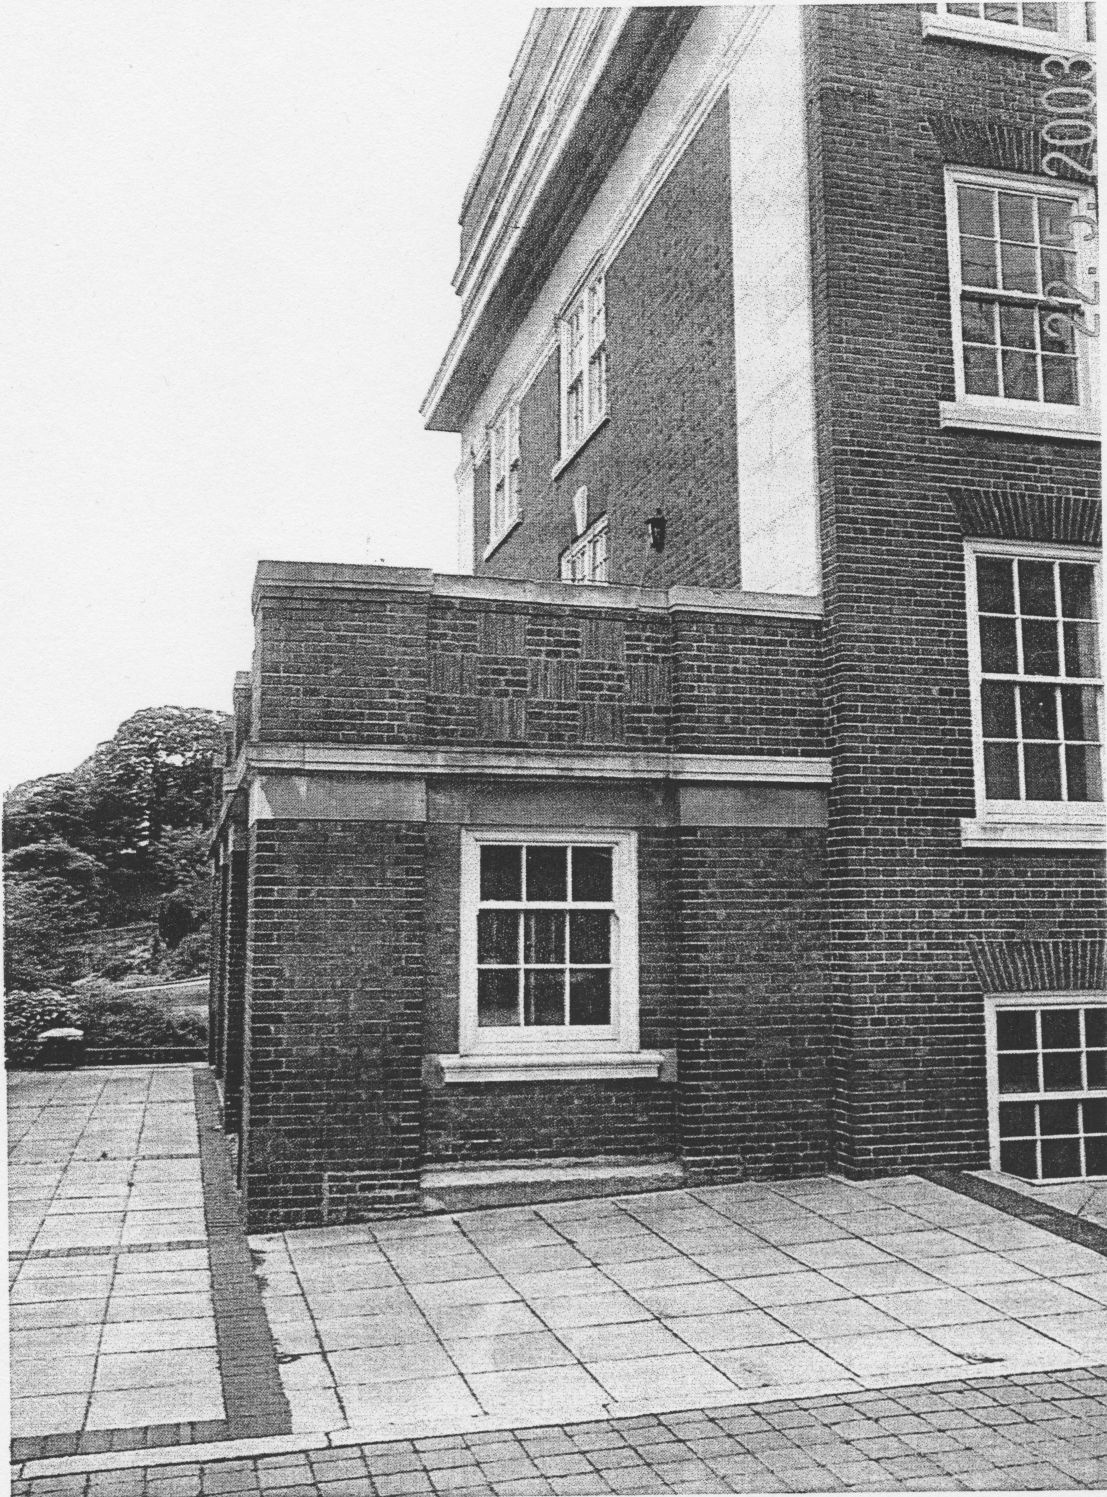
Left Hand Gable End: Inspection of this was extremely difficult due to the close proximity of adjacent boundaries.

There is a single storey flat roof structure, above which the resident has now constructed a roof garden.

Brickwork is displaced particularly above the head of the front window and there is general deterioration to the elevation as a whole, particularly at low level and above the stringcourse over the head of the windows.

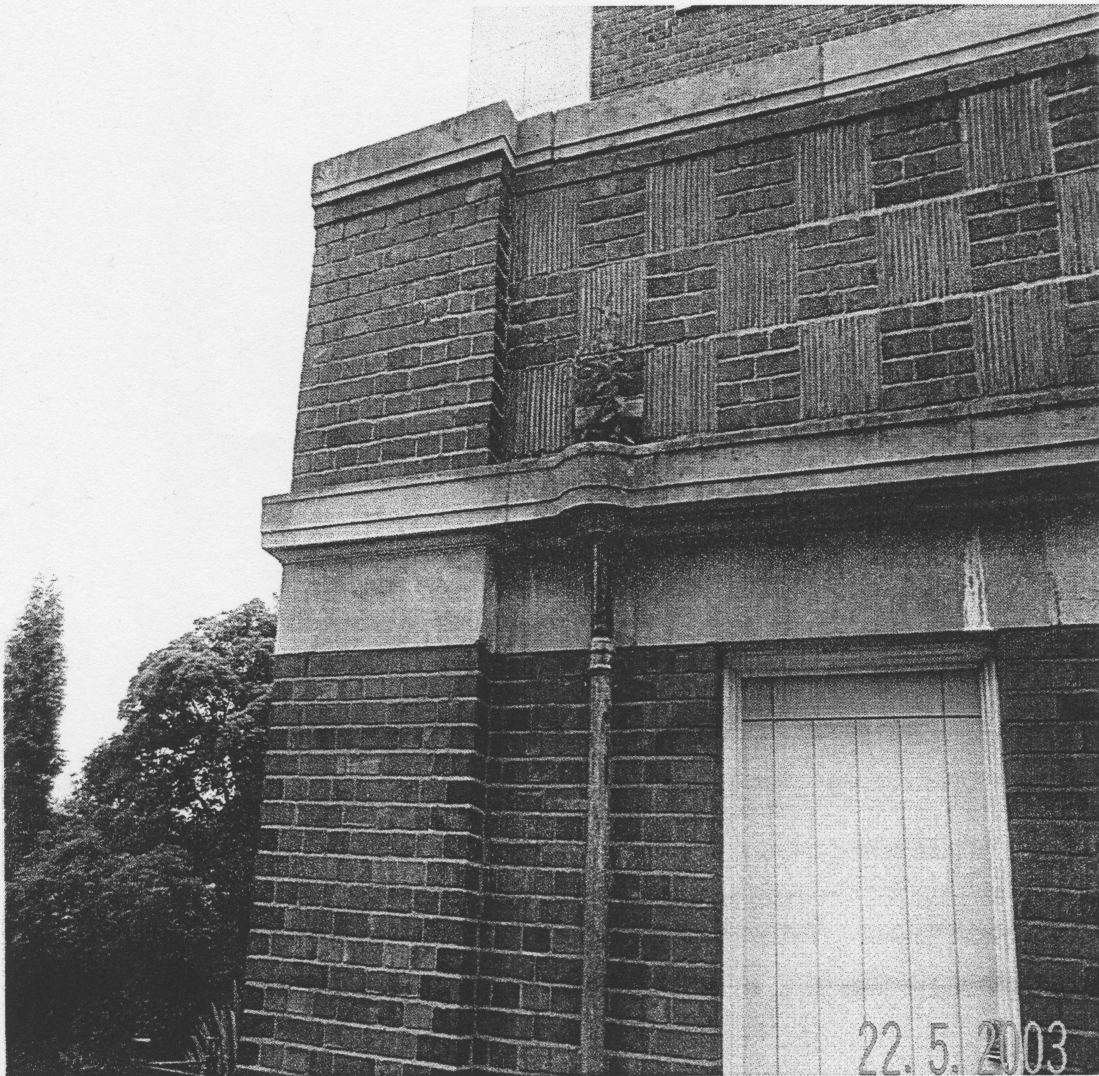
The roof is drained via two hoppers into cast iron rainwater pipes each in poor condition but that to the rear being displaced, with weeds growing out of the top and a broken pipe.

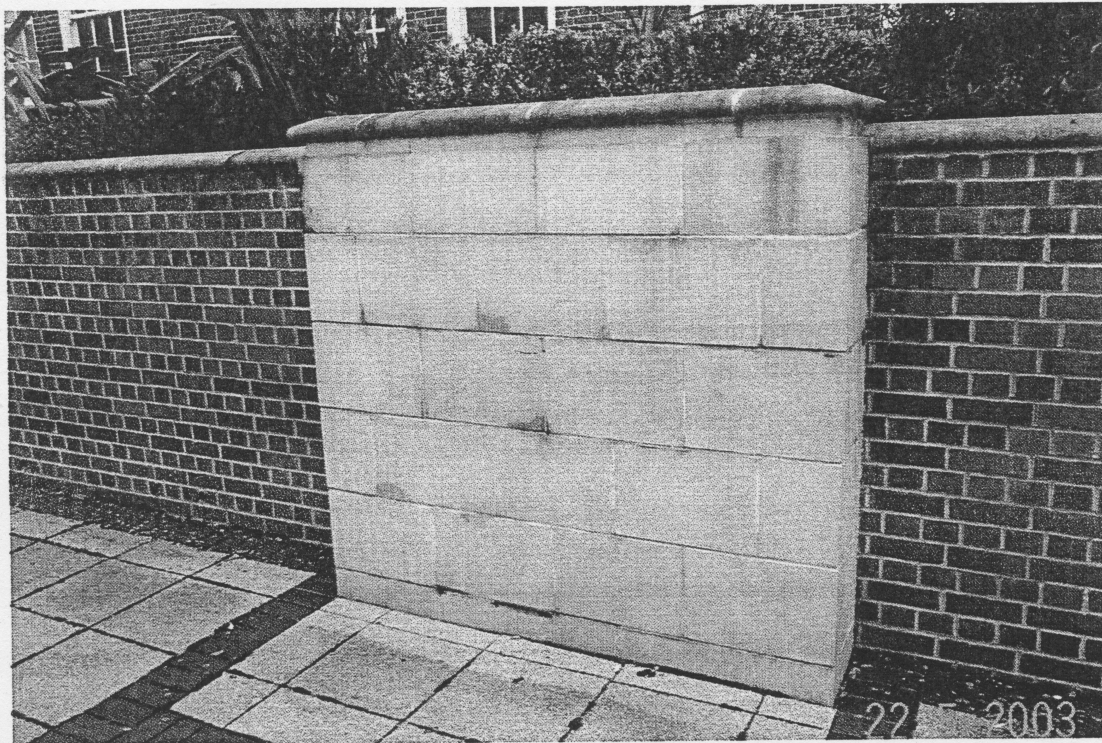
Moss has grown out of the joints of bricks immediately beneath the stone coping notwithstanding that there is a throating and there are weep holes to the bottom courses of brickwork to relieve to the build up of ground water pressure.

However, in the stone clad sections moisture is leaking through the various joints. Some cracking has already occurred and minor displacement, this will become progressively worse over a period of time.

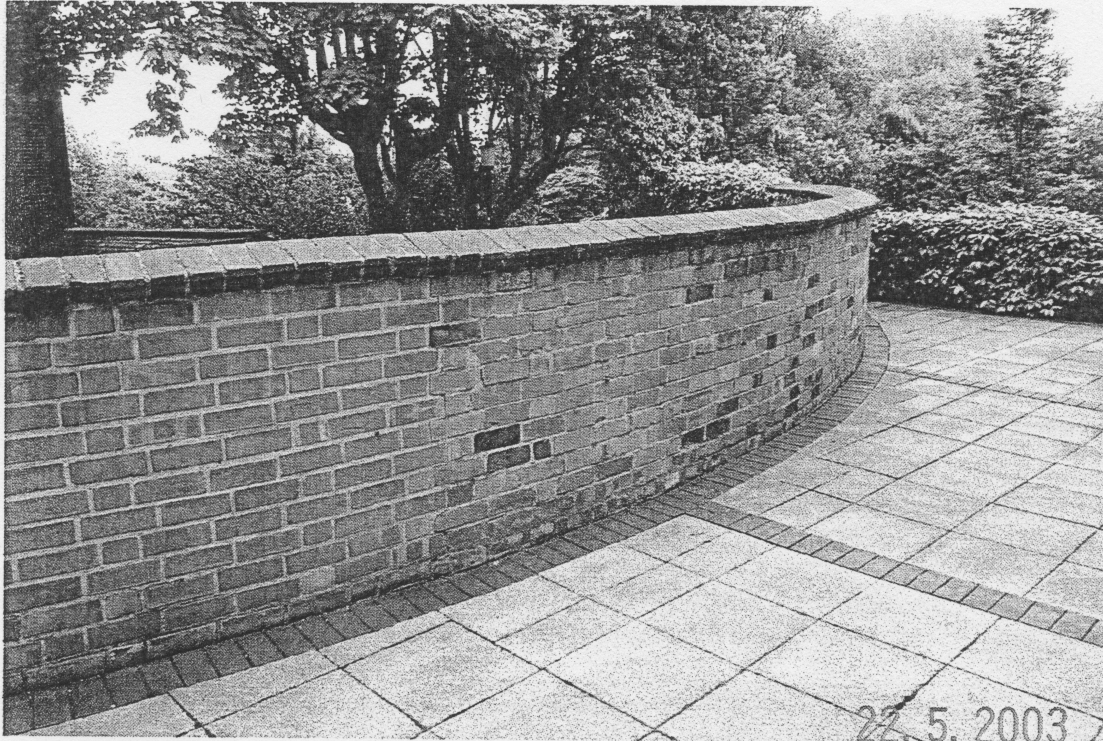
There is general erosion of brick faces and damp staining in various locations and in the approximate mid position a crack has developed with opening of joints.

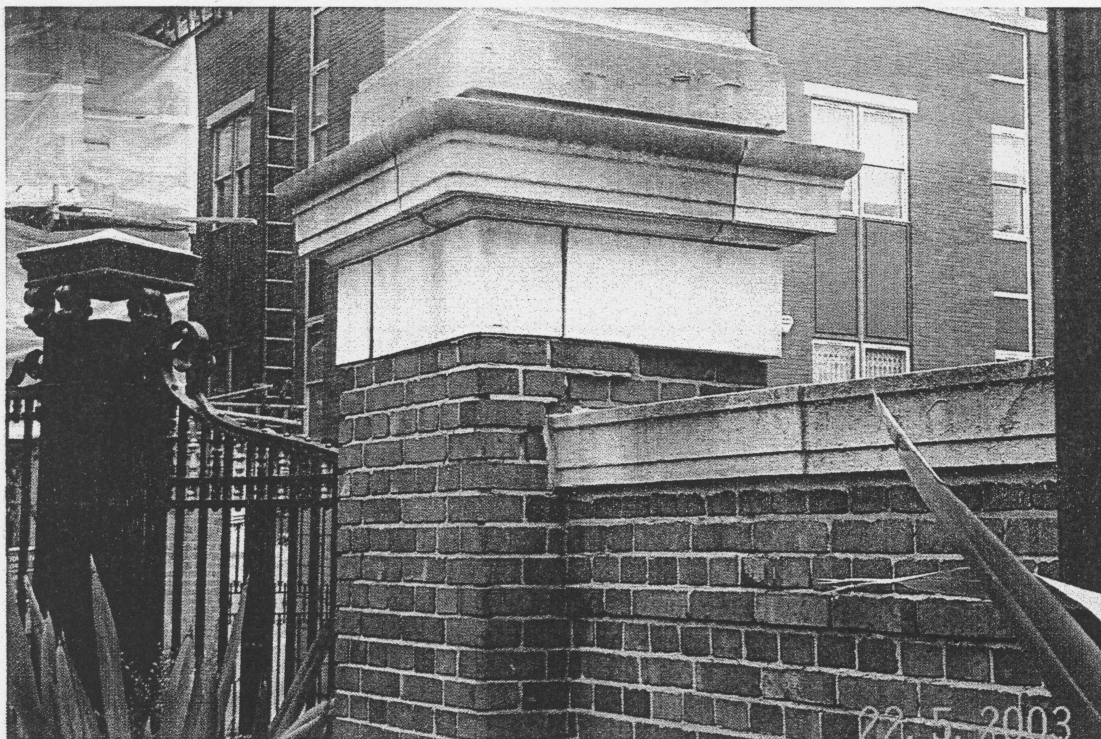
Further along it would appear that some of the brickwork has been rebuilt with bricks toothed in to a Flemish Bond but again cracks have developed with opening of joints.

N.B. Reference curved wall to left hand side, I noticed that the weep holes were actually immediately beneath paving level and underneath that on the outside there is extensive damp staining showing that there is no provision for the collection and discharge of surface water or ground water behind from the terraced area.

The remaining perimeter of brickwork is original with stone capping to match the elevation. To the extreme left hand side the corner cap is displaced from one of the pillars.

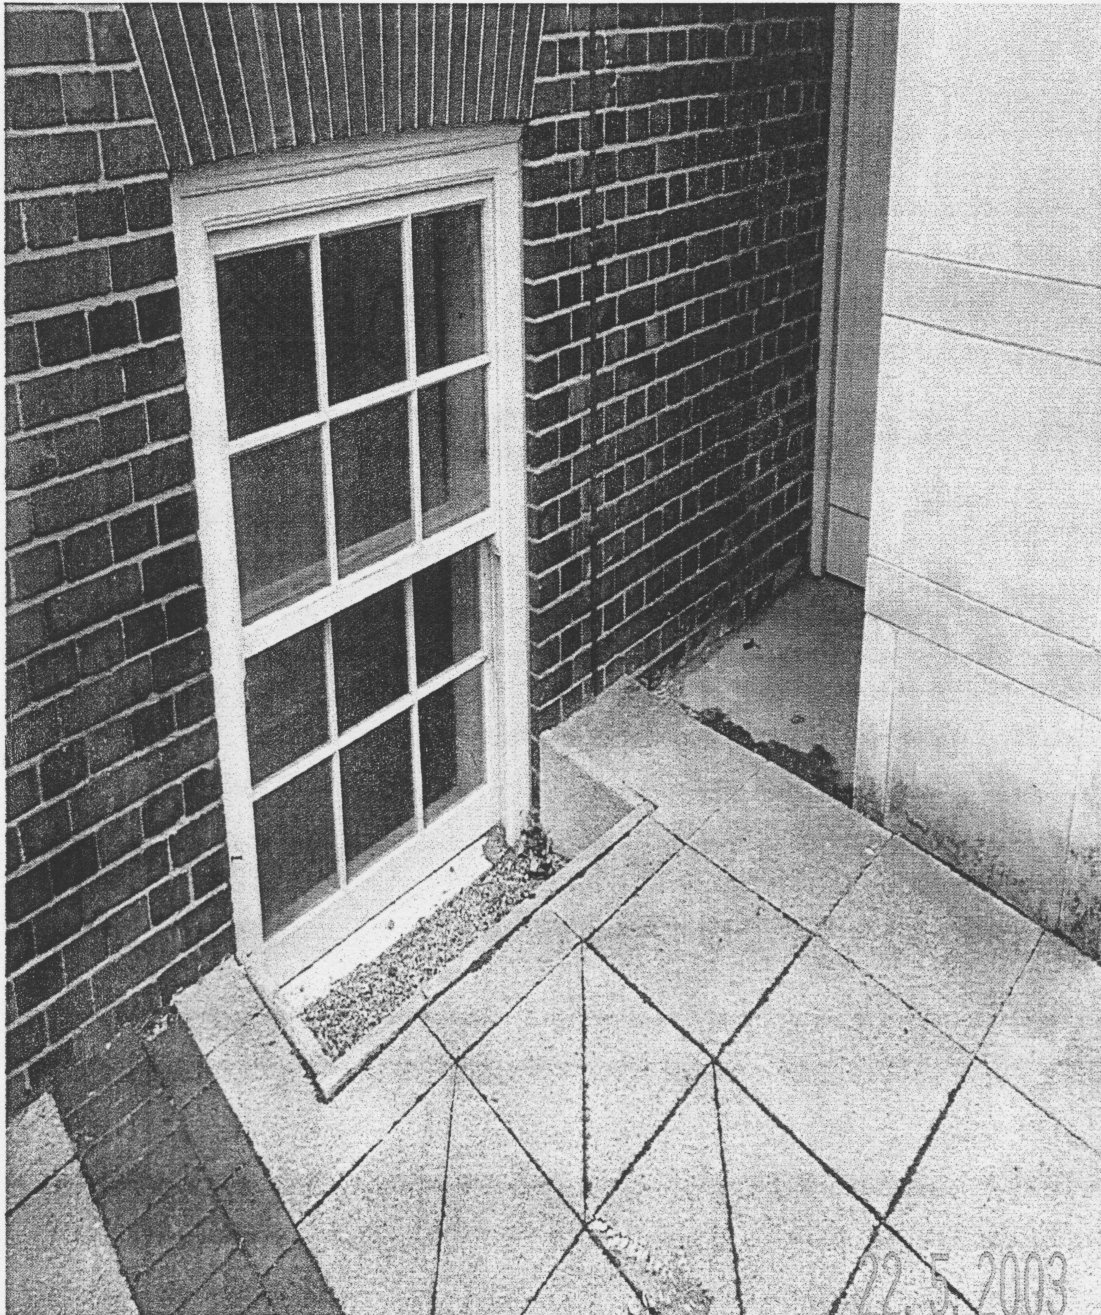
The Left Hand Unit Stores: There is evidence of damp staining immediately beneath the threshold with the floor being laid lower than that of the adjacent pavings and no provision for collection or disposal of rainwater.

The window immediately alongside has a cill level with a dropped paved area covered in gravel.

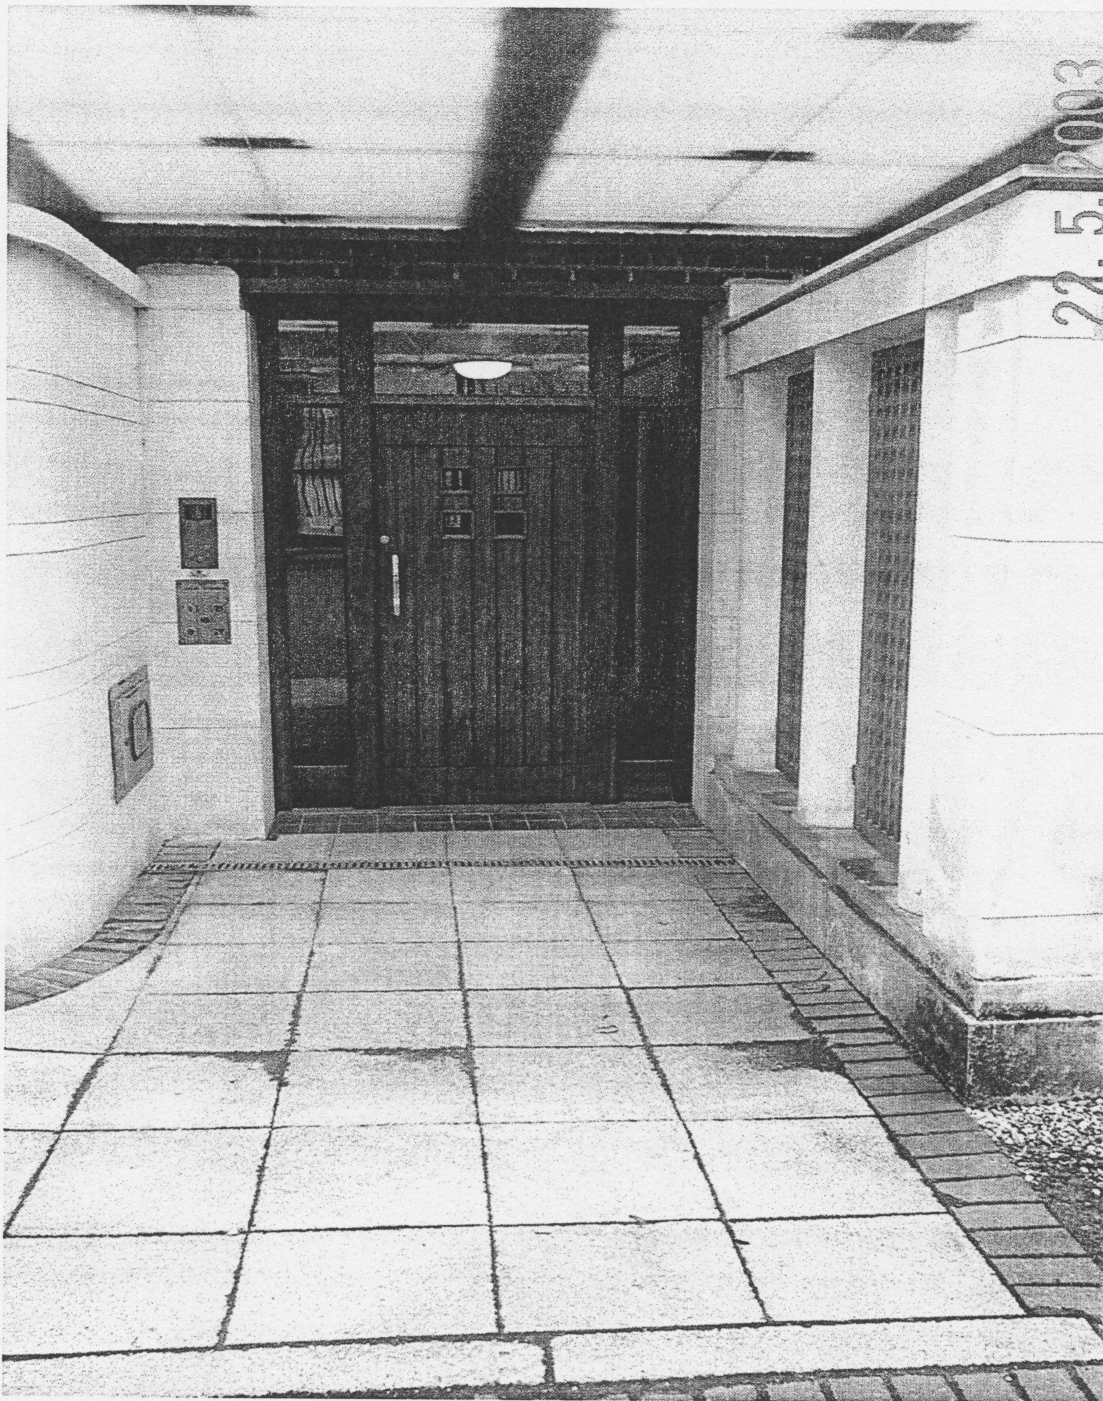
Mould growth and damp staining to stone pier.

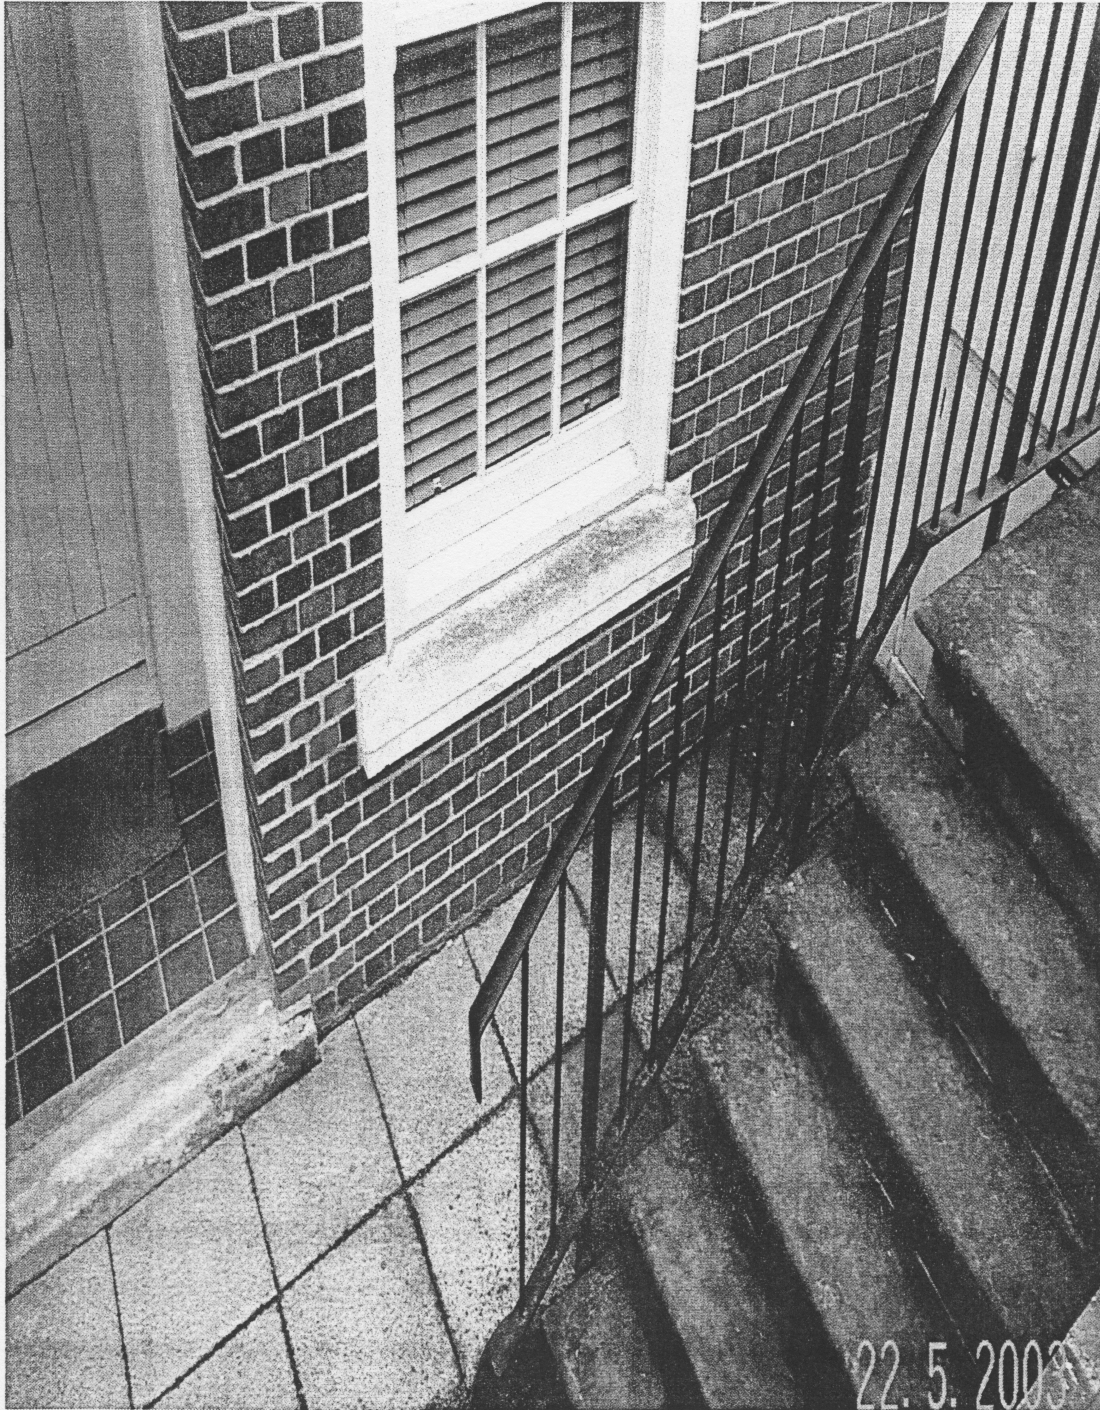
Basement Access to Apartment 2: The stone steps leading down are saturated as indeed are the pavings adjacent to the meter cupboard and stores.

There were signs of extensive weather penetration and damp staining. Ventilation grills have been fitted to some doors but without proper effect.

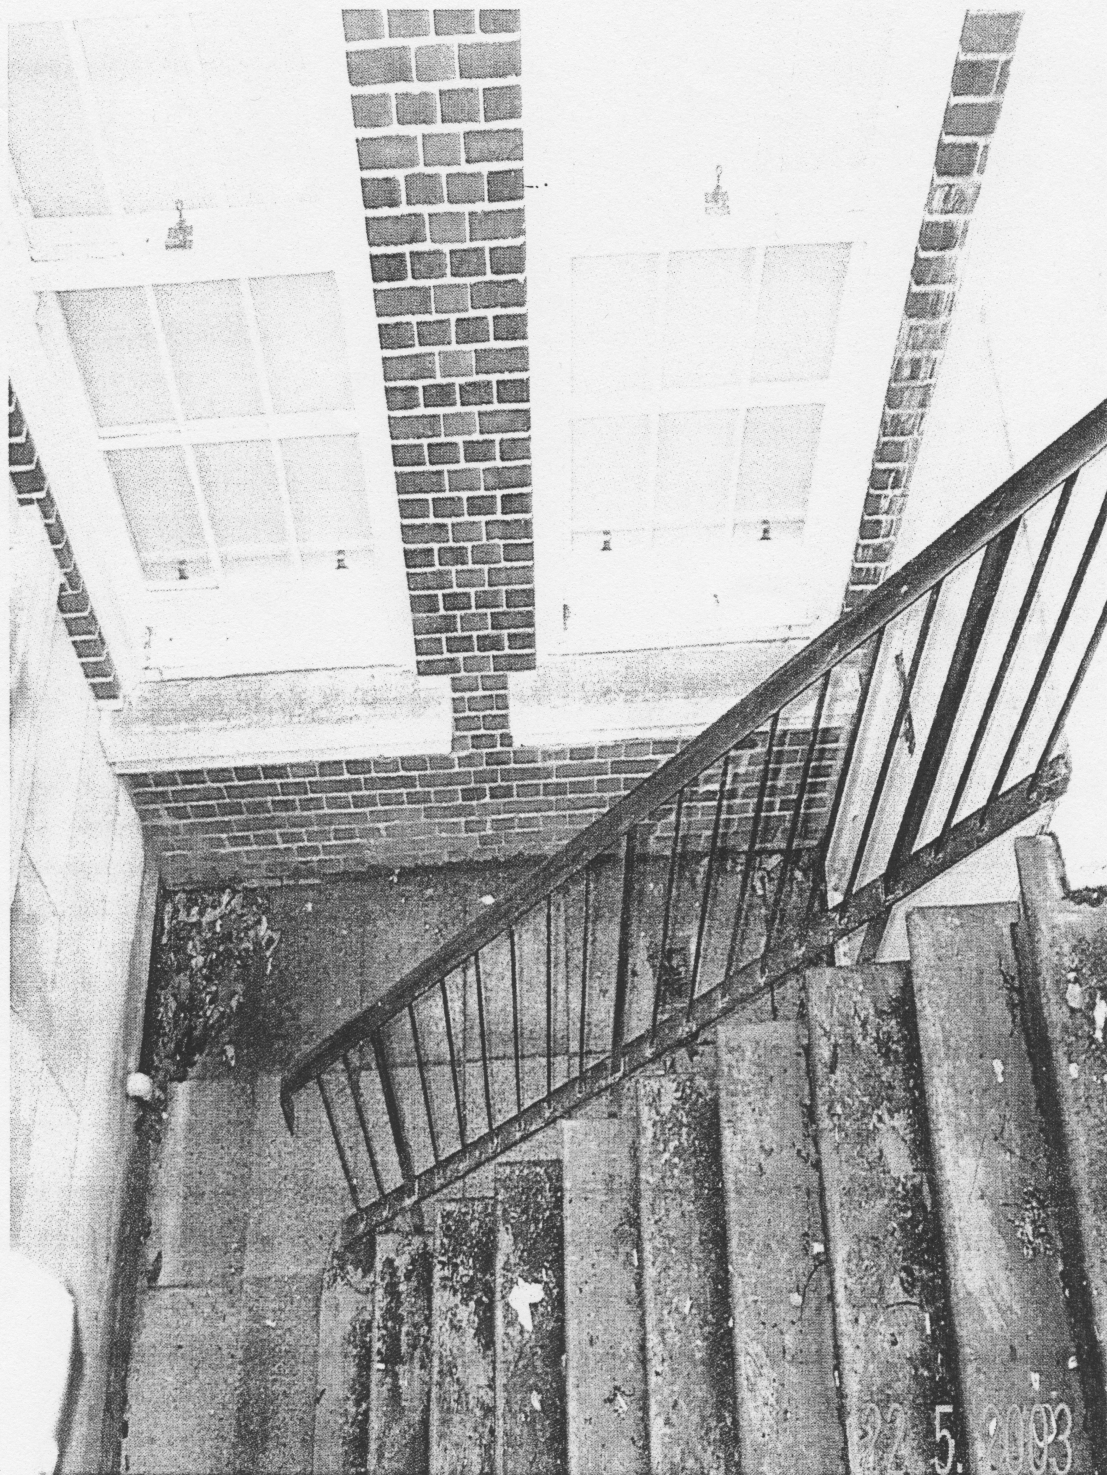
Basement Access Stores to the Right of Central Entrance: Again this is saturated with a partially blocked surface water gully.

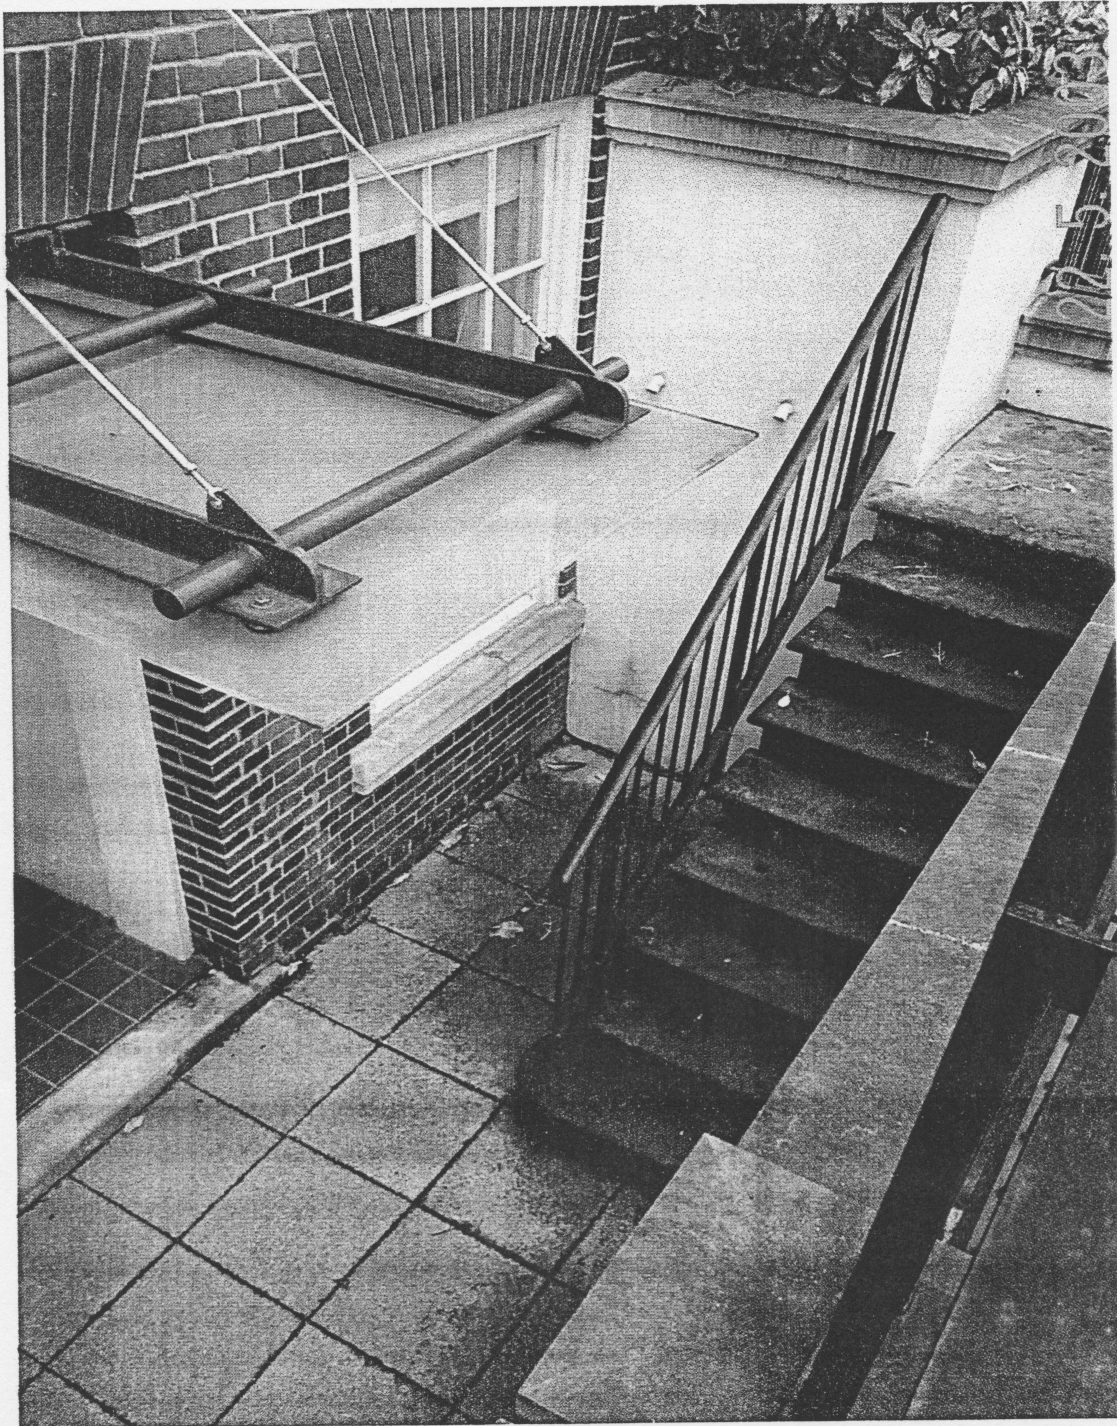
Basement Access to Apartment 5: Saturated stone steps and also pavings to the right hand side of the entrance together with mould growth and stain to the step threshold.

Also damp staining and saturation of pavings away from the wall.
