2.0 ROYAL STANDARD: The property comprises a conversion of what was originally nurses accommodation for the local hospital.

2.1 EXTERNAL

Front Elevation

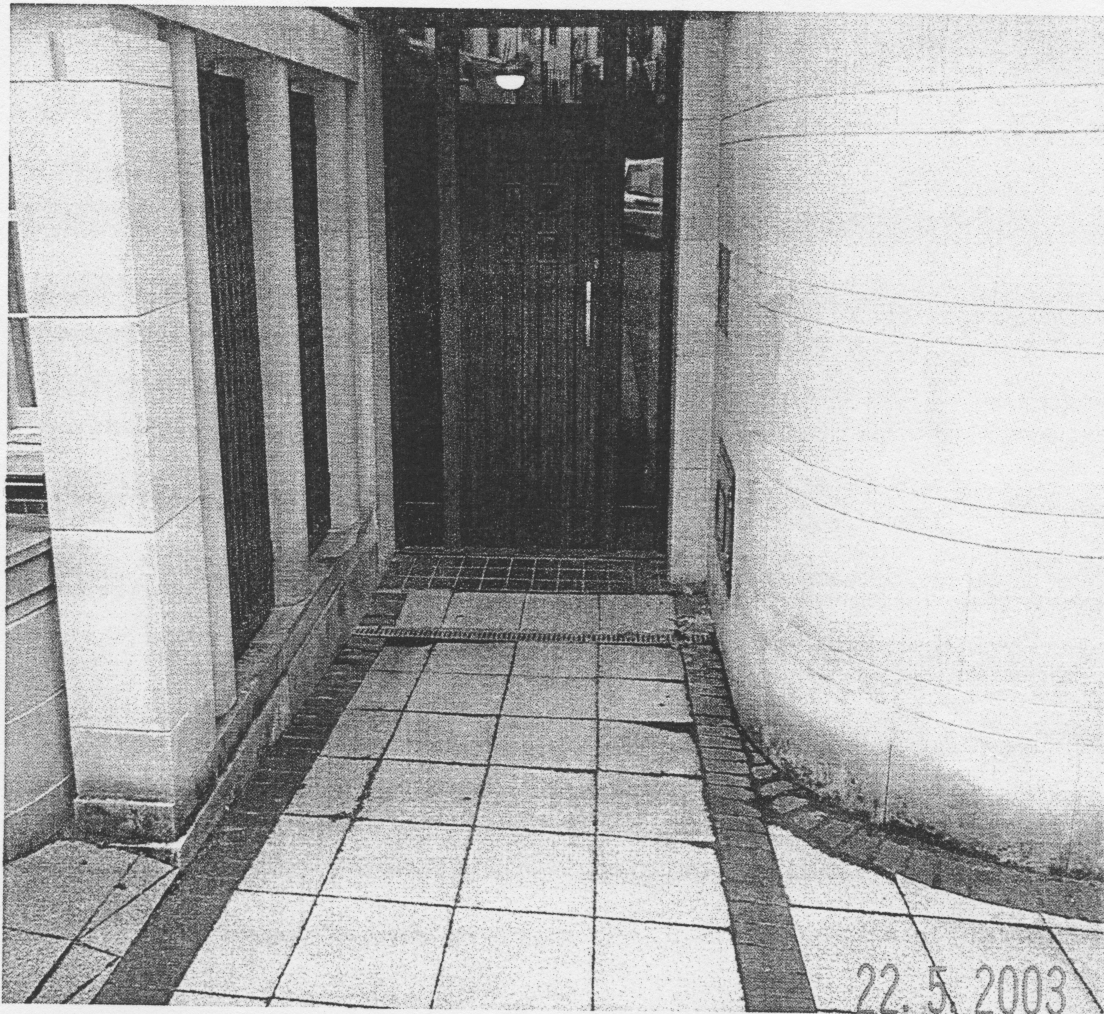
Communal Entrance to Apartments 7,8,13,14,19,20,25,26&30 to the Right Hand Side: There is an Aco drain across here with a more distinct fall to the pavings from the carpark and driveway. There is still some ponding and general accumulation of slurry and staining.
