3.0 *CITY POINT*: City Point is of new build construction with four floors above a basement garage.

### 3.1 External

#### *Front Elevation*

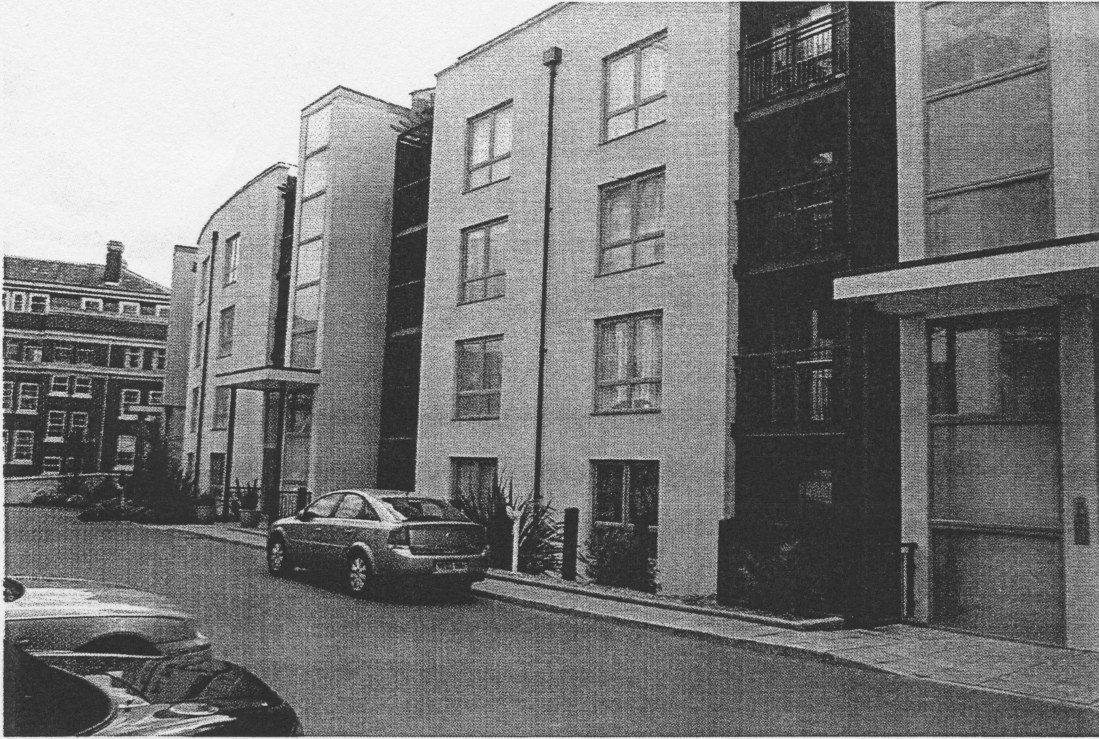
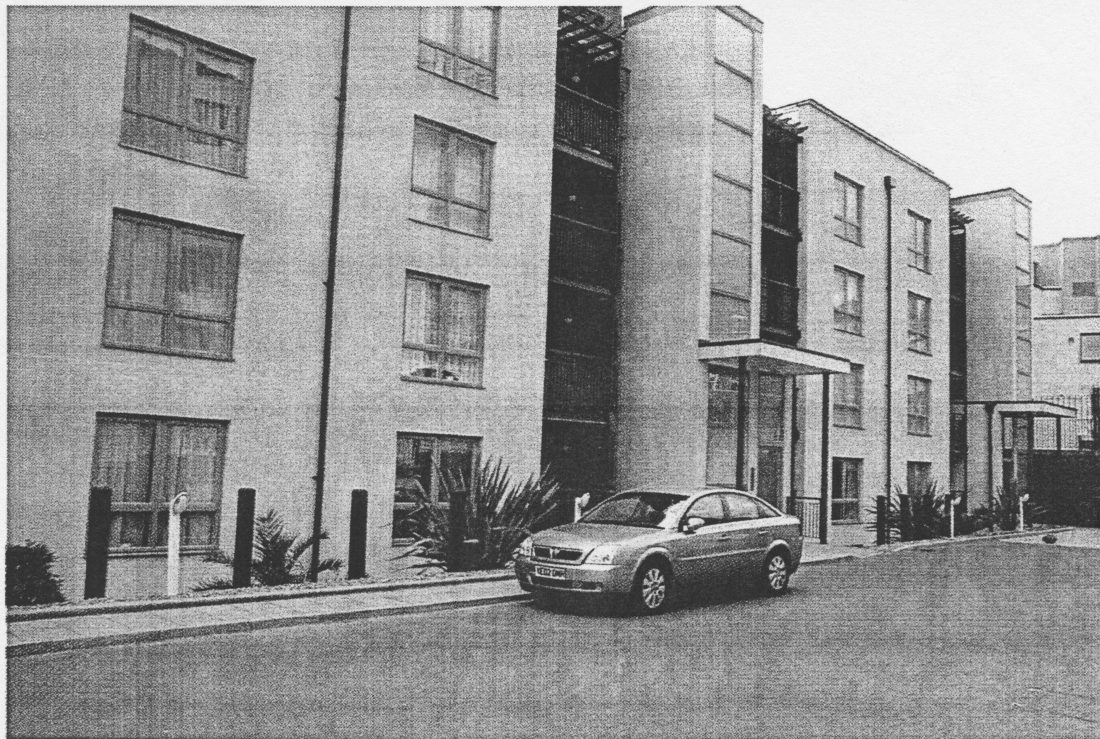
There are composite finishes to the external elevations with brick cavity panels, rendered (believed concrete or block construction) and horizontal boarding to the balconies.

The communal circulation areas are render onto block or brickwork with porch canopy roofs off steel posts.

The main roof is believed pitched with intermediate parapet walls and the doors and windows are powder coated aluminium with timber to the balconies.

*Specific Defects:* There is significant run-off and staining of brickwork beneath the coping stones of the various intermediate parapets.

The quality of cut to the angle trims to the external angles of the upper fascia is very poor, the fascia is misaligned and the line through at the base of the cuts is irregular. This fascia appears simply to be a strip of metal with no apparent welt to the base and certainly on staircase C there are signs of detachment of the render and patch repairs immediately beneath.

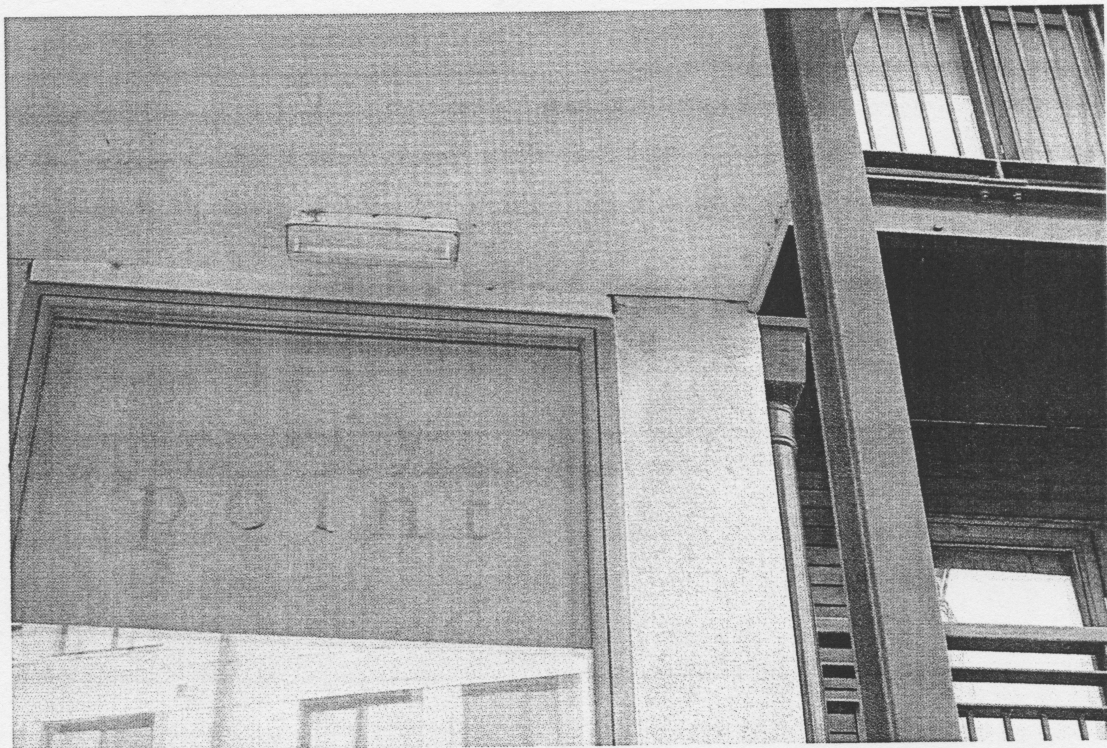
I was advised and noted that the rainwater discharges via hopper heads onto the flat roof of the various canopy entrances and is then collected and discharged via further hopper heads to the underground drainage.

There are problems here with overflowing in periods of heavy rainfall and it would appear that in some locations the fall of the roofs have been incorporated to the full depth of the roof, rather than laying with a horizontal flat soffit and furring strips above.

The quality of brickwork leaves something to be desired, particularly the cut ups to the raking parapets at roof level and also the brickwork immediately beneath the concrete copings to the upper landing areas.

There is evidence of poor patch repairs around the outlets to the hopper heads in the render to the canopies and also of weather penetration overflowing and staining to the upper sections.

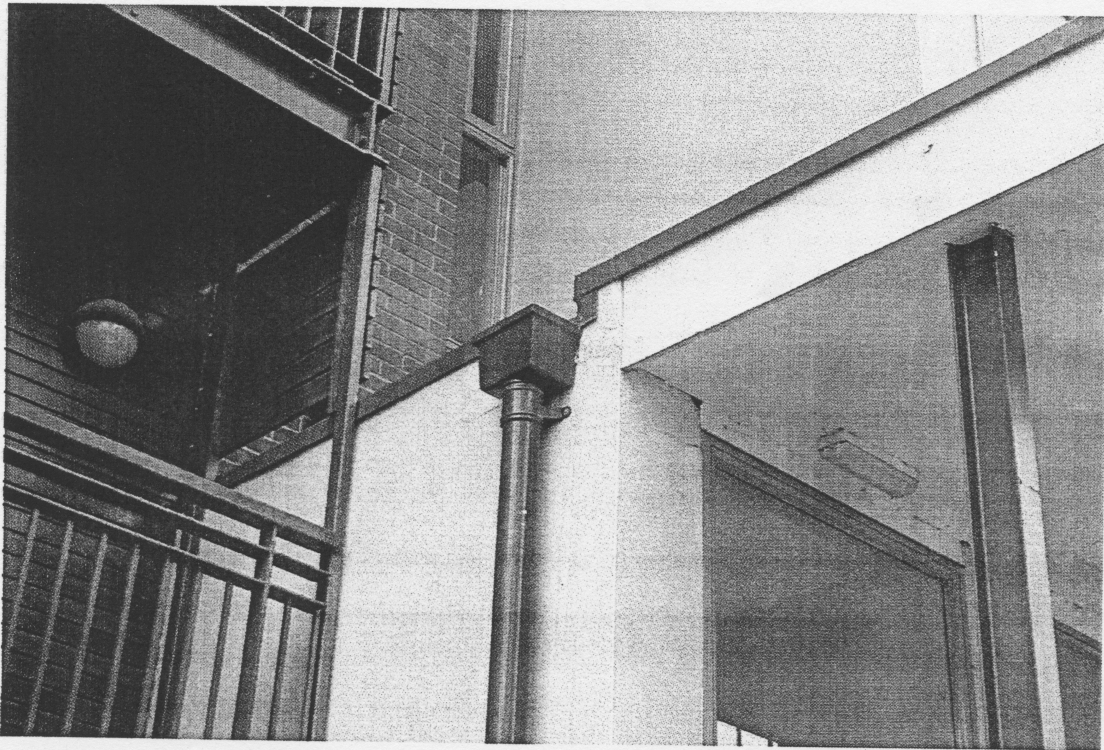
A number of rainwater pipes are displaced with bends due to improper positioning of the underground drainage connection relative to the brackets where fixed to the walls.

*The quality of workmanship:* Expansion joints in the panels of render are irregular both horizontally and vertically in terms of finish and sealant strips are becoming displaced. Some cracking has occurred to the front elevation on the curved section between windows visible from ground level from ground to first, first to second and second to third floor levels.

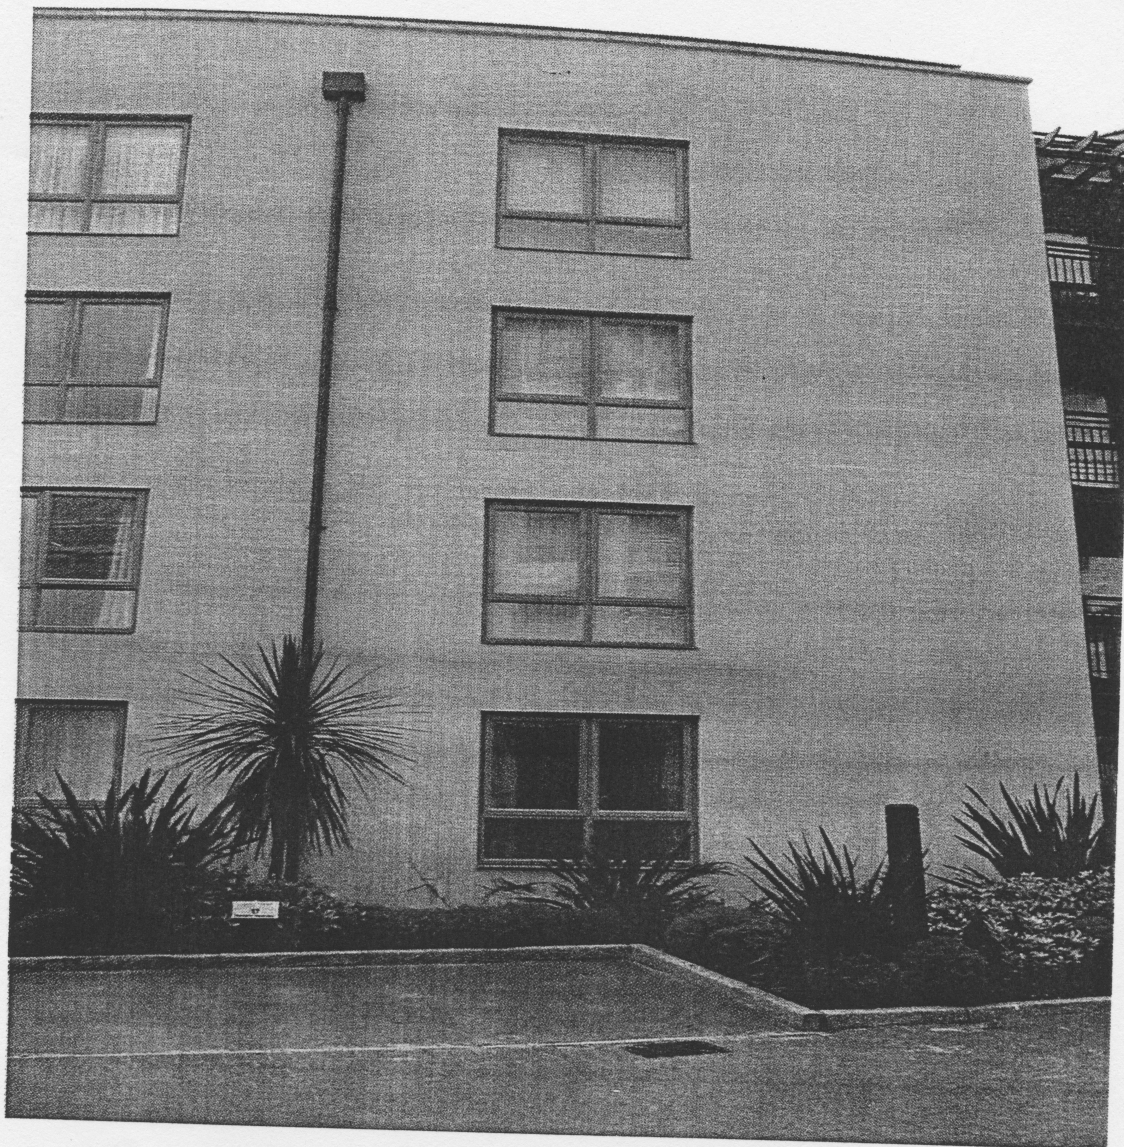
The render is becoming stained due to run-off from cill ends of the various windows.

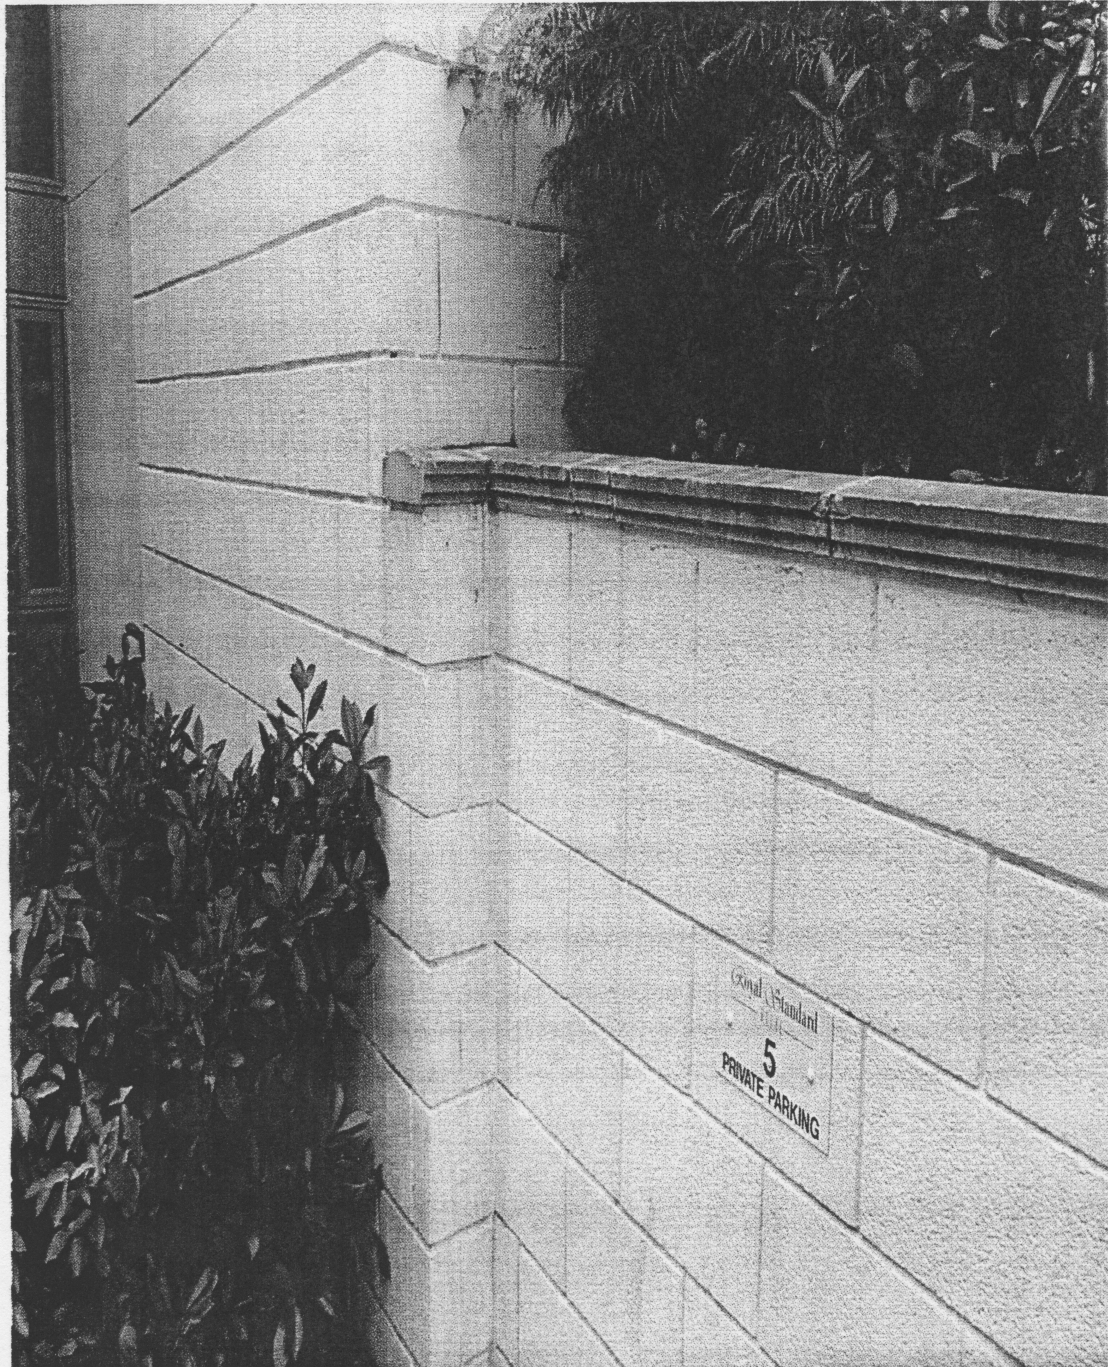
To the lower parking area for bays 5,6 and 29, the coping stone has an inadequate overhang to the end and there is no floating, therefore, there is some rainwater discharging down the face in various locations causing staining.

There is physical damage or poor quality of finish to the render finish to the extreme left hand render panel above the garage entrance.

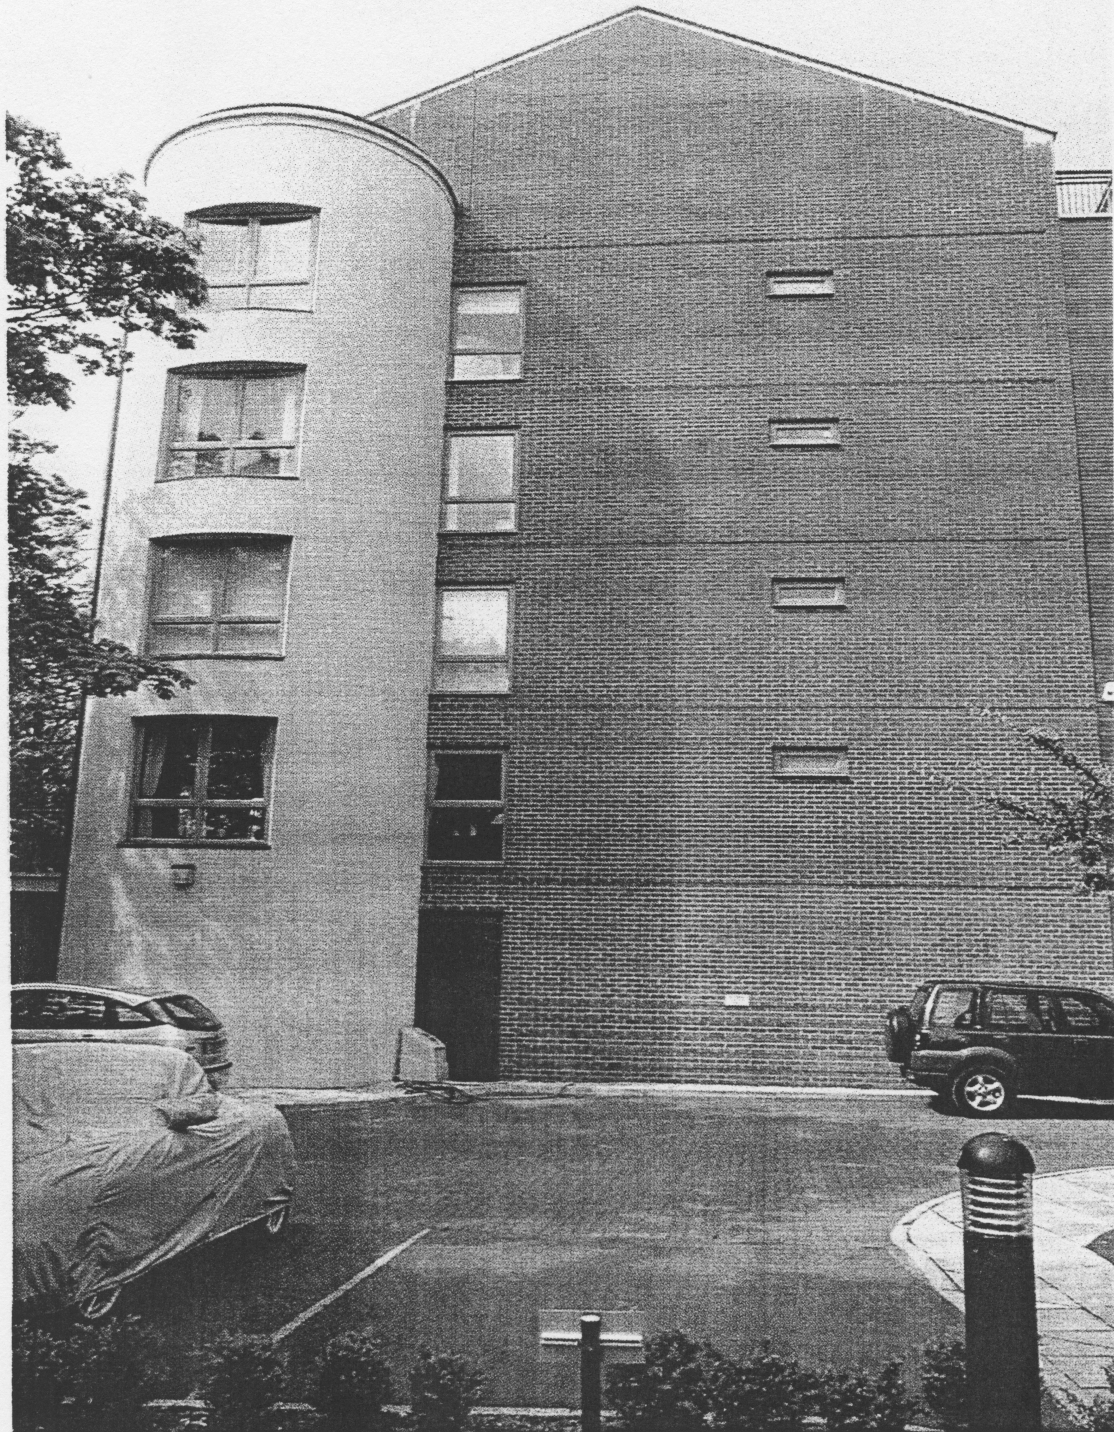
*LeftHandGableWall*

There is significant stain due to run-off from the parapet coping stones, this is causing damage and aesthetic disturbance to the upper sections of brickwork.

The curved rendered section to the end, again has irregular finish and seals to the horizontal joints.

The overall standard of finish here is somewhat inferior to that of the front elevation and particularly to the cill ends to the first and second and third floor windows their finish is generally irregular.

Again the bottom section of rainwater pipe is slightly displaced relative to the bracketed sections above.

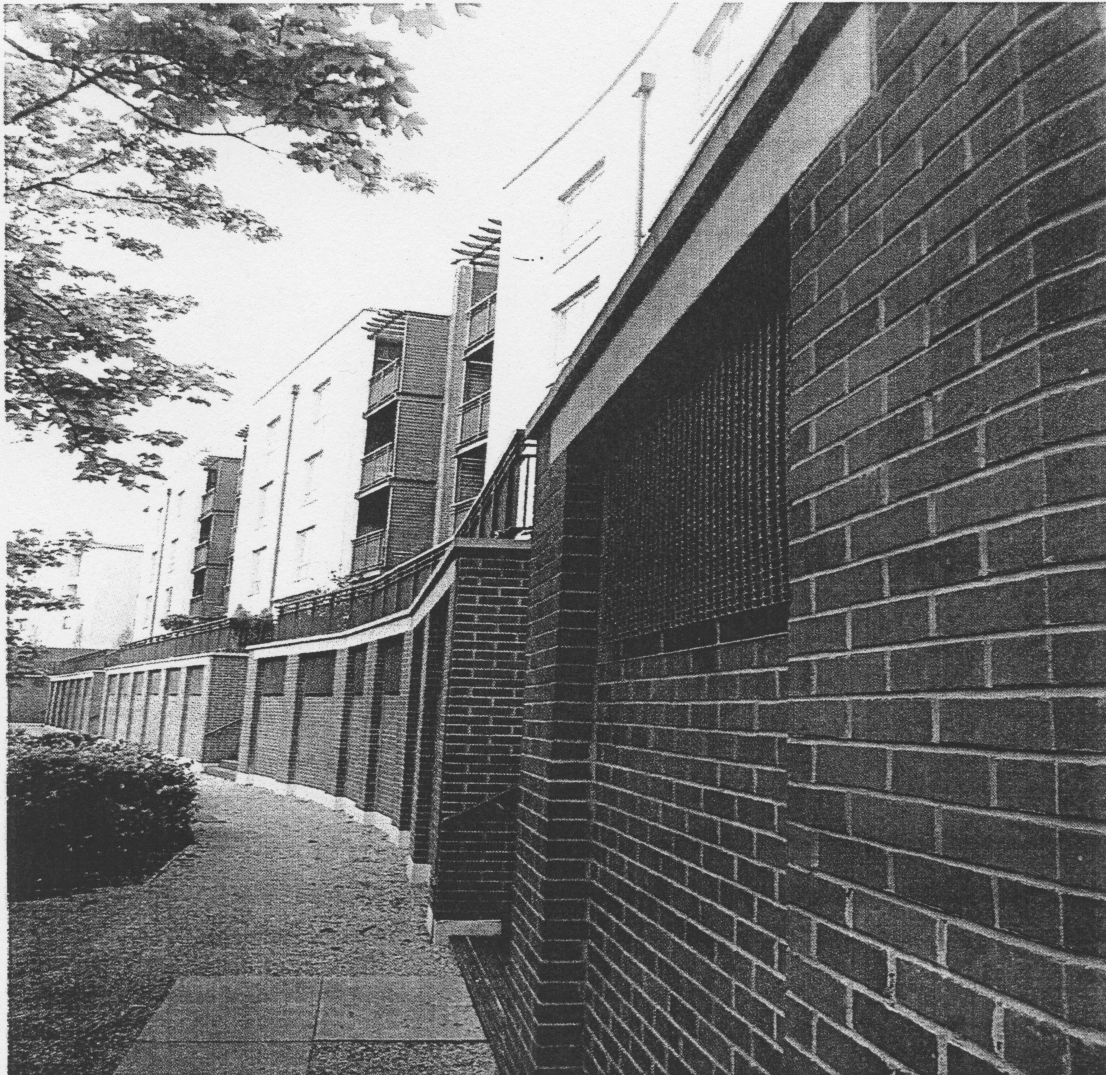
*Rear Elevation*

This follows similar layout and construction to the front although there are recessed set back entrances and exits to the common areas. Access from the basement gravel area is by timber decking.

The rear framing to the common areas is of what appears to be powder coated aluminium with curtain walling panels above.

There are deep fascia panels at intermediate floor levels.

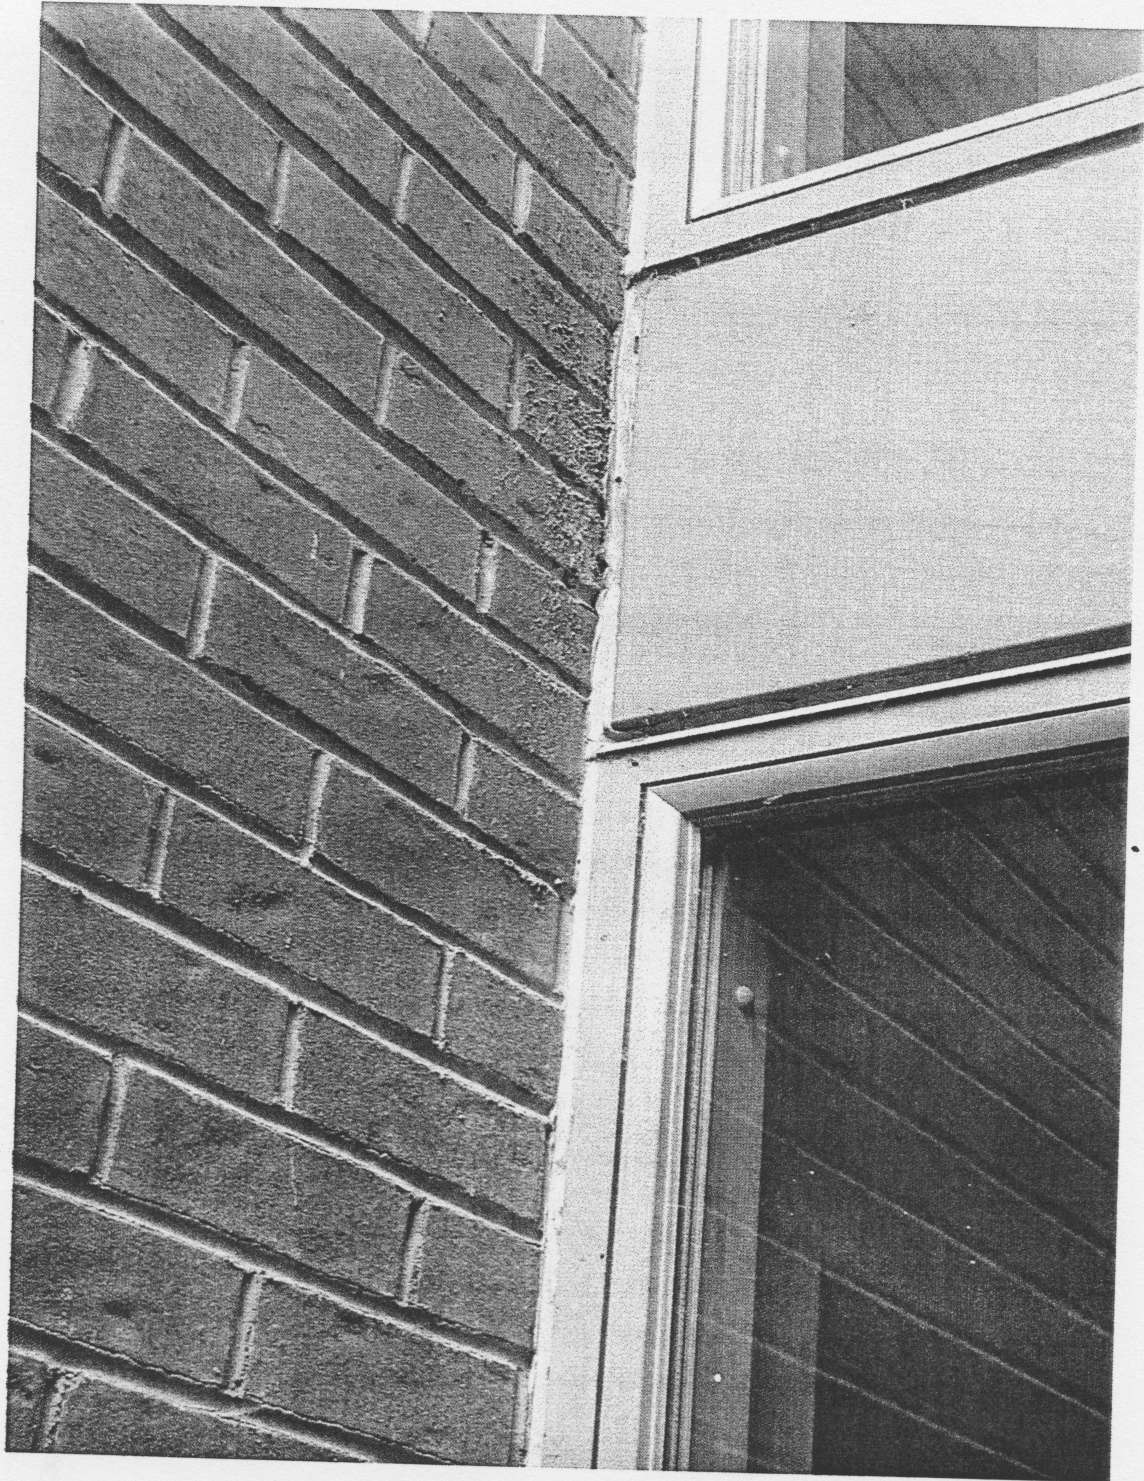
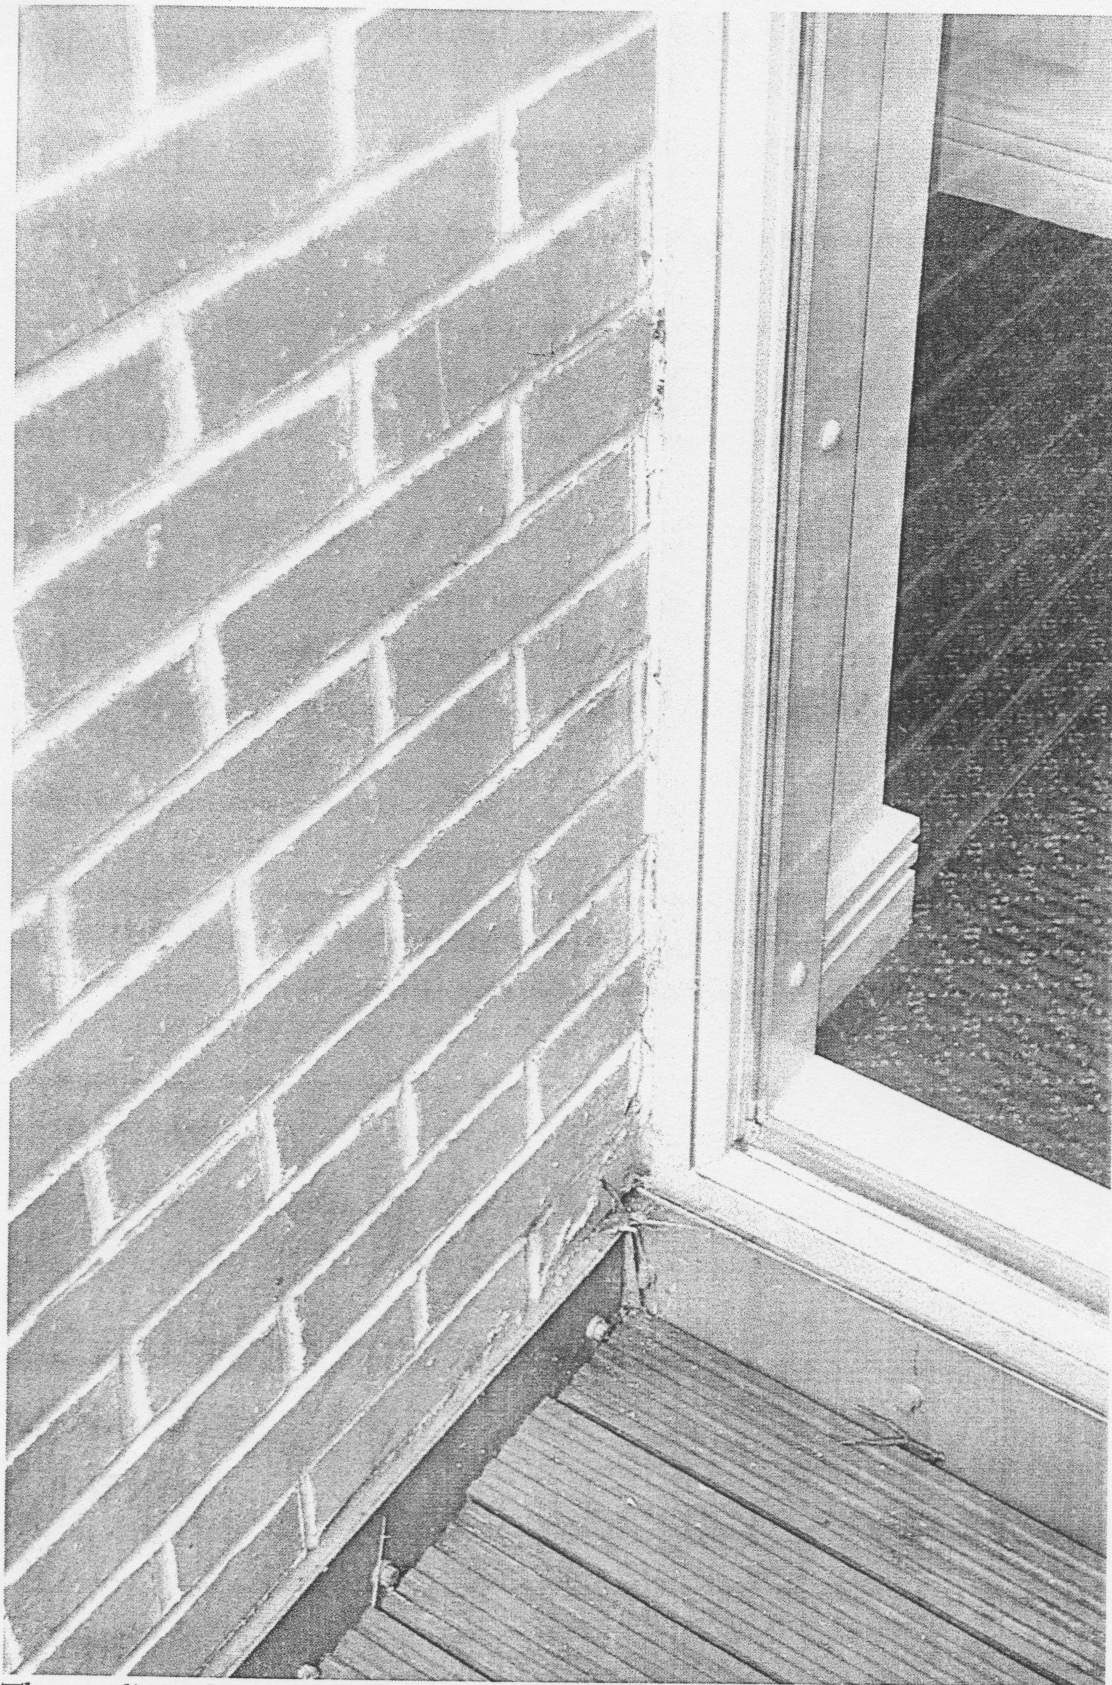
The quality of mastic pointing at the abutment of the panels to the brick walls either side is extremely poor and it is believed that there is weather ingress occurring in various staircases, particularly to the ground floor at ceiling level.

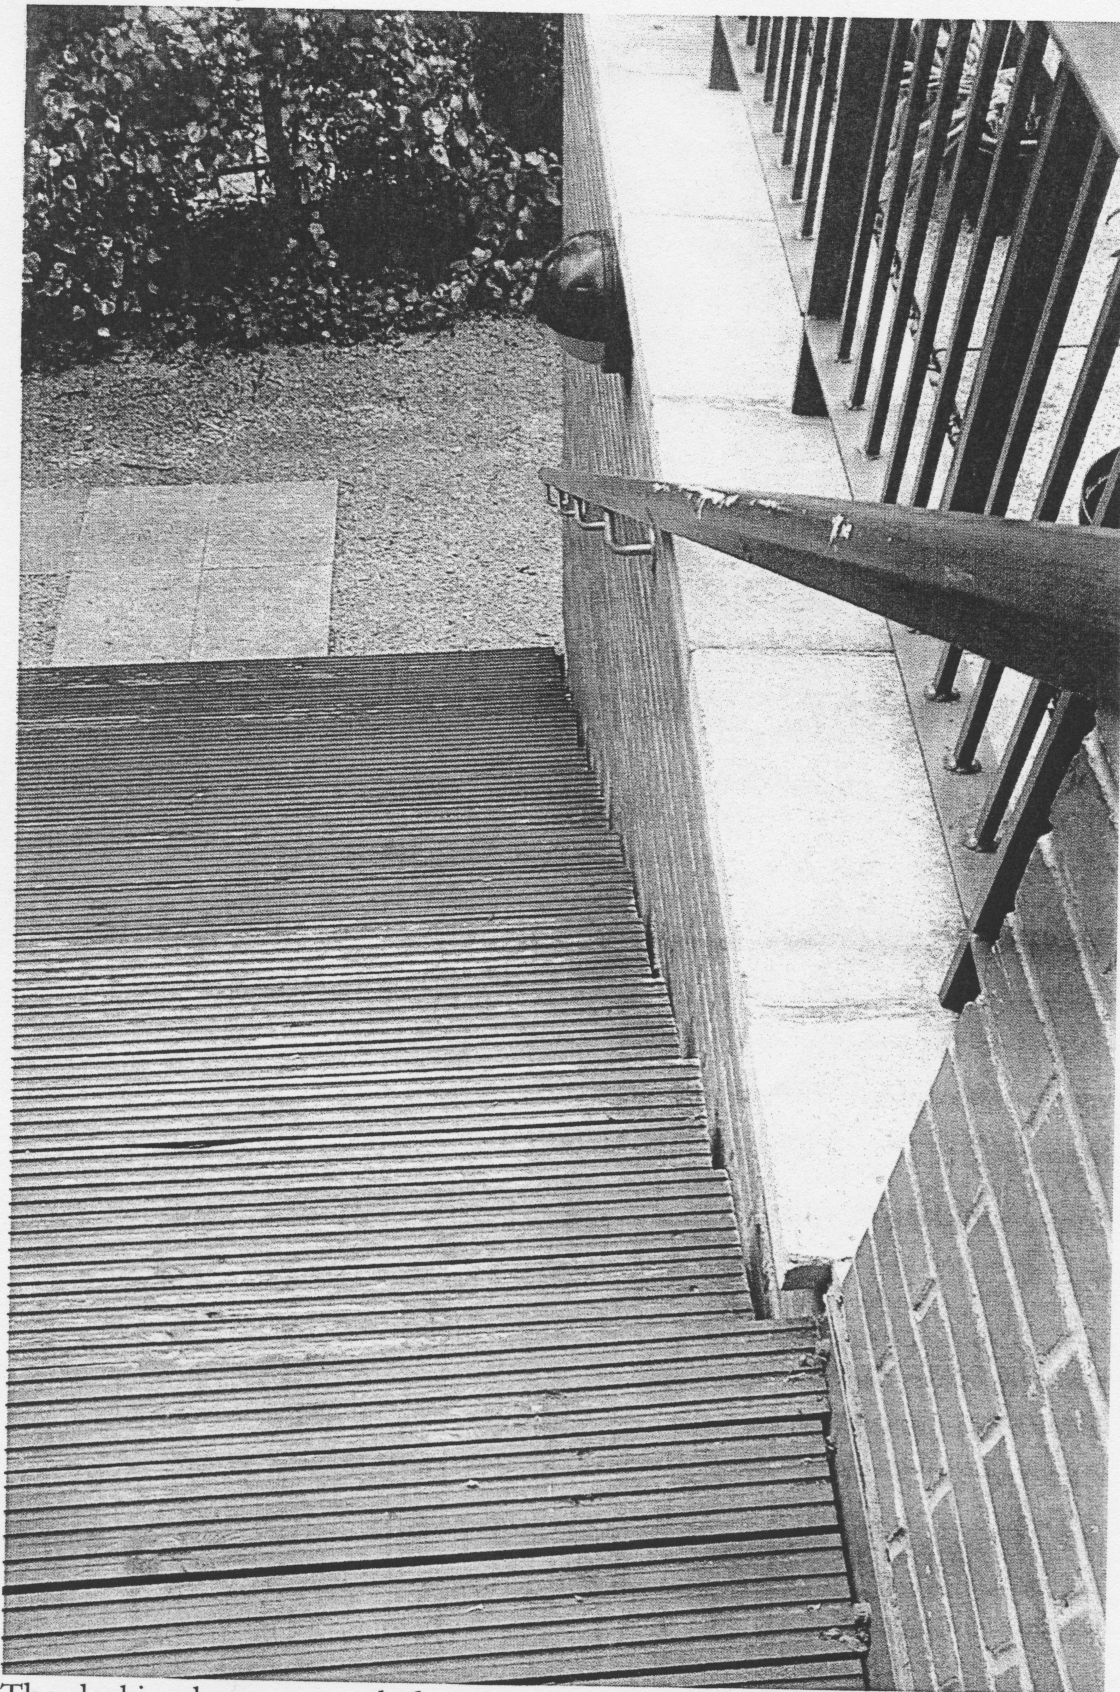
The decking has apparently been giving problems with water ingress to the edges of the steps.

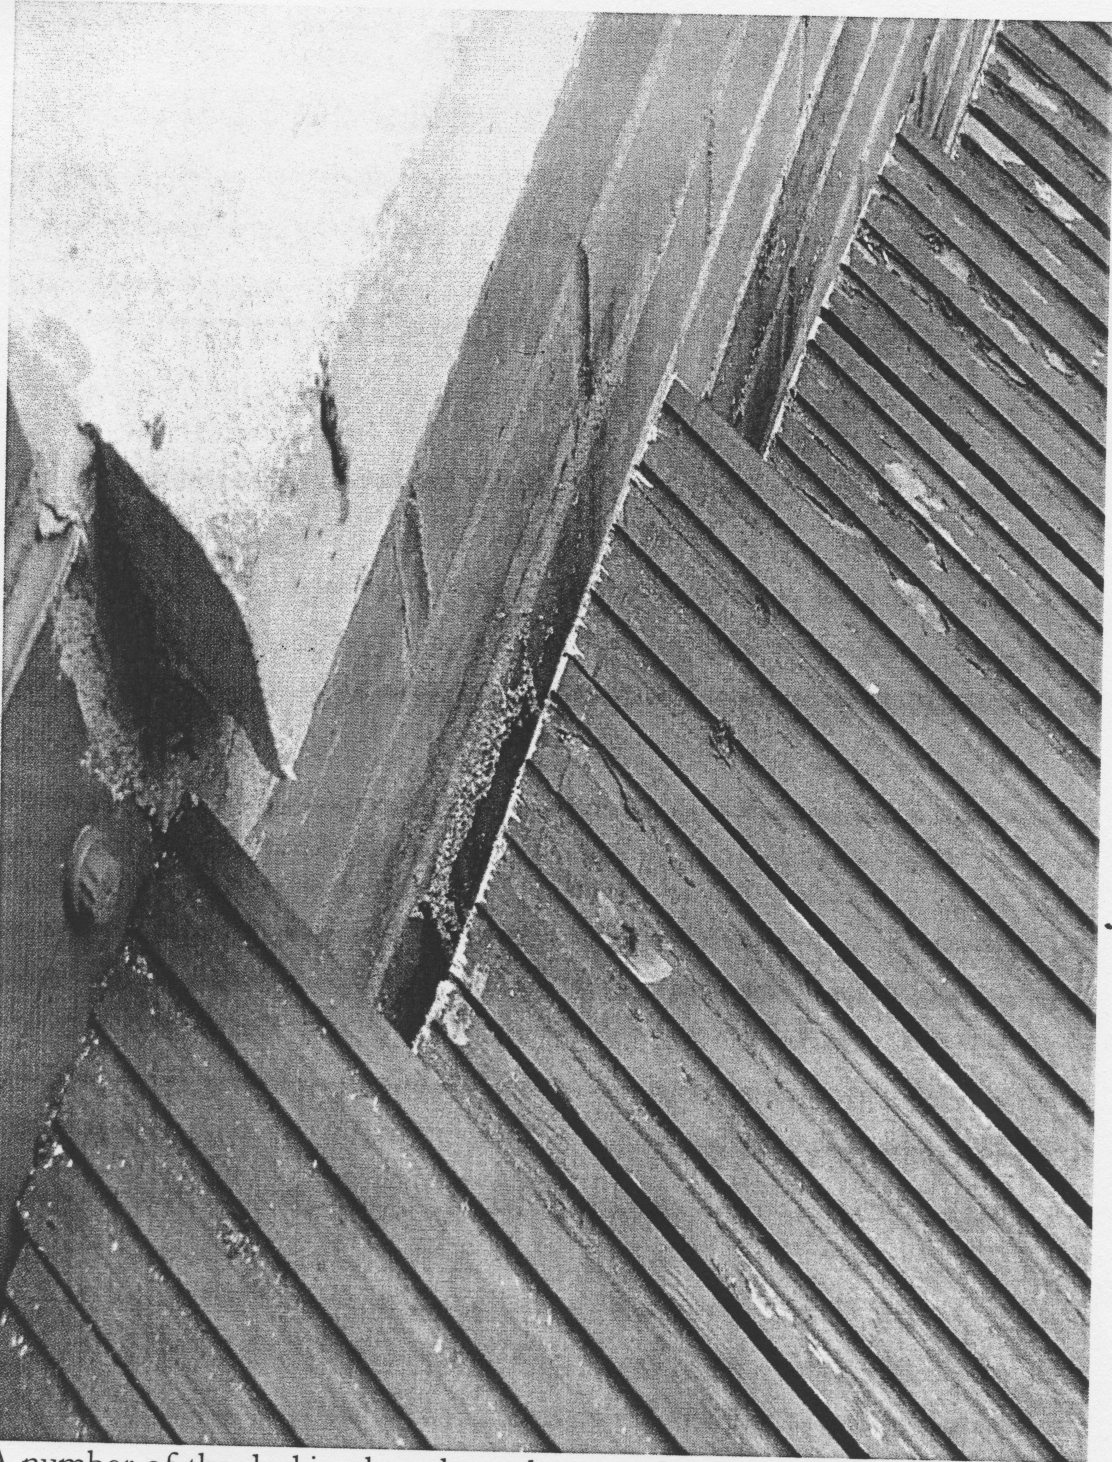
A number of the decking boards are loose and rattle underfoot. The standard of cutting out of the edges is very poor and irregular.
