2.2 INTERNAL COMMUNAL AREAS

2.2.A CENTRAL ACCESS

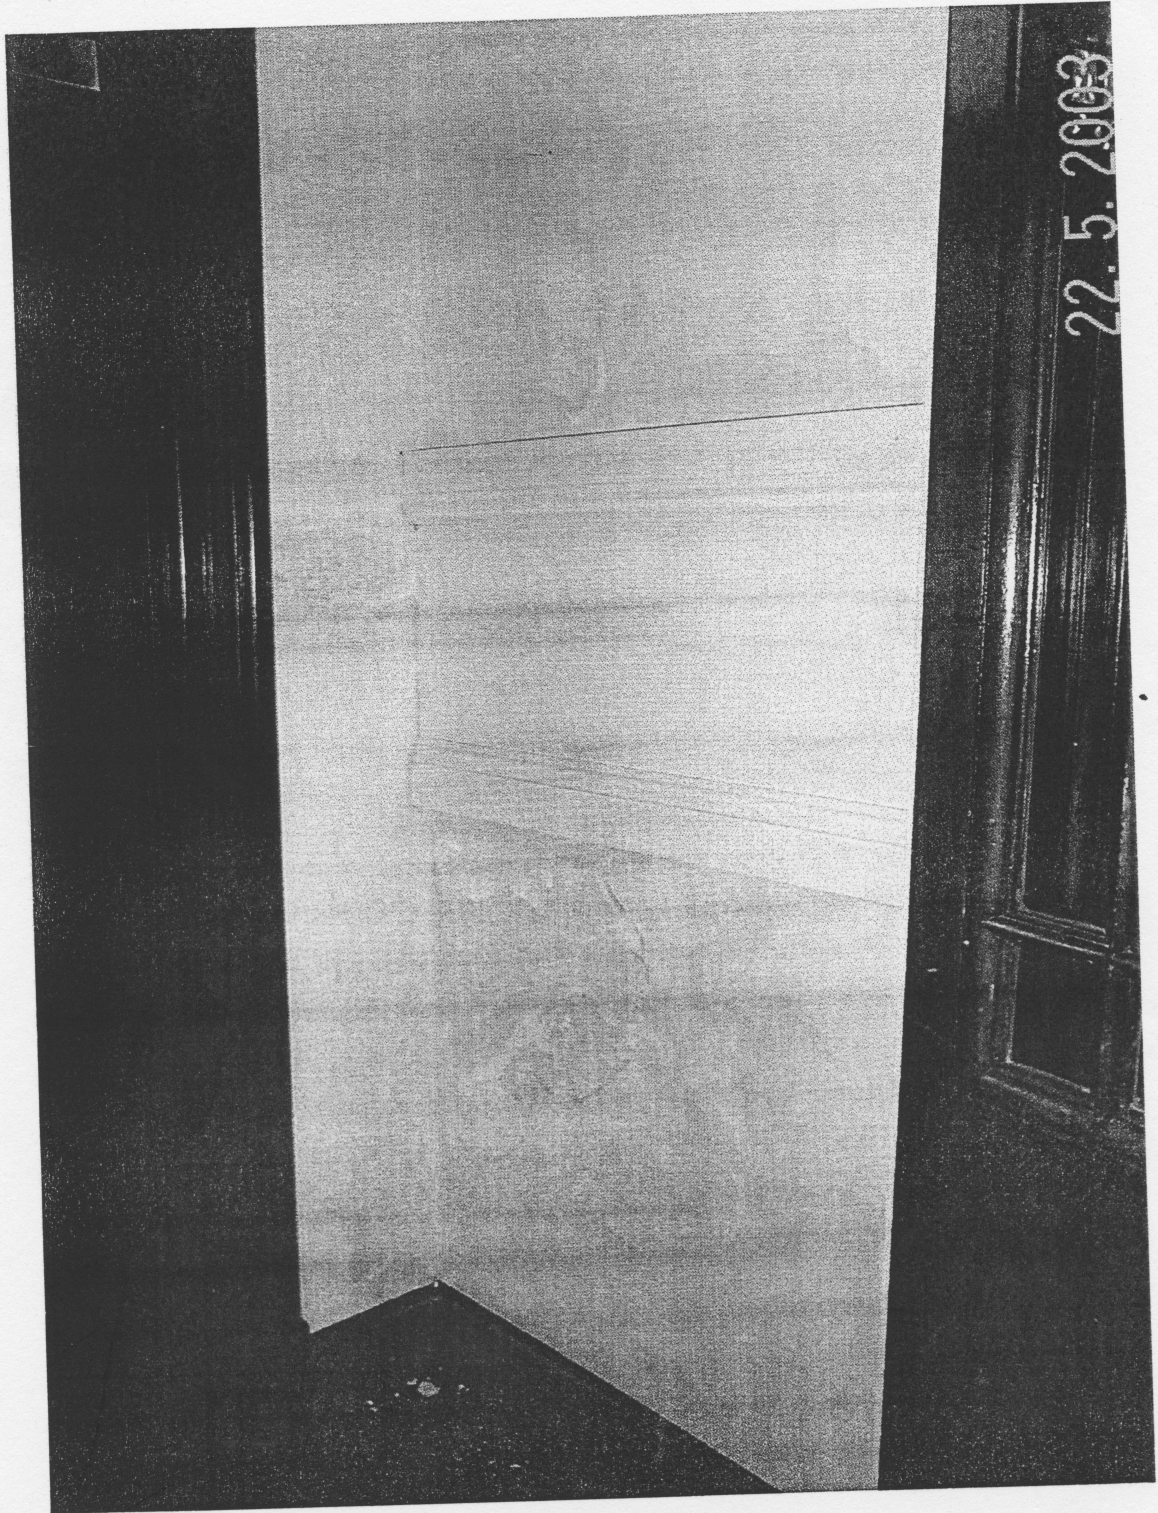
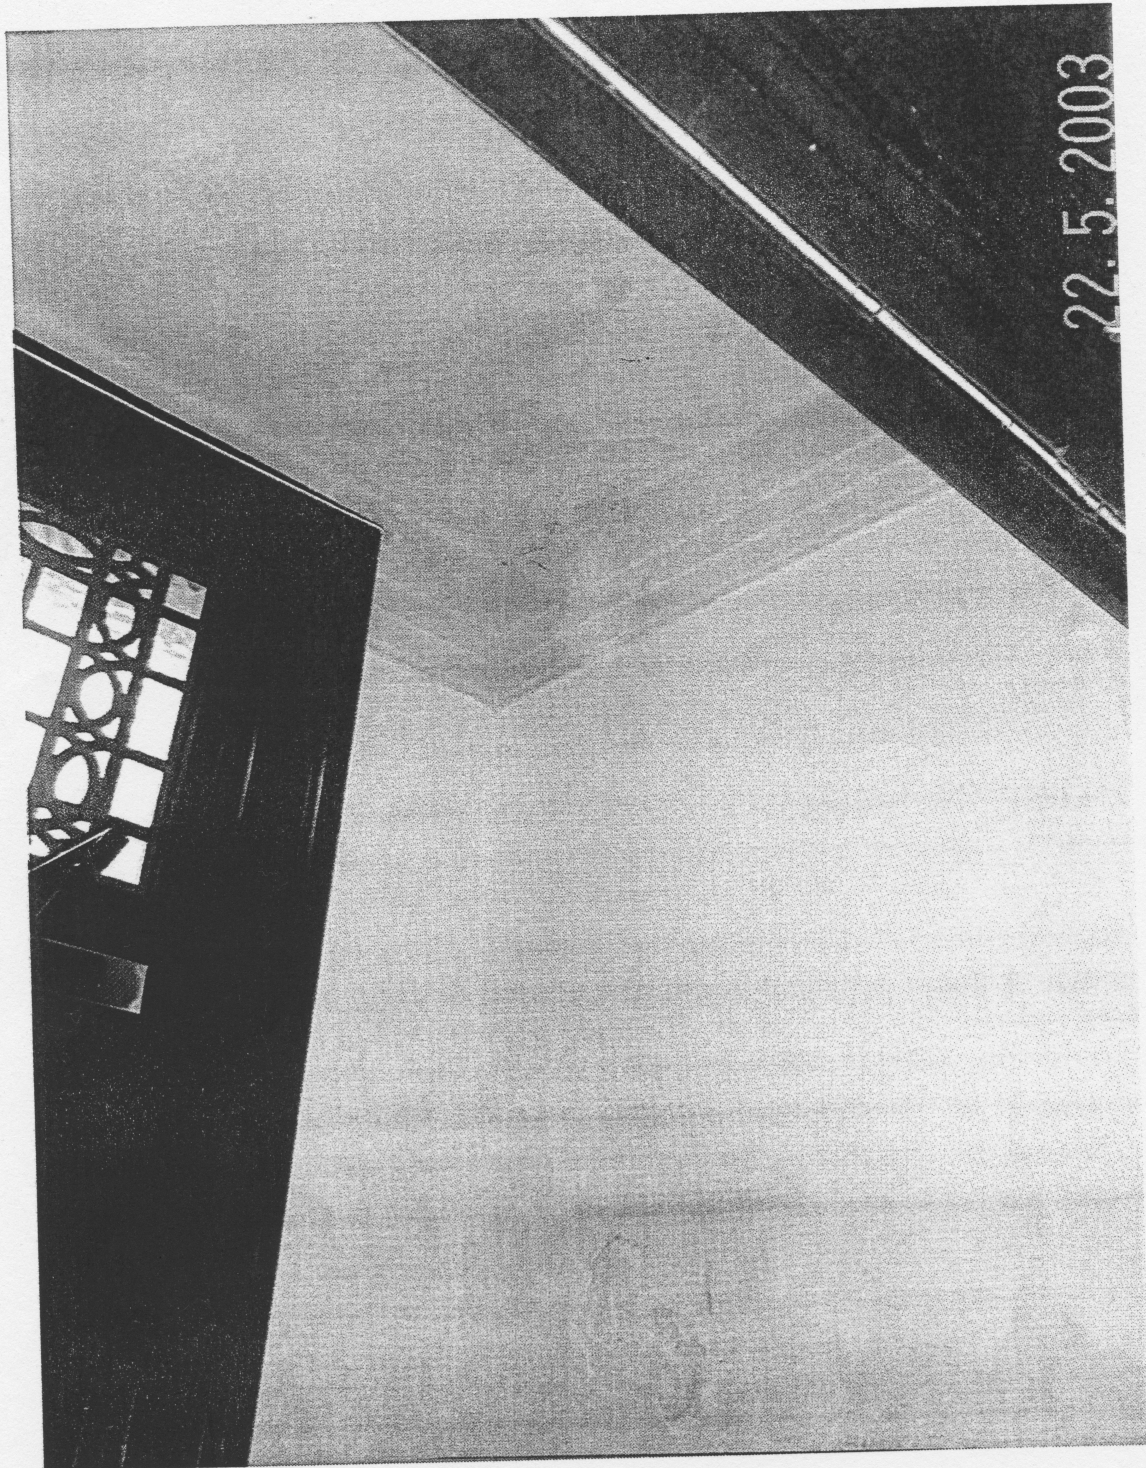
Above the head of the main entrance doors there is clear evidence of weather penetration with powdering off of paint, plaster and the like and also approximately half way up to the left hand side of the doors themselves.

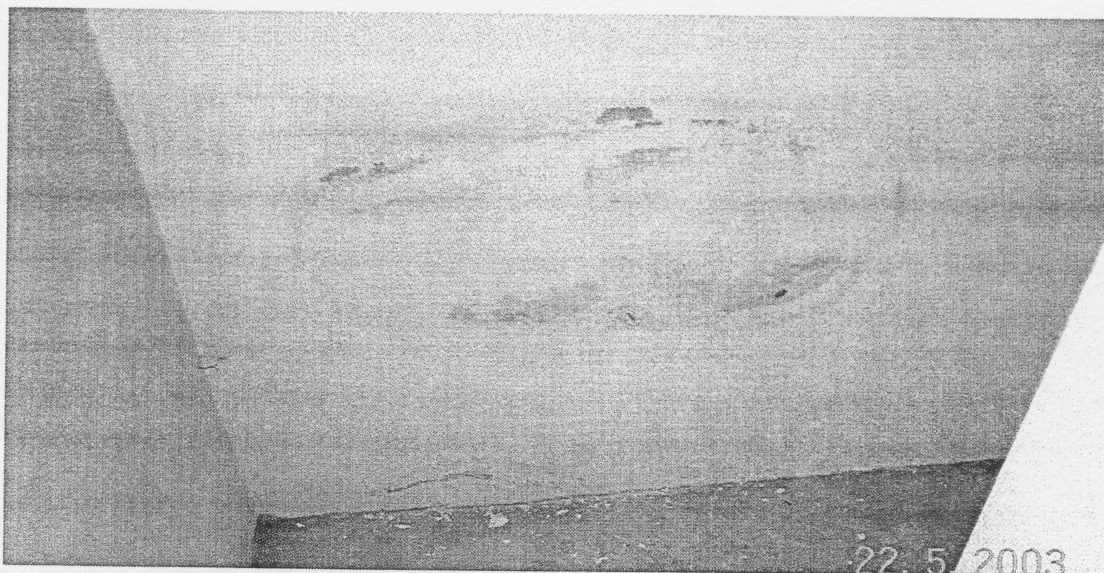
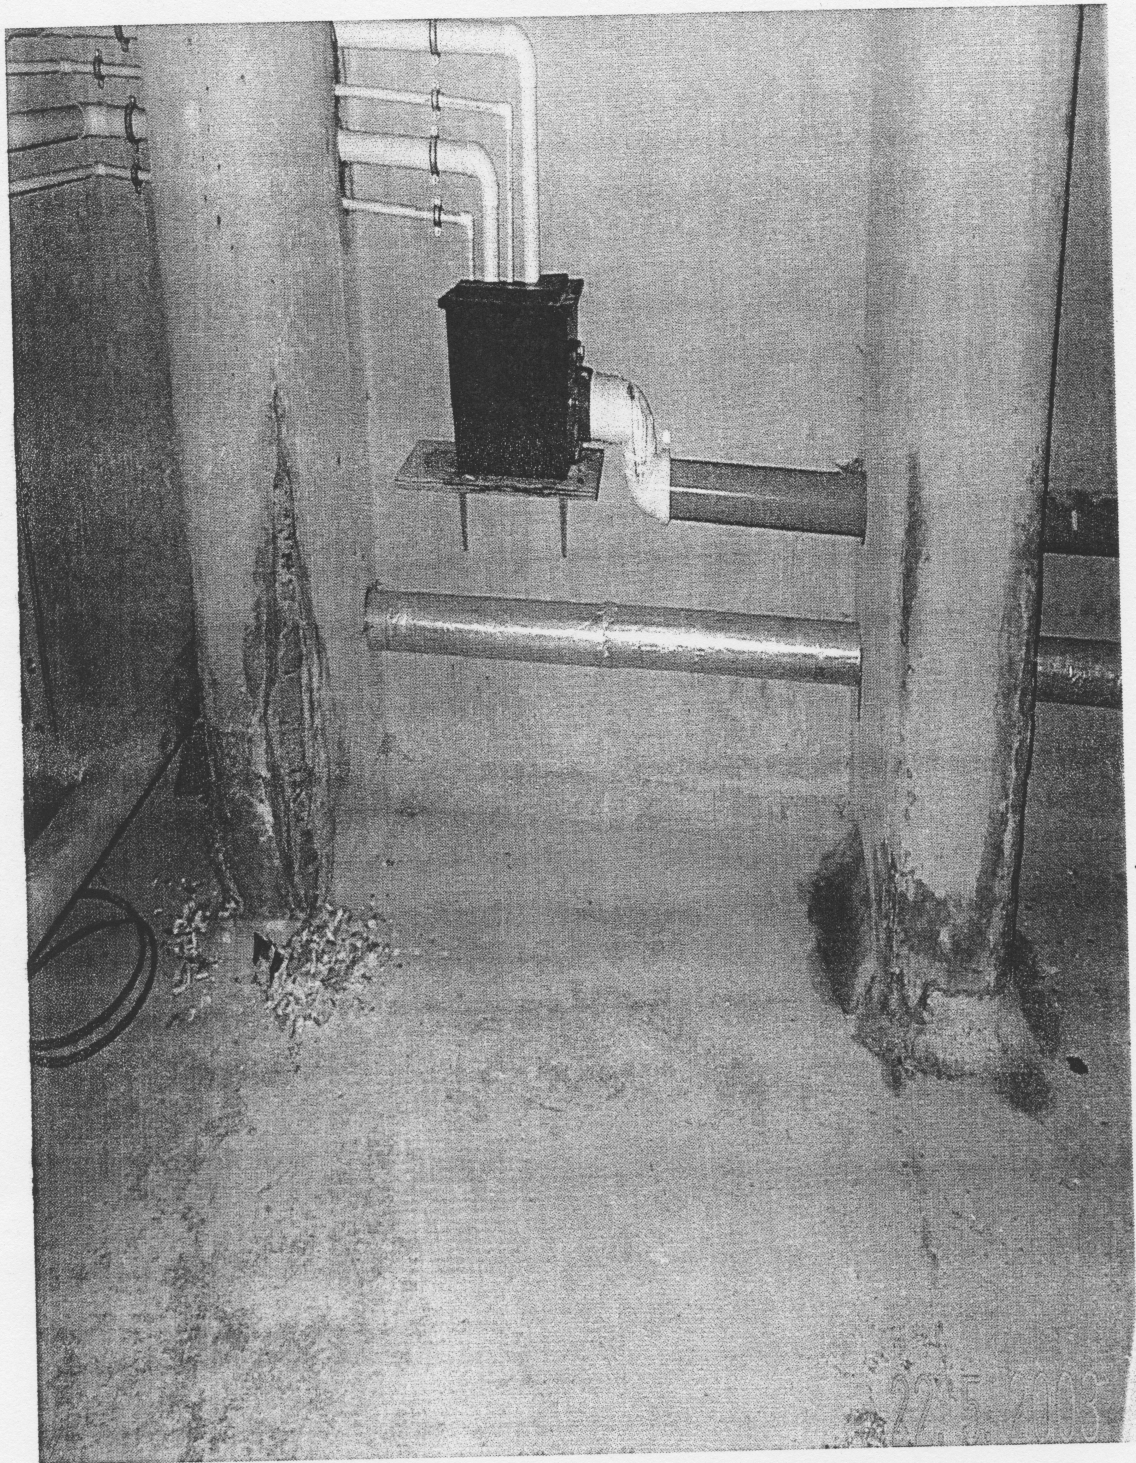
Leading down to the basement stores and meter cupboards etc, extensive evidence of weather penetration through the front wall below ground level.

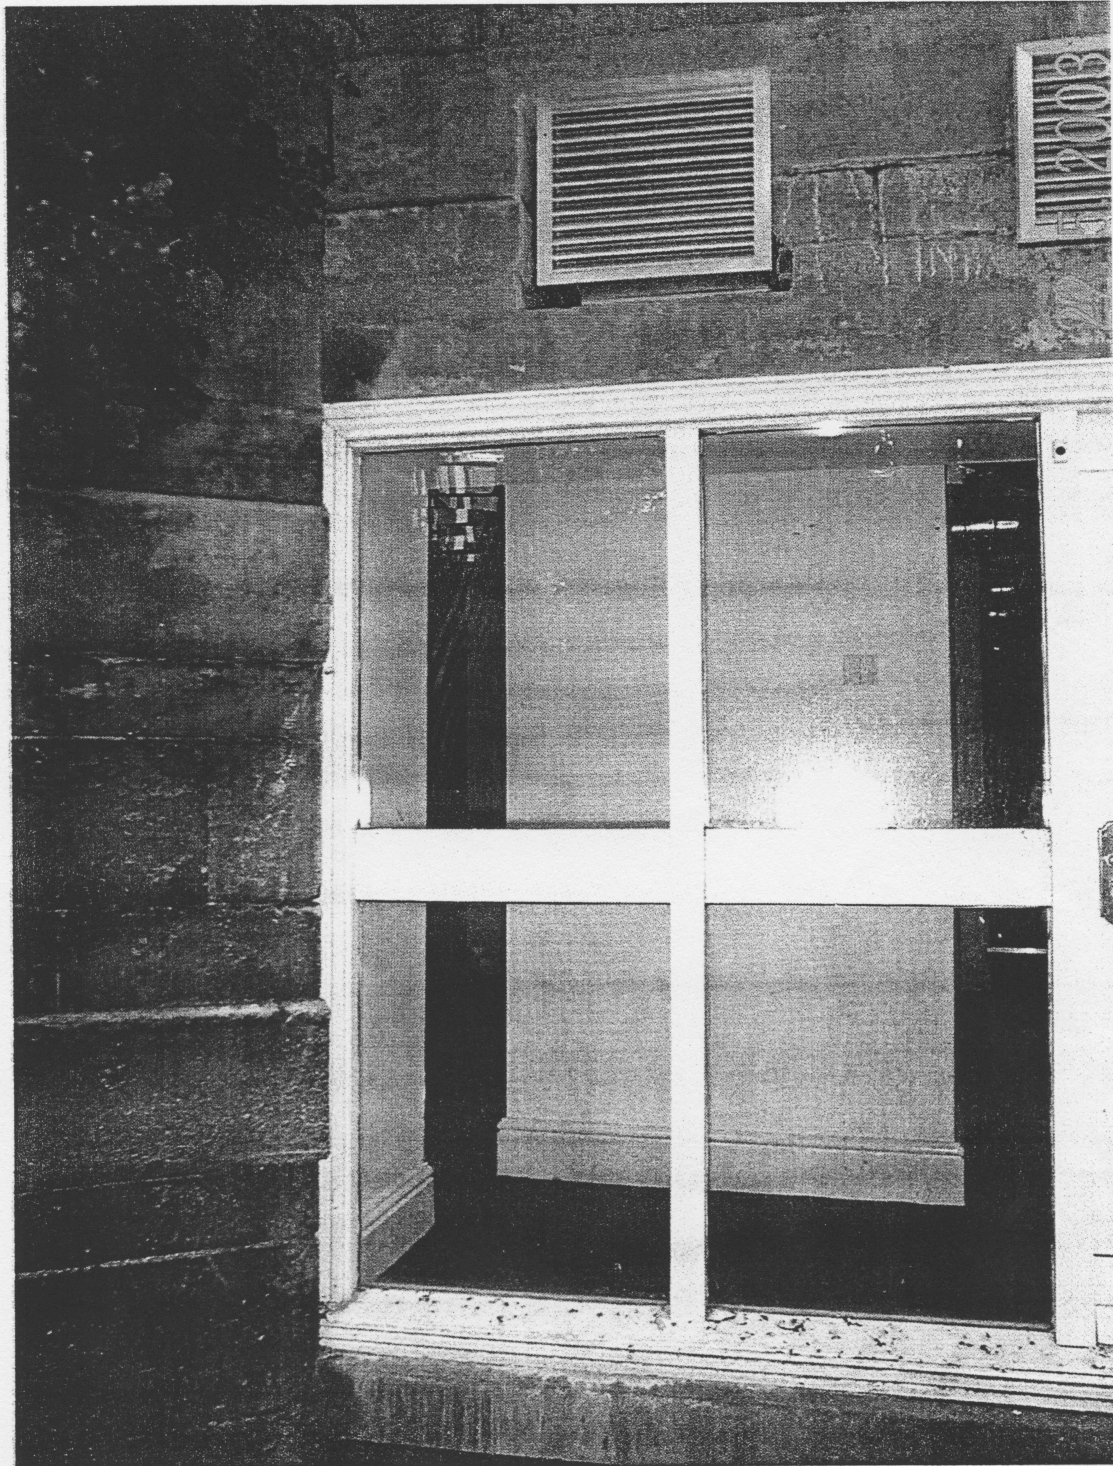
NB: The frame externally has an architrave to the head which is acting as a catch for rainwater allowing it to penetrate internally.

The photograph below illustrates the outside of this entrance screen.
