3.3 *Basement Carpark:* This was examined from right to left having gained access via the basement staircase of communal area D.

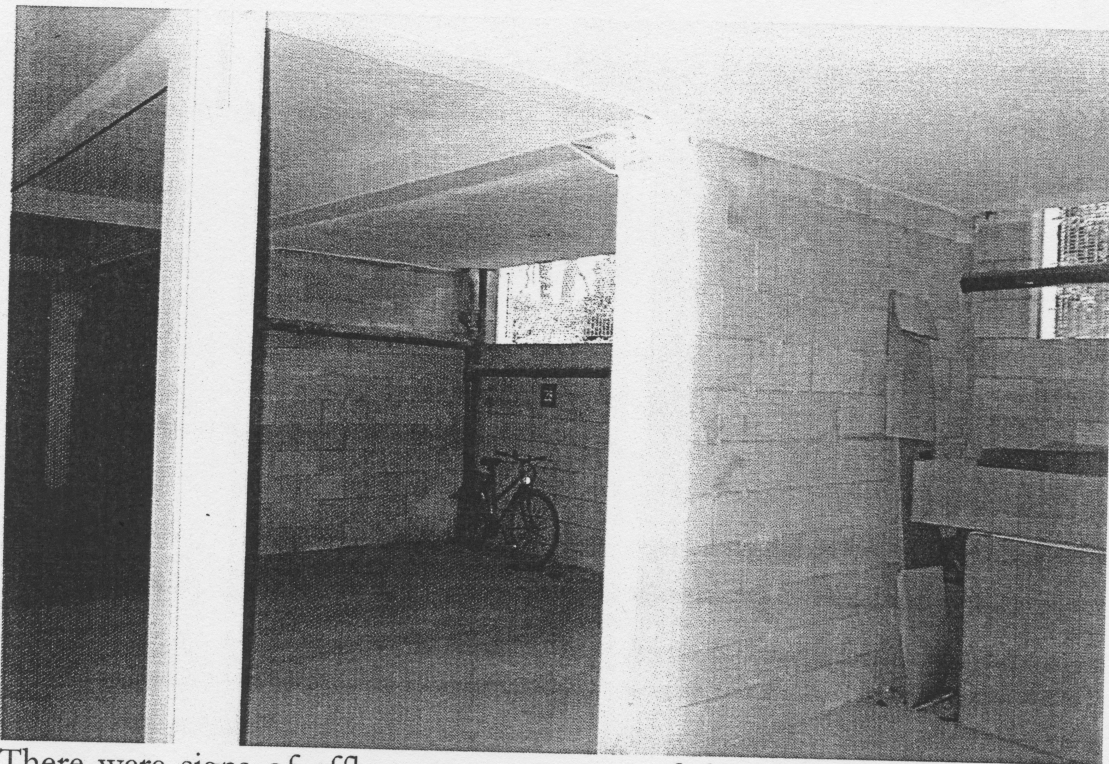
There were signs of efflorescence to most of the partition walls to rear panels of the carpark as typically photographed to bays 26 and 28.

To the base of some support columns corrosion is occurring.

There is a large hole to the forward section of the carpark adjacent to bay 25.

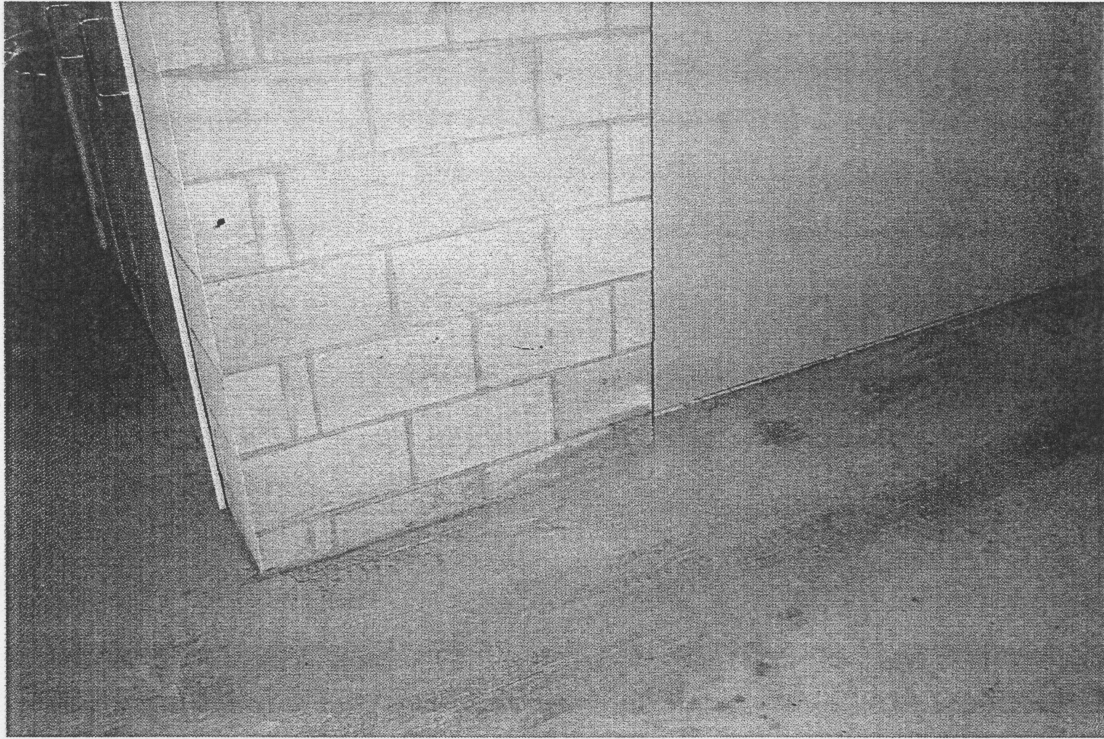
Where decorative rendered panels have been applied over what I am advised is a bitumen type material on battens with expanded metal, this appears to have been undertaken in order to address the problem of weather penetration from above beneath the rear decking and staircases.

Whilst this may have addressed the problem with weather penetration through the sides, unless this membrane is dressed into the damp proof membrane of the floor, then damp staining and ingress will occur at low level and indeed to the base alongside bay no. 18. This could be seen with damp staining to the bottom and top sections of blockwork adjacent.

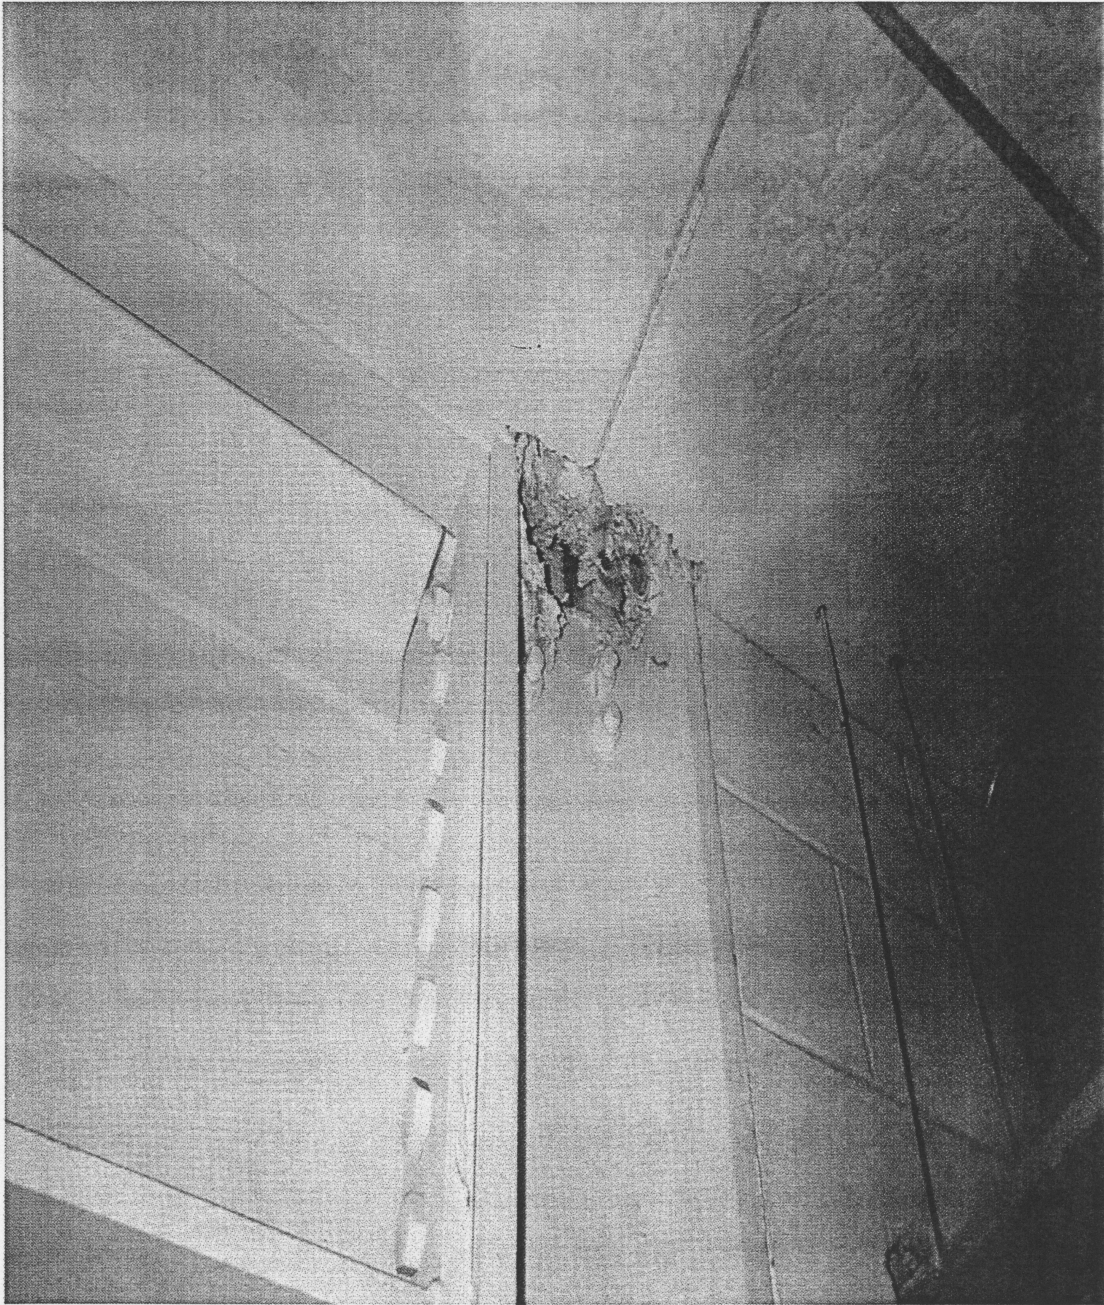
Some of the holes around penetrations of soil and vent pipes, particularly to the forward section in bays 20, 21 and 22 remain to be sealed and this somewhat negates the fire proofing of the structure as a whole.

In particular there is a large hole adjacent to the column at the base of the staircase from section C.

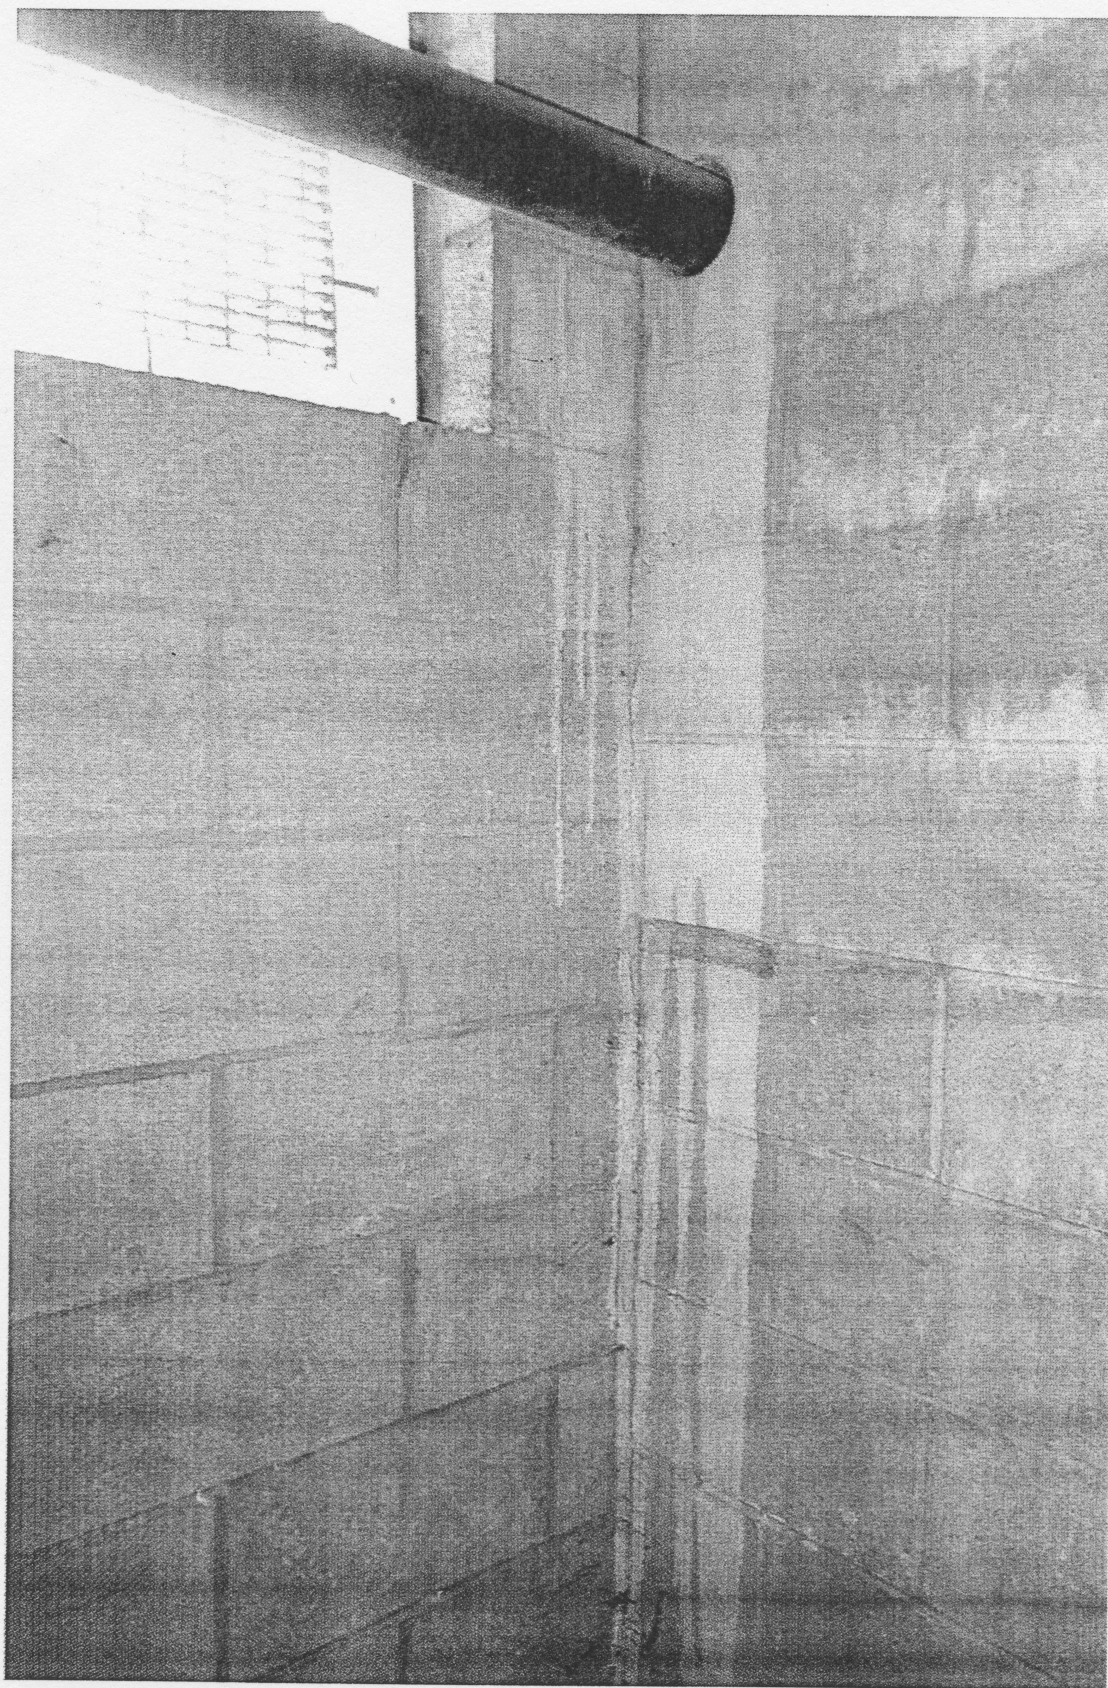
Some separation cracking has occurred between the main rear wall and intersecting partitions see photograph bay 16.

N.B. There are mortar stains above for example the door into mains room B and separation cracking to the external angles of blockwork immediately adjacent.

Some cracks where piers are attached have been untidily repointed.

There is damp staining at high level in the vicinity of the staircase exit from the base of Stairwell/Communal Area B and again further holes which should be properly filled and dressed.

Alongside Bay 15: A panel of blockwork appears to have been cut out and recessed and built back in again.

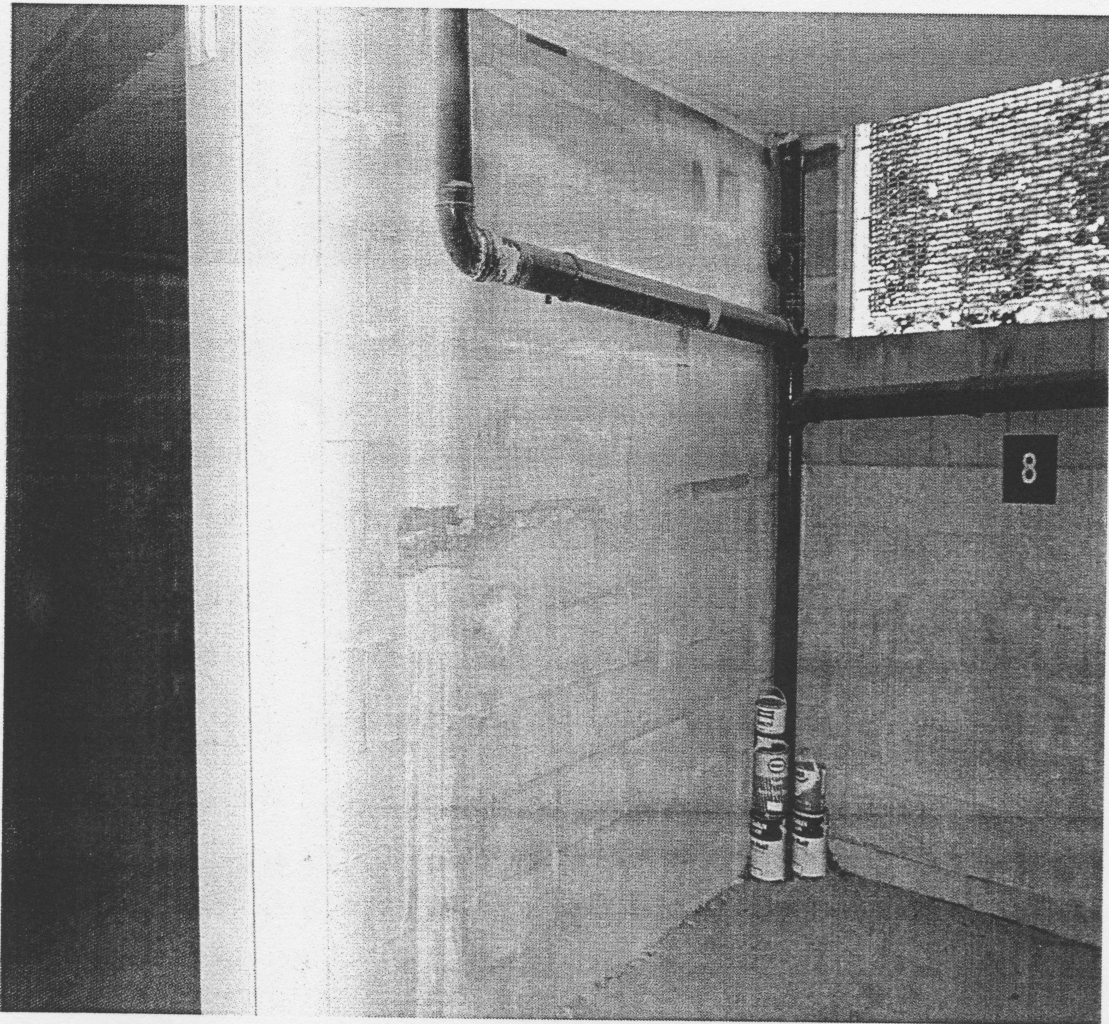
Throughout wherever there are holes with pipes penetrating, there is significant damp or staining, indicating that moisture is penetrating. The most illustrative photograph is that for bay no. 8.

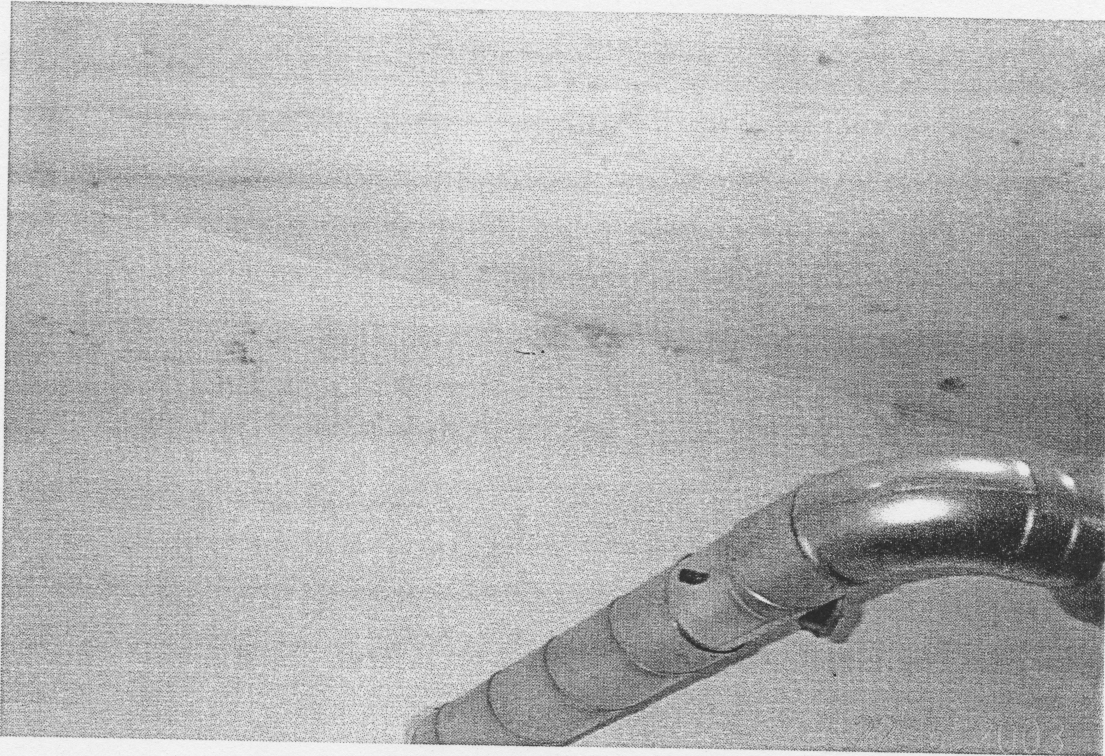
There is also extensive damp staining to the soffit of the entrance door to the external angle with plaster blowing off and corrosion of the angled bead and trim.

External angle beads to columns are grinning through where there is inadequate plaster cover.

At the abutment of the entrance door screen there is further damp penetration and mould growth to the vertical plaster line.

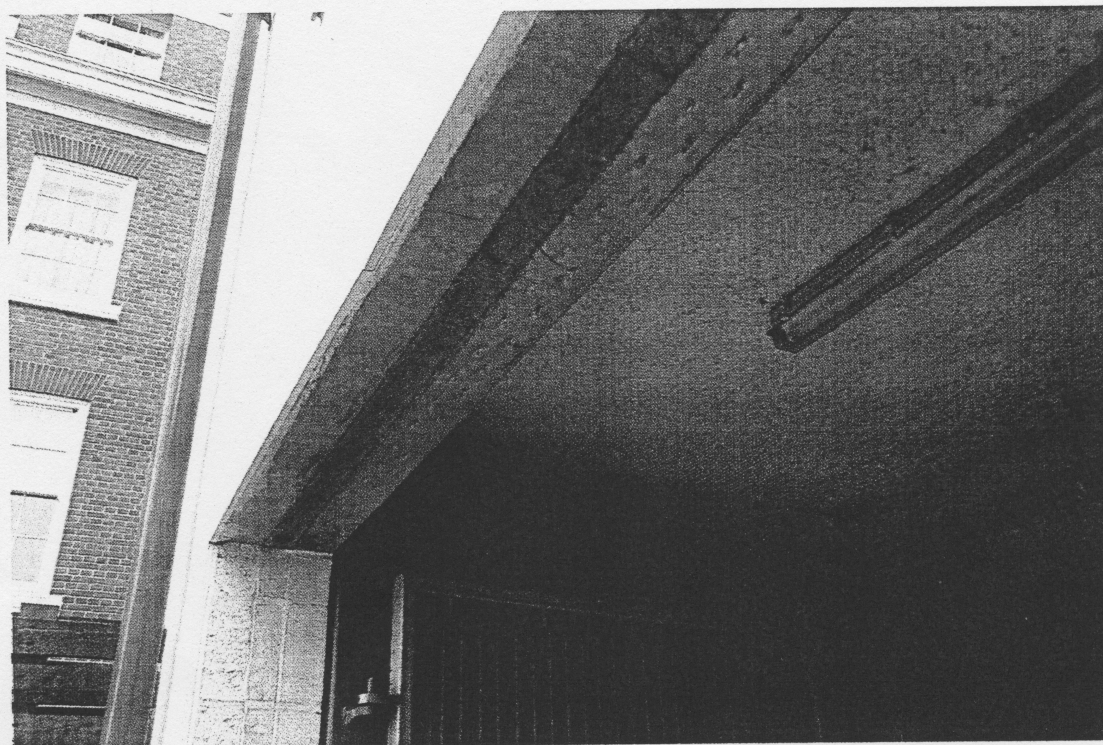
At very high level around the perimeter of the entrance/exit doors to the carpark, there are signs of colour staining and there is corrosion staining to the head of the lintel above.
