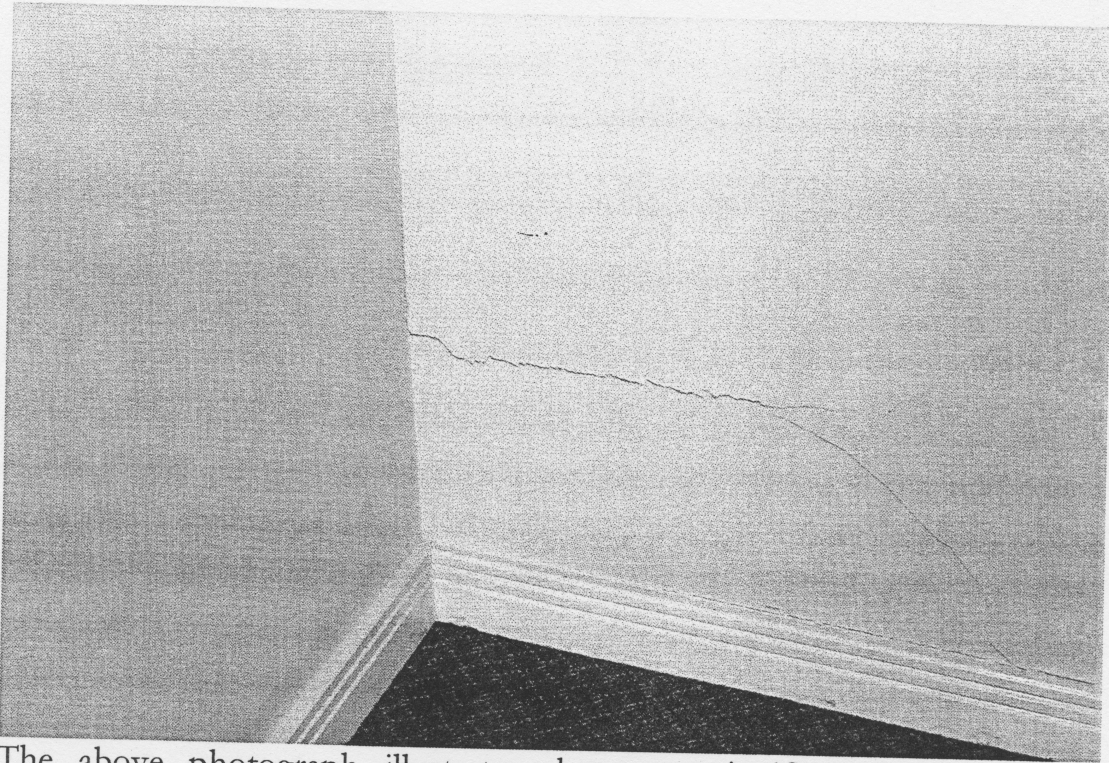
Further cracks have developed in the vicinity of the front wall adjacent to the lift access with outer displacement of plaster to the bottom crack and vertical cracking immediately beneath the narrow window.

The above photograph illustrates the most significant cracking adjacent to the lift at first floor level in staircase communal area A. Also at ground floor the quality of finish to the skirting in the curved section is extremely poor.

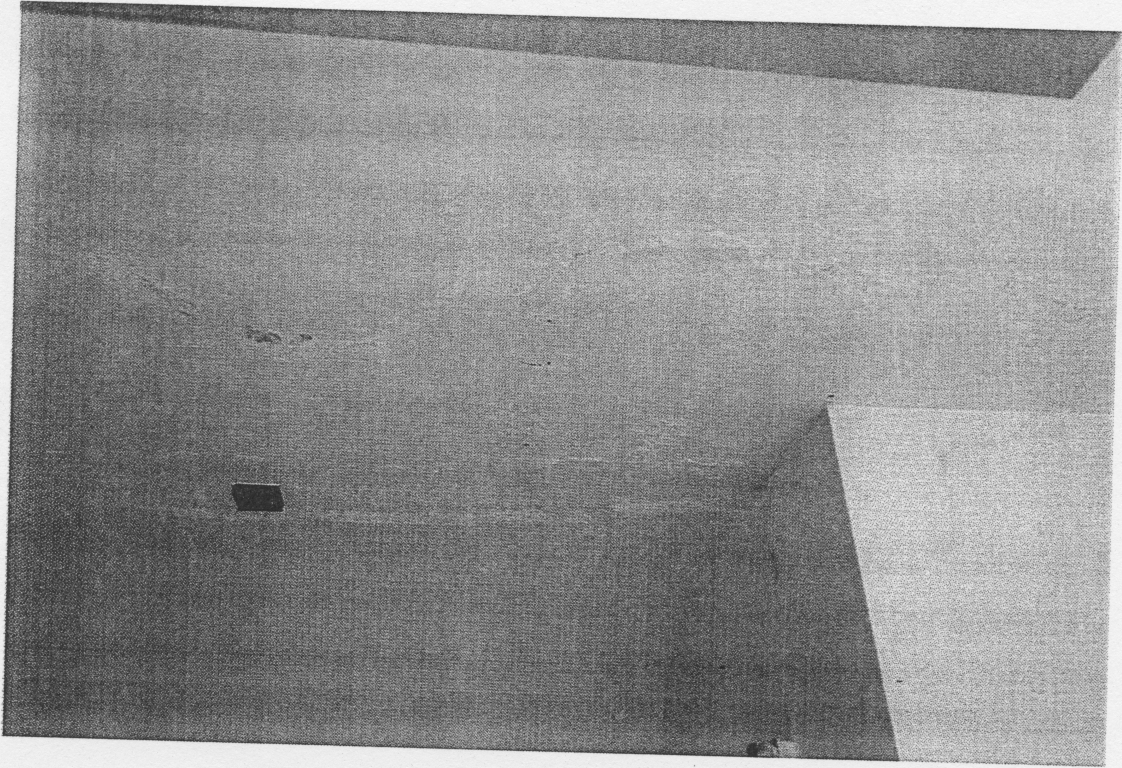
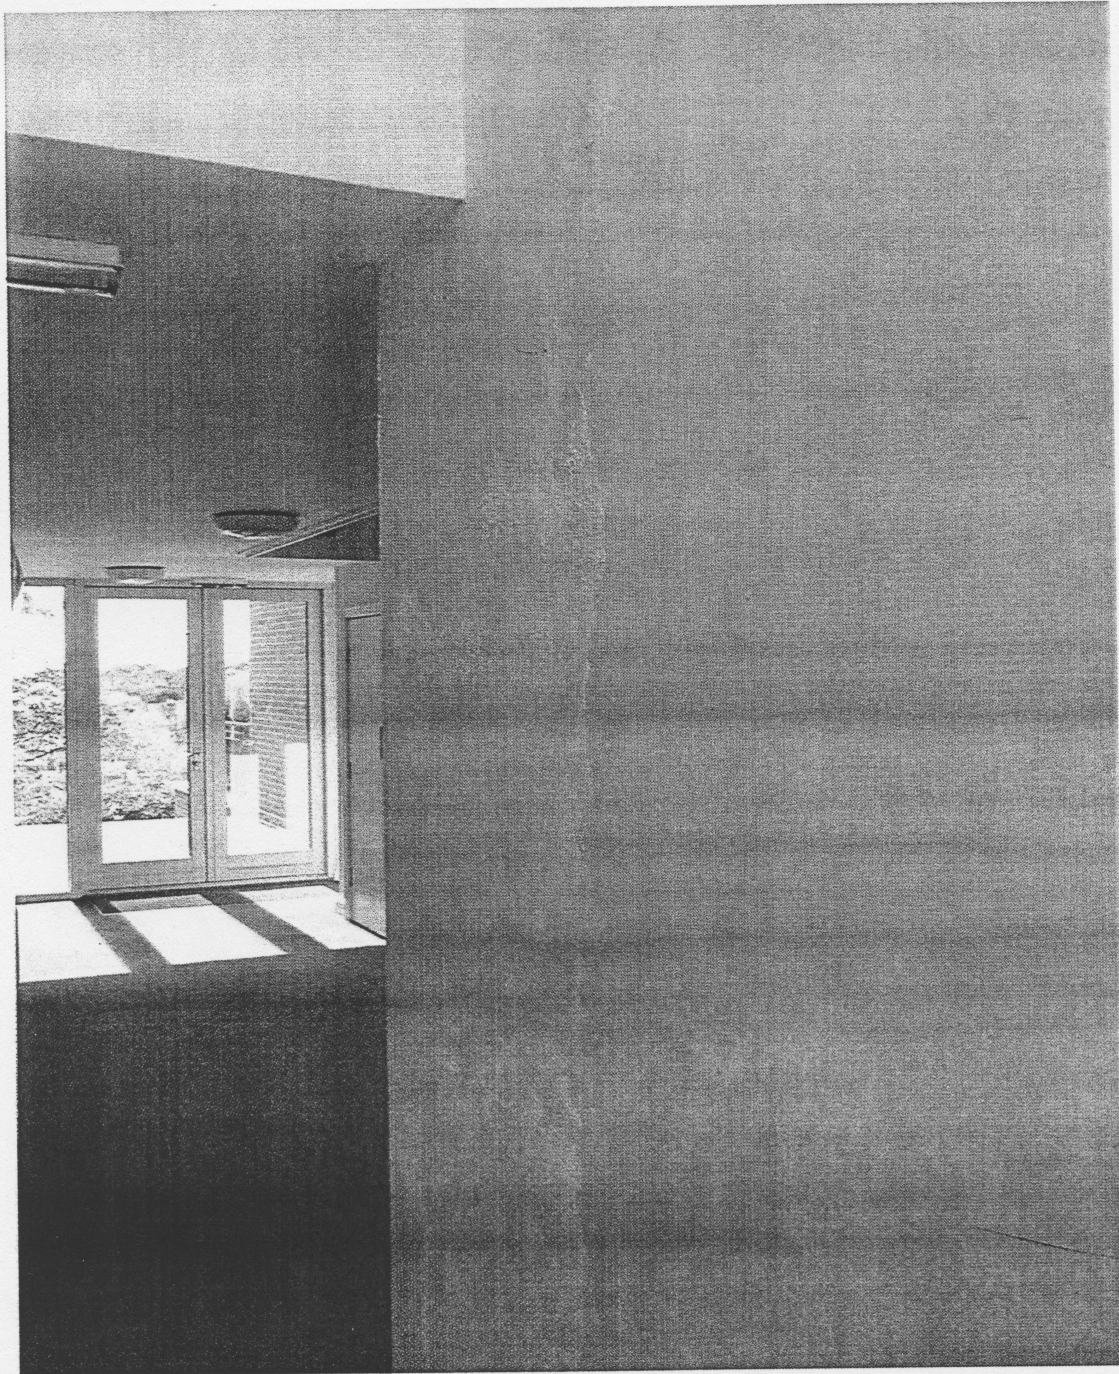
There is significant weather penetration and damp staining immediately as you walk through, either side of the walls and also to the ceiling.

The above photograph further illustrates the damp staining.

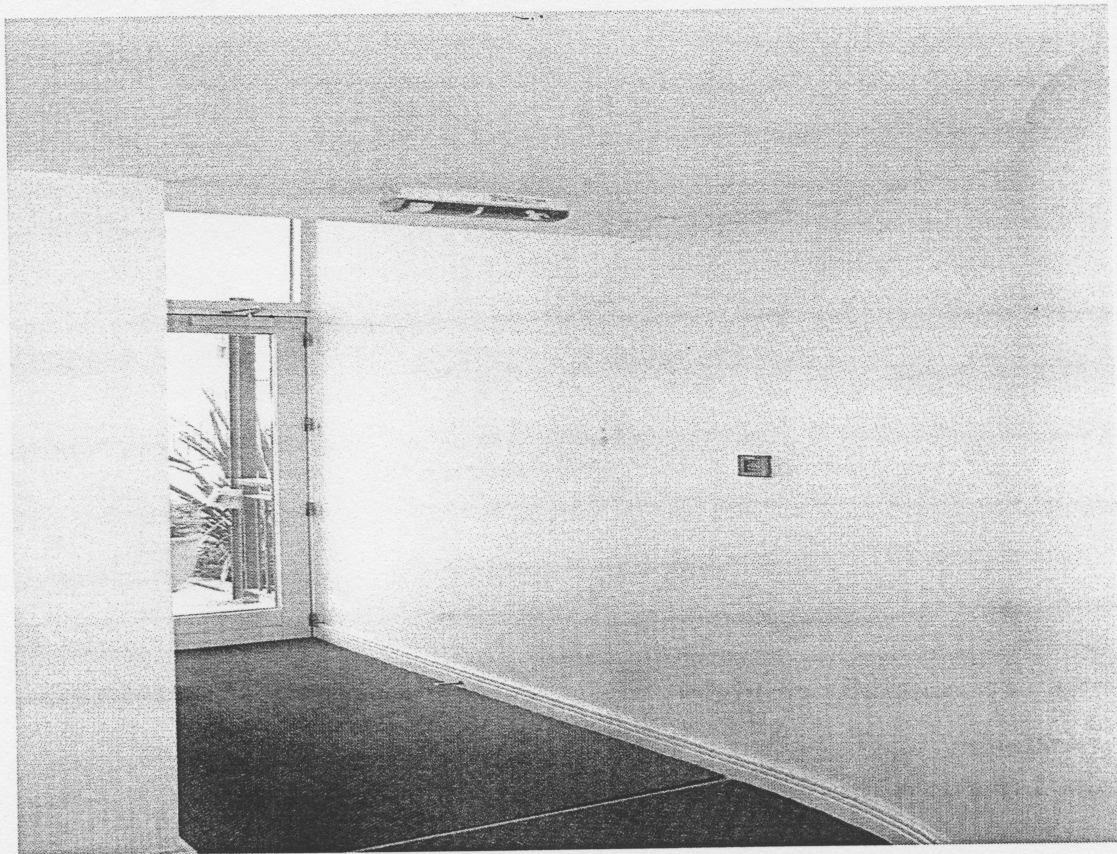
Damp staining was also recorded to the lift wall itself on the return from the main entrance area.

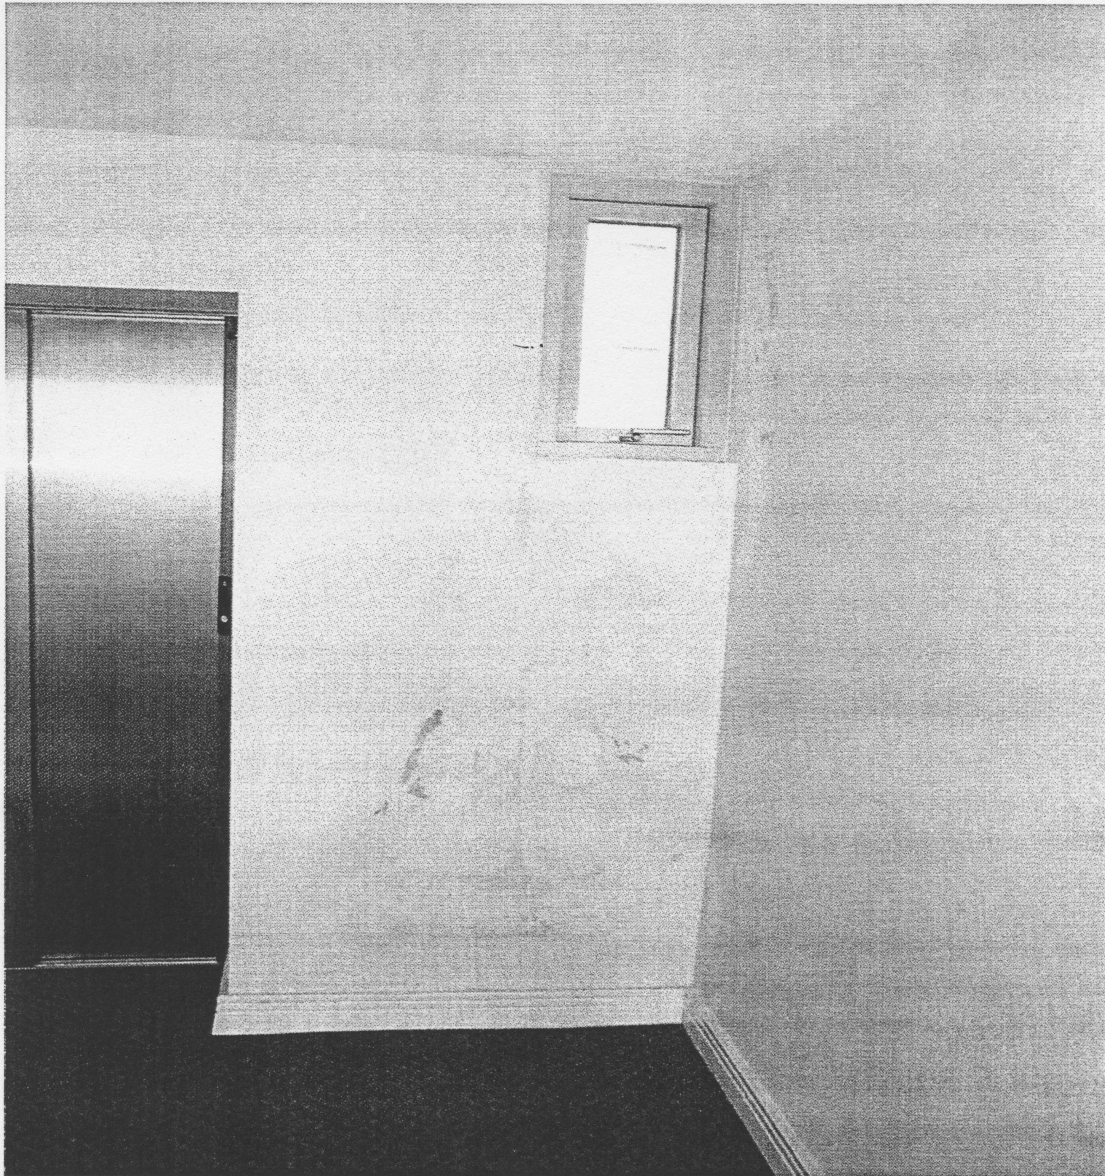
There is significant damp staining and efflorescence to either side of the lift wall at first floor level, with penetrating damp both from above and also the jams and returns of brickwork. The ceiling is stained and plaster is powdering off.

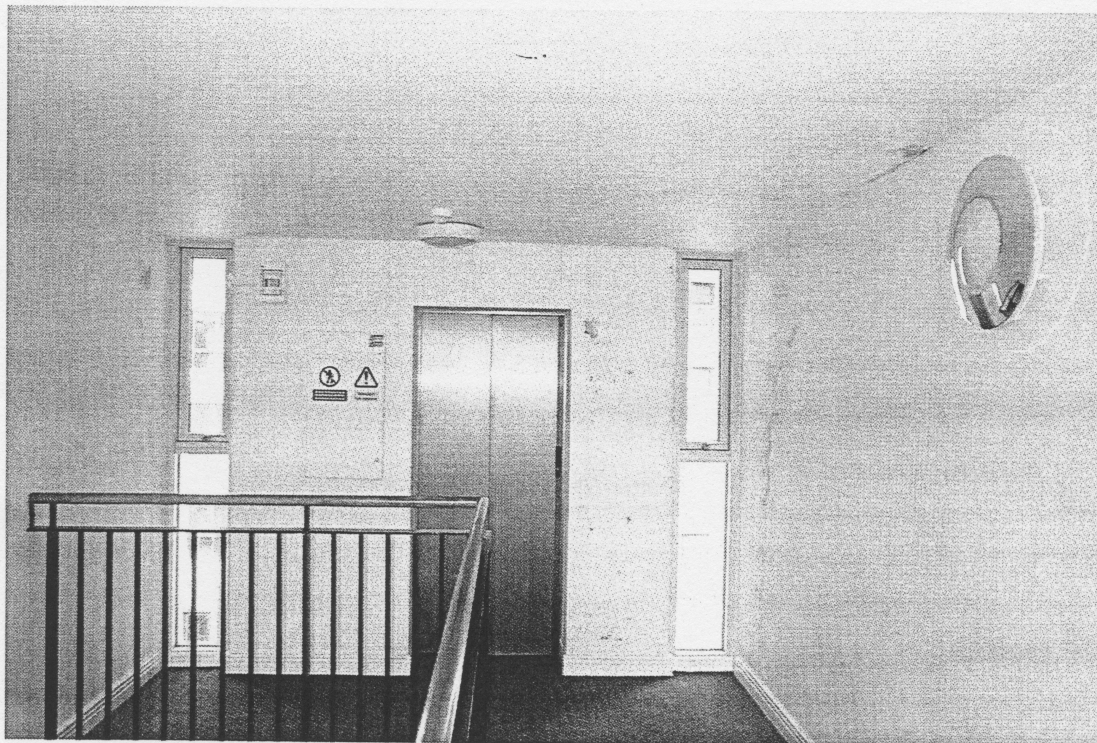
All around the lift is significant damp staining both to the walls and the ceiling.

The major problem here is obviously weather penetration from high level which has descended all the way down the lift shaft area. Looking above indicates that there is a parapet wall above with rainwater discharging into hopper head but it would appear that the

rainwater has ingressed from what is believed a flat roofed section above between opposing balconies.
