2.0 ROYAL STANDARD: The property comprises a conversion of what was originally nurses accommodation for the local hospital.

2.1 EXTERNAL

Front Elevation

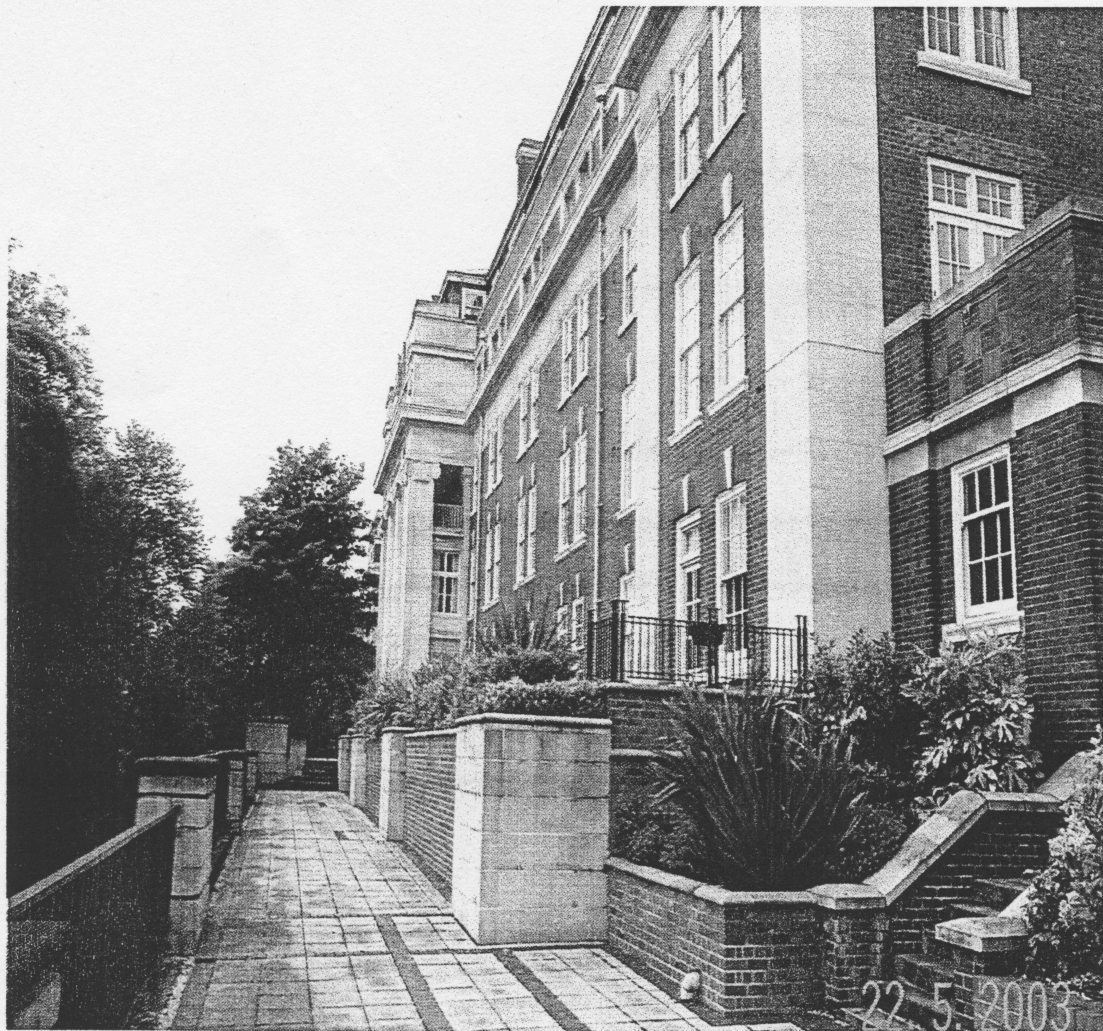
The elevation is illustrated by the photograph below and construction is similar to the front albeit the decorative treatment to the central portico is somewhat grander.

There is a raised garden with brick retaining wall of new construction.

Moss has grown out of the joints of bricks immediately beneath the stone coping notwithstanding that there is a throating and there are weep holes to the bottom courses of brickwork to relieve to the build up of ground water pressure.

However, in the stone clad sections moisture is leaking through the various joints. Some cracking has already occurred and minor displacement, this will become progressively worse over a period of time.
