Gaskell
CONSTRUCTION CONSULTANTS

Ten Year PPM Report

City Point Apartments
Standard Hill
Nottingham

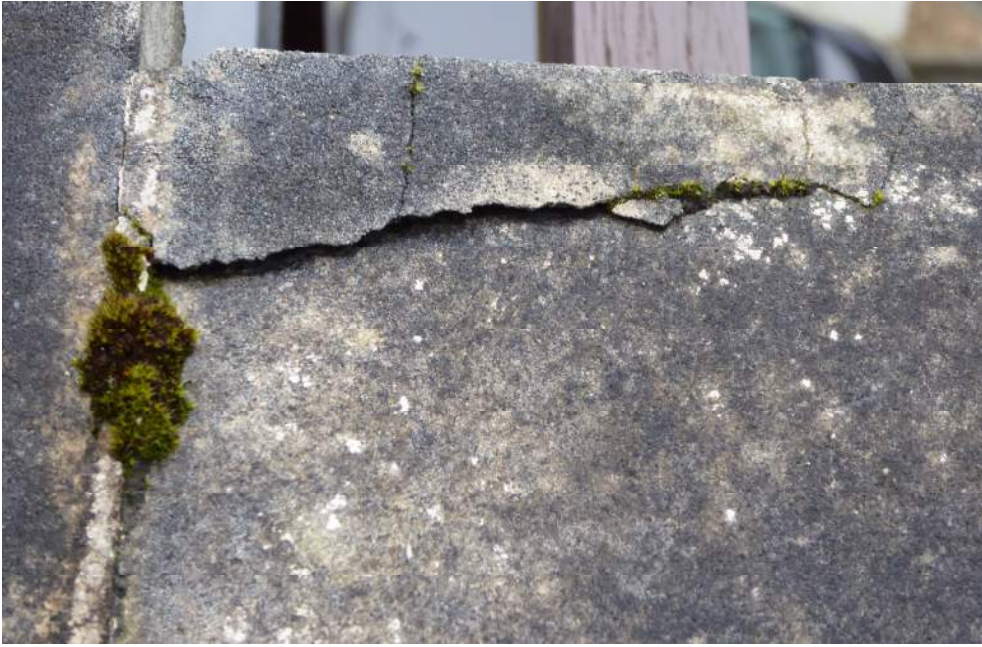
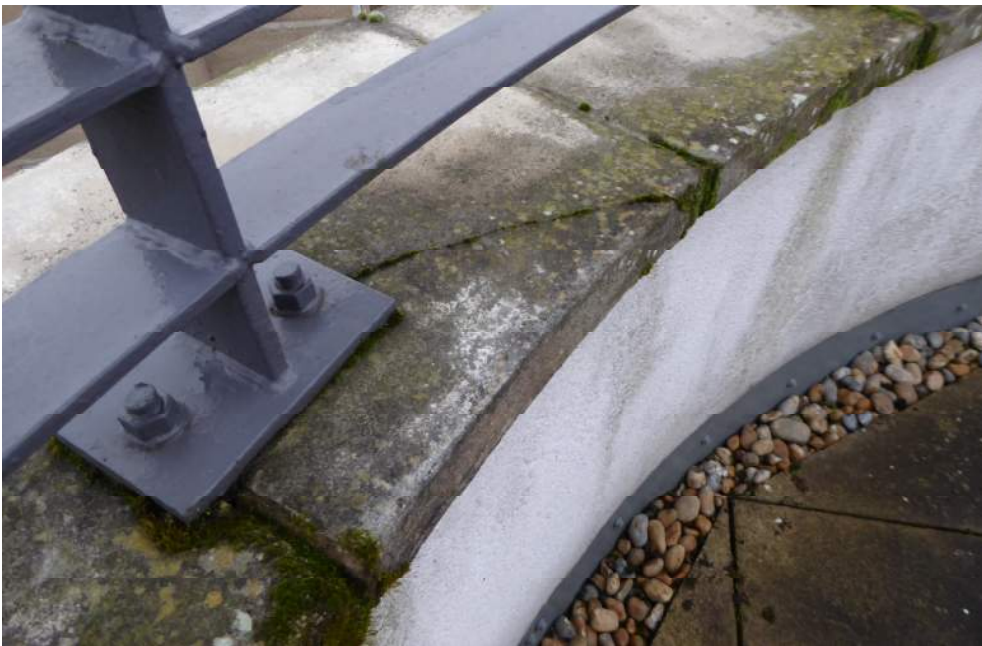
13.	Copings to high level parapets and details	Good but localised spall and cracks to concrete copings	B	41,59,109	Carry out isolated piecement repairs to coping stones.	3			1,000						1,000

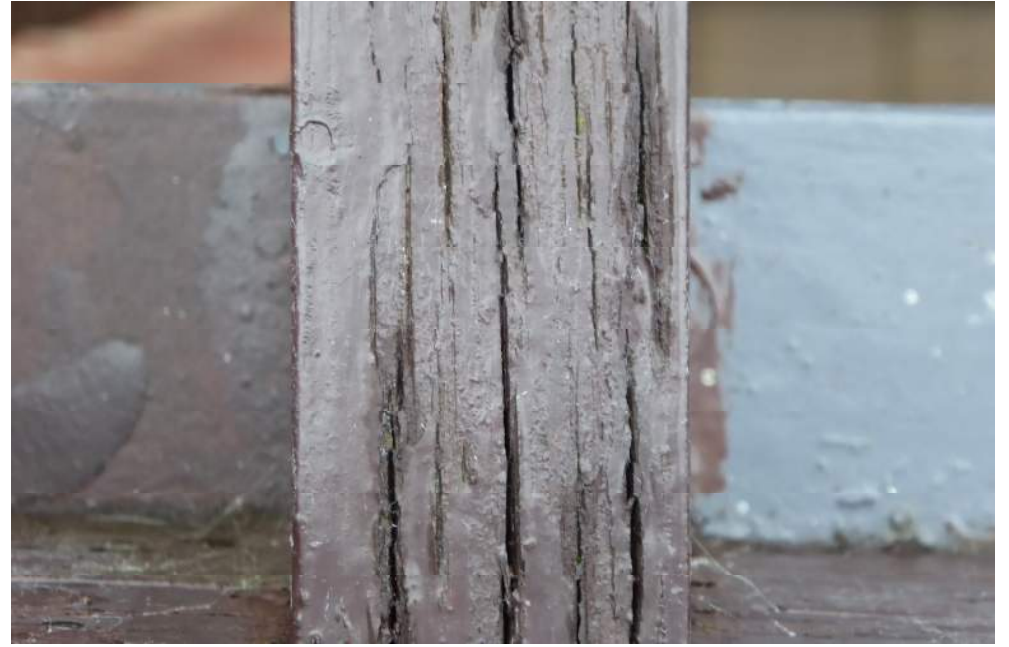
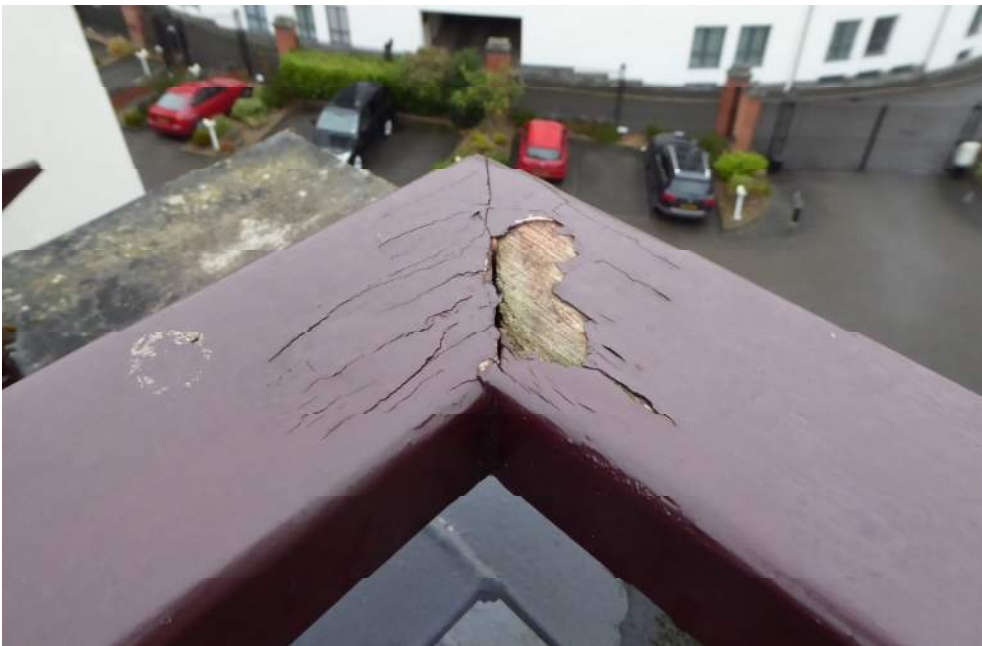
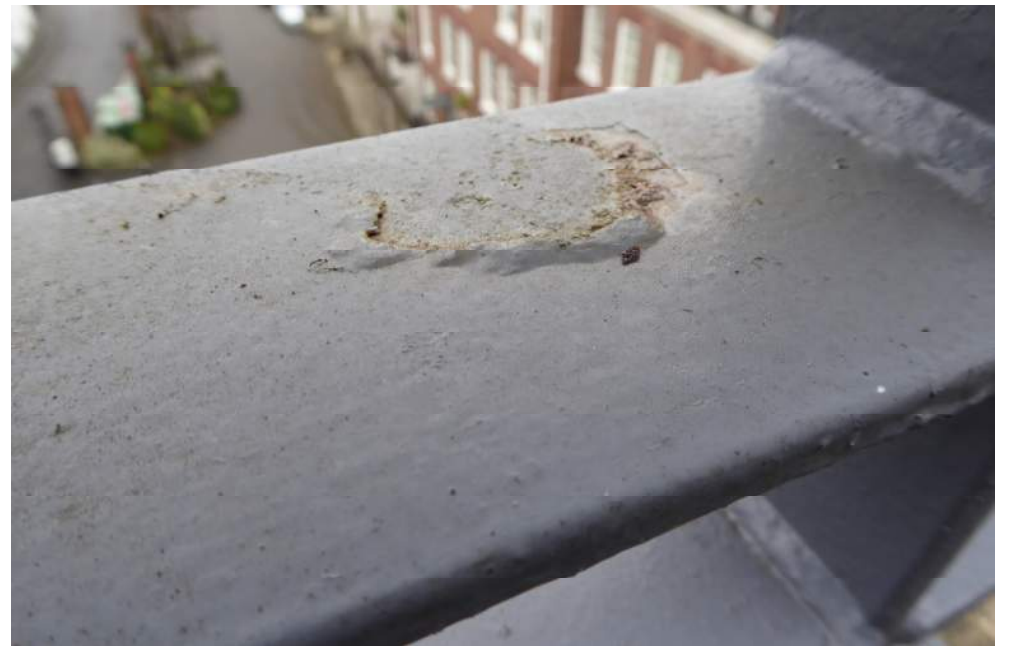
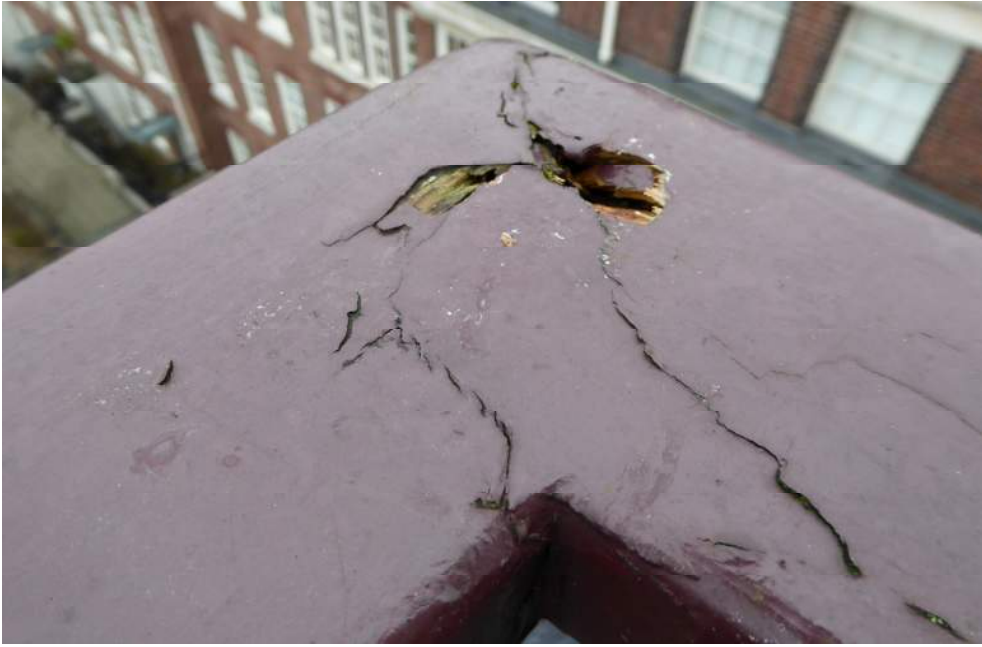
11.	High Level Balcony balustrading and feature timberwork	Timber elements and balustrading fair, but isolated areas of timber decay and failing finishes noted	C	27,37,38, 42,47-49,	Remove areas of decay, make good reinstate and decorate to suit where failing. (Decorations included in Item 2)	2	500		1,500							2,000

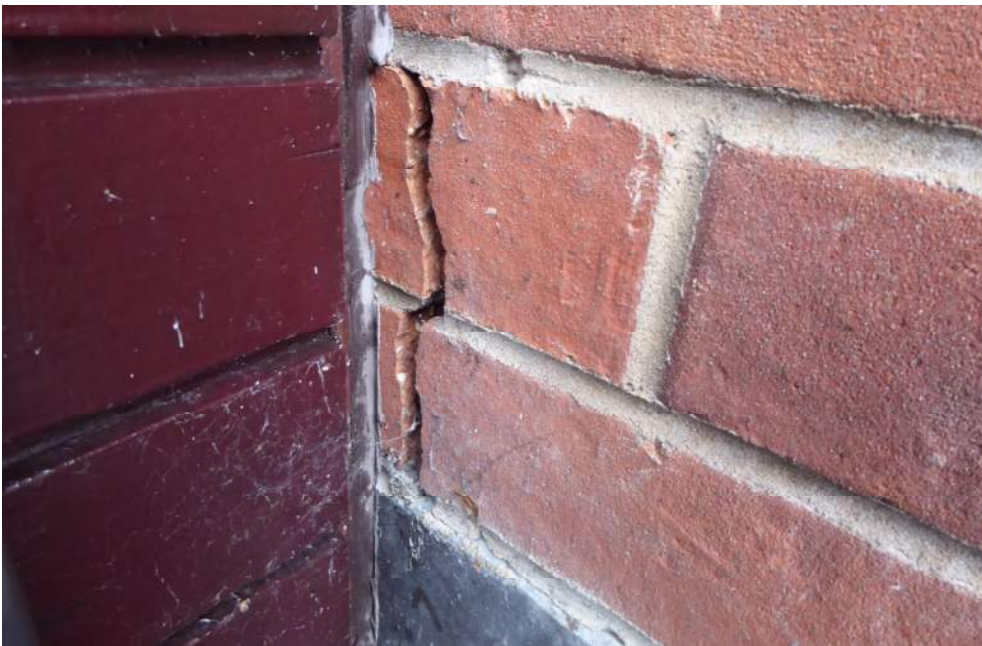
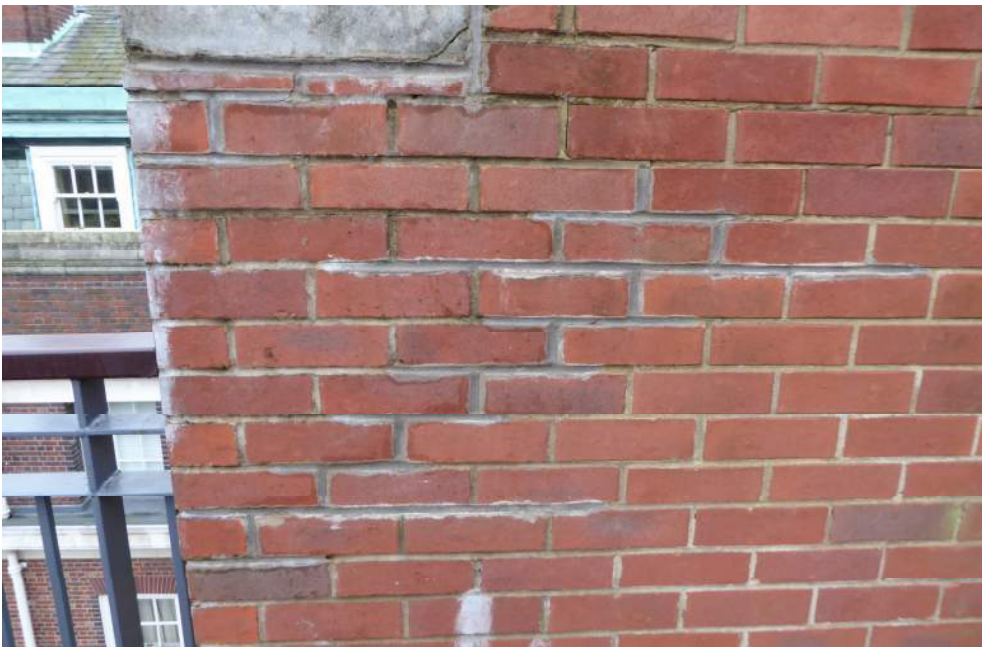
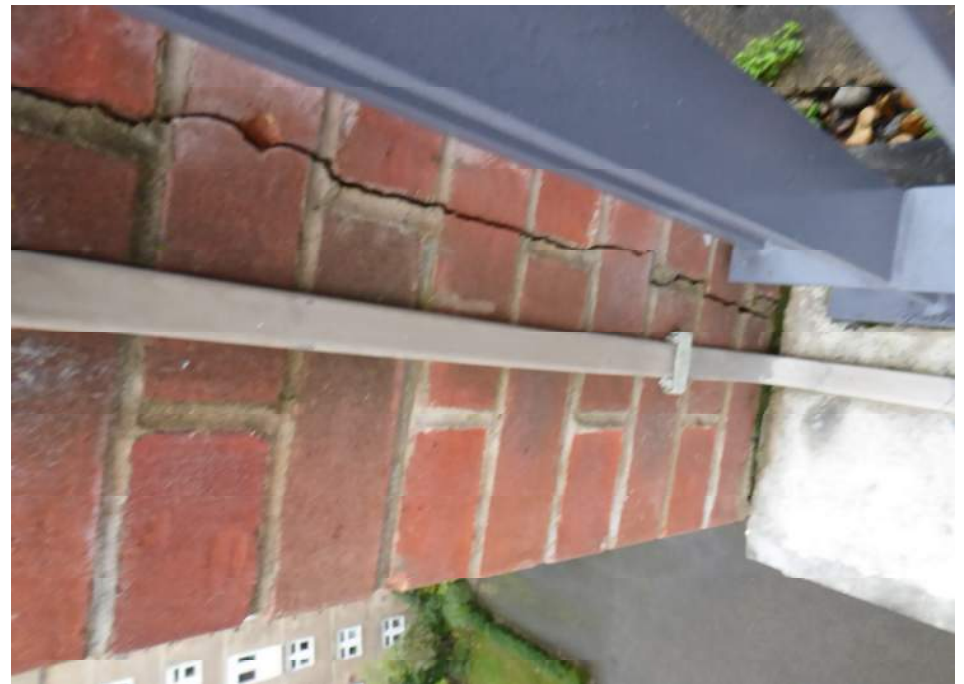
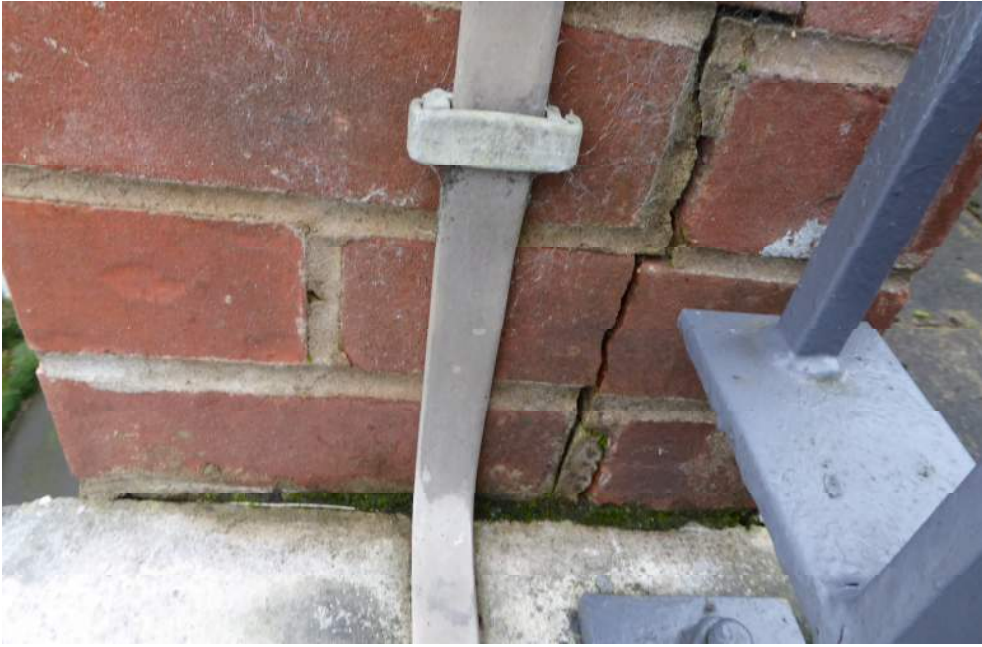
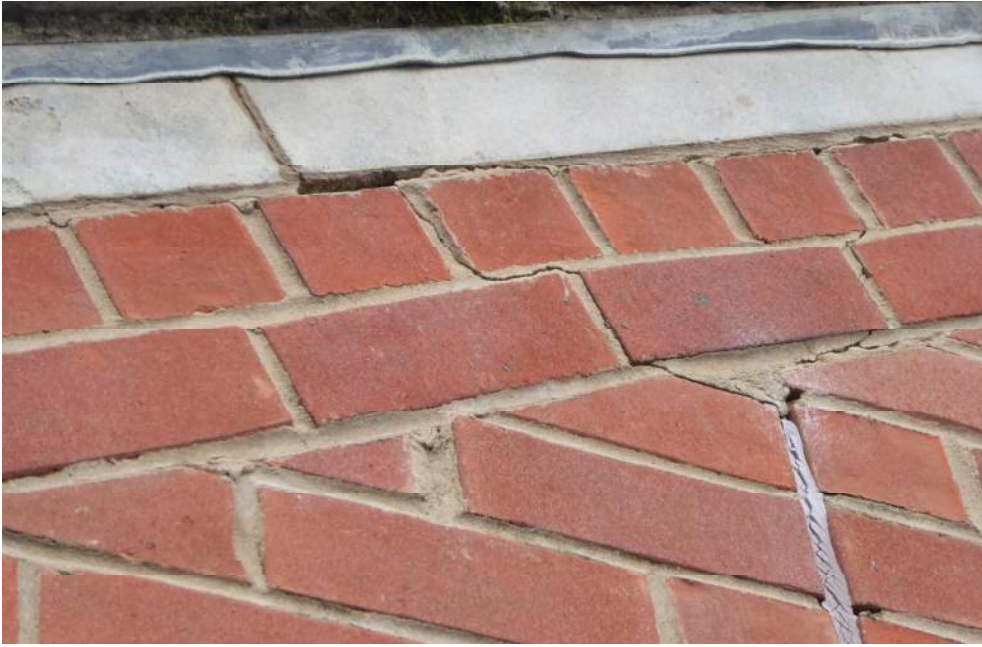
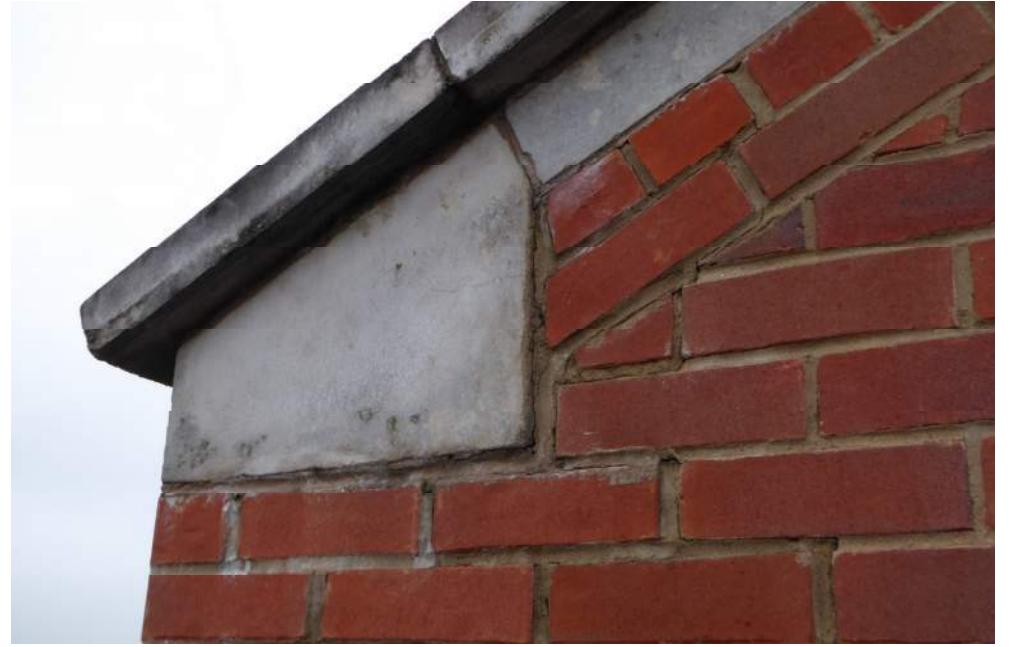
12.	Facing brickwork at high level	Good but isolated areas of cracking and deterioration	C	18,19,43,5 1-53, 57, 58	Carry out specialist crack repairs to high level areas where fractures recorded.	2	3,500									2,500

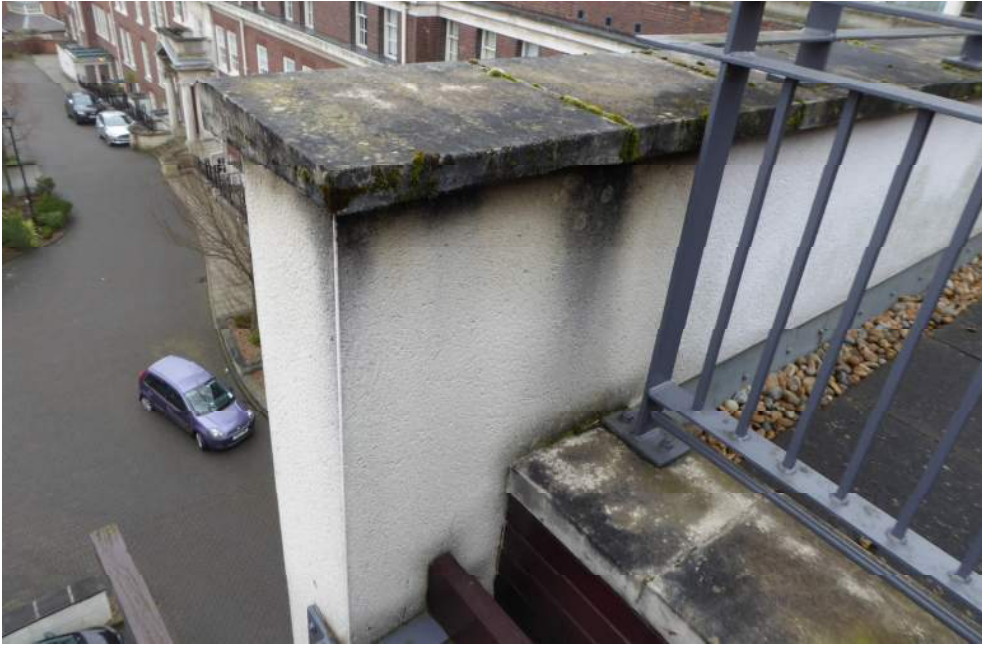
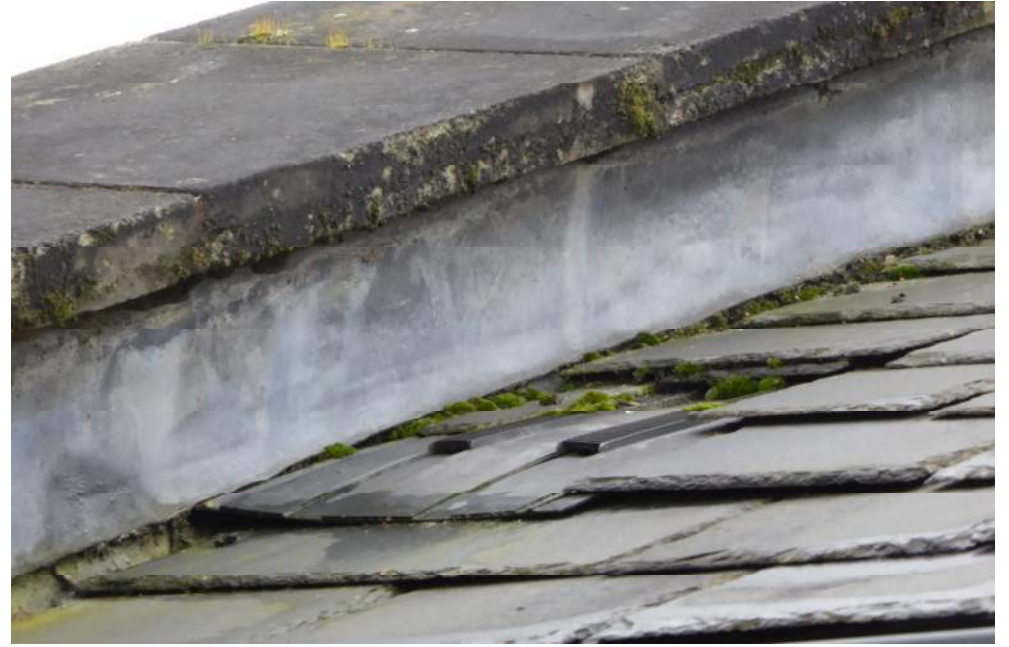
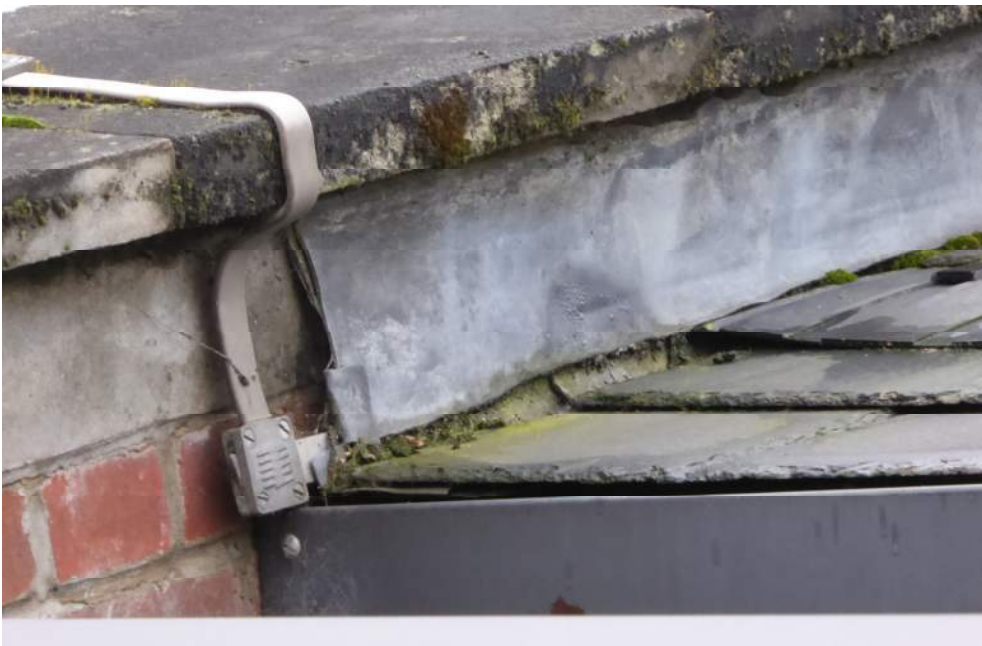
14.	High Level Copings and Parapet Copings	Fair but stained and engrimed and causing staining to surfaces below.	B	12,22,24,2 5,29,30,45 ,54,55,102 ,104,105	Surfaces to be cleaned off and consideration to be given to application of surface coating treatment to concrete copings (clean off only costed)	3			1,500							1,500

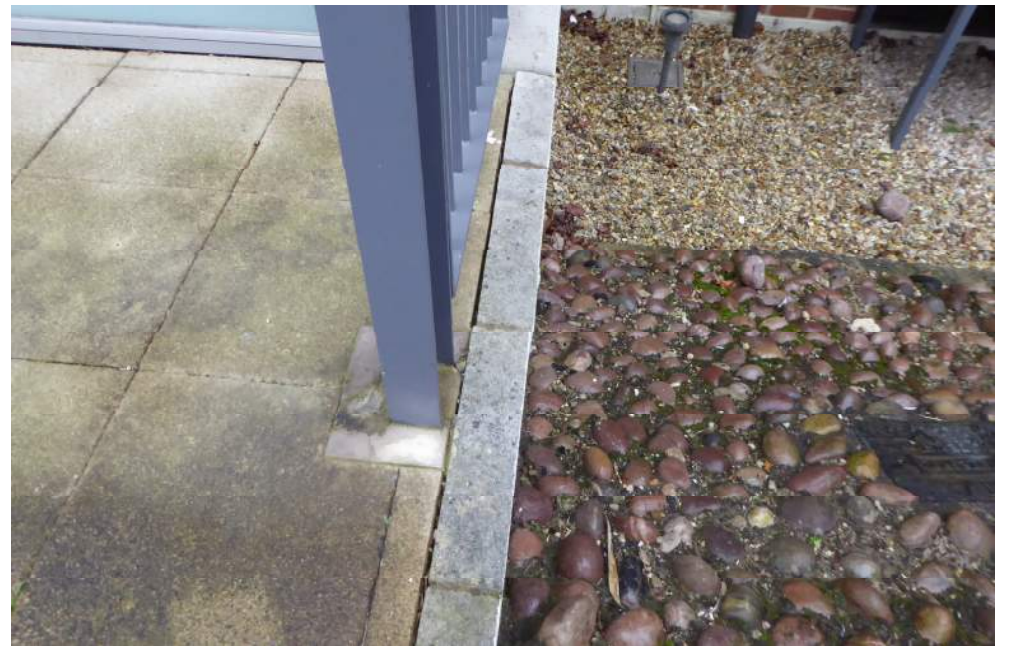
80

15.	Ground Level Access Points	Fair but blockwork locally loose and dislodged	B	80-82, 130	Refix where dislodged.	3			1,500							
16.	Electrical fitments generally	Good	A	-	PAT testing + 5 year fixed wiring	2	60	60	60	60	60	60	60	60	60	60
